**RAPID UPDATE**

# Rapid Update 597 Grecale – 48V system – Four points Nut tightening torque check

DATE: FEBRUARY 21 2023

Certain Maserati Grecale (M182) MY23 listed in MODISCS+ are involved in a Rapid Update related to the potential of five cable nuts losing torque.

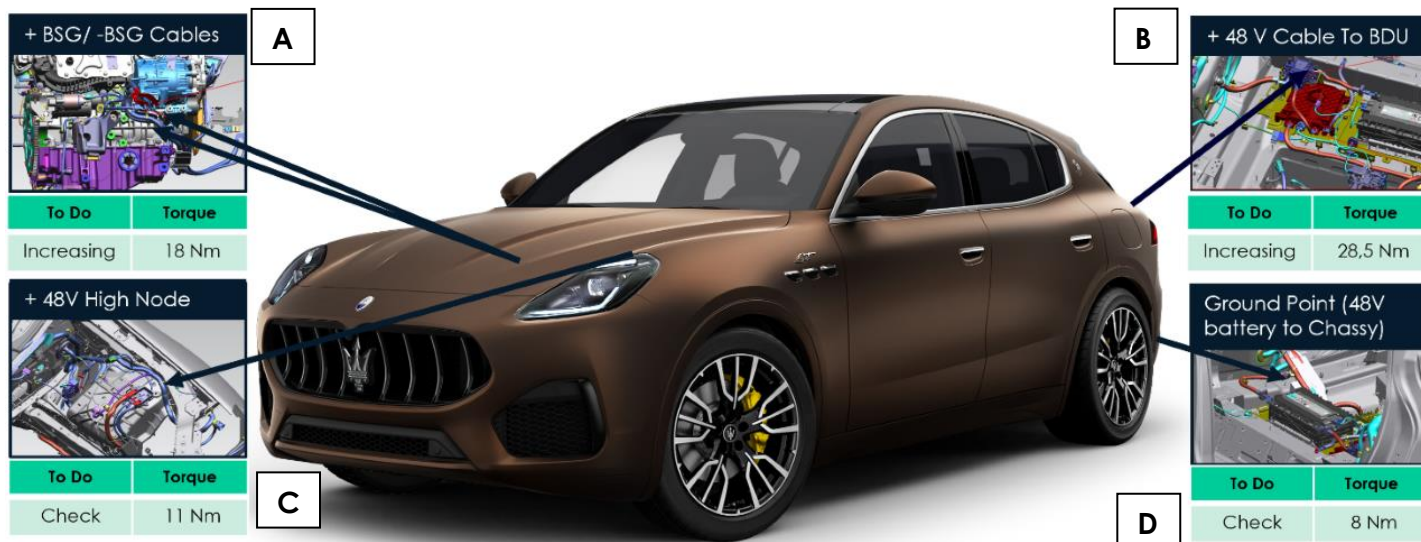
It was found that a wrong tightening torque has been applied in production with potential electrical issues on the vehicle and Hybrid system malfunction or in some case the complete discharge of the 12V battery. The remedy will require the inspection of four nuts located in the trunk and engine compartments, restoring the correct tightening torque.

To complete this rework, it is necessary to check the 5 points below:

- A. Positive and Negative BSG Cable on the engine block. -> Increased nut Torque to 18 Nm
- B. Positive 48V Cable to BDU in the trunk compartment -> Increased nut Torque to 28,5 Nm
- C. Positive 48V High Node in the Engine Compartment. -> Check Only (11 Nm)
- D. 48V battery to chassis Ground point in the trunk compartment. -> Check Only (8Nm)
