MAS003413 RU 22-10

**RAPID UPDATE**

# Rapid Update 574 MC20 - Interior handle replacement

DATE: FEBRUARY 14 2023

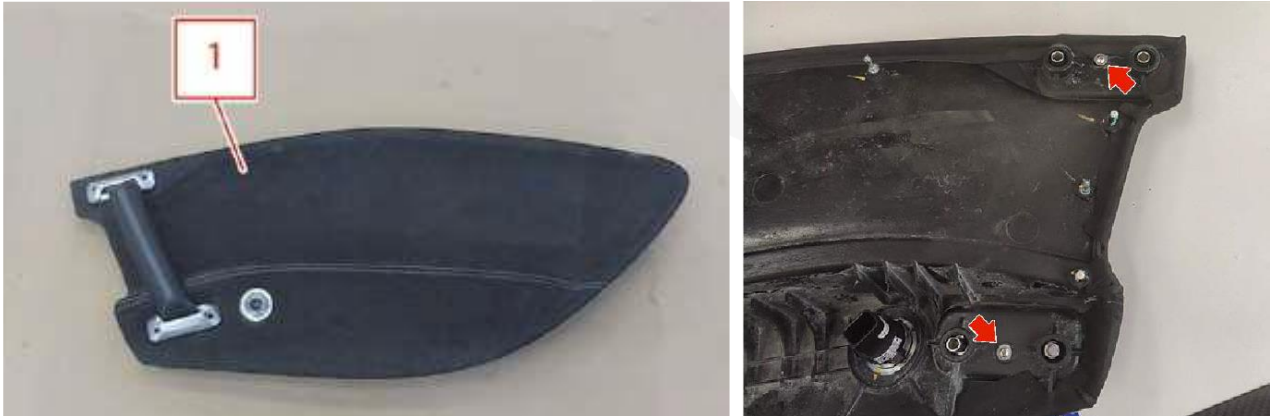
This intervention is necessary because a limited number of cars have been fitted with handles that do not meet the high Maserati quality standards and may present fraying with the passage of time. The phenomenon is due to the use, on this limited lot, of a textile fabric that is not properly cauterized.

3. Place the paneling (1) on the workbench, taking care to protect the inner part from all types of scratches and dirt and move the handle by unscrewing the additional two screws inside the paneling.

4. Then replace the standard handle with the new one, taking care to correctly reposition all the screws previously disassembled.
5. Perform the same procedure on the left side of the car, replacing both handles.
