SIB 63 02 23

INNER TAILLAMP TURN INDICATORS ARE NOT FUNCTIONING

E-Series	Model Description	Production Date
F44	2 Series Gran Coupe	July 18, 2022 – October 18, 2022

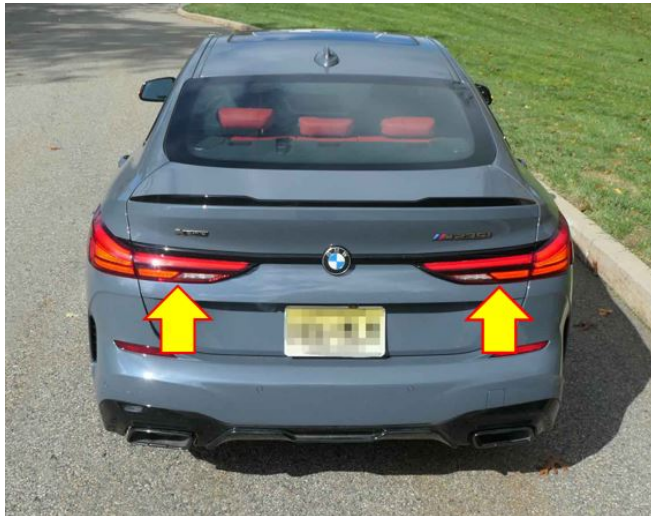
The trunklid-mounted inner taillamp turn indicators (arrows) do not function.

A software error in the BDC (Body Domain Controller).

Program the vehicle using ISTA version **4.38.1x (S18A-22-07-559)**; released late Oct. 2022).
