# Technical Journal

**No AC Charging with DTC OBC-P0D1513 and/or OBC-P0D1556**

<b>REF NO:</b> TJ 36522.1.1	<b>ISSUING DEPARTMENT:</b> Technical Service	<b>CAR MARKET:</b> United States and Canada	
<b>PARTNER:</b> 3 US 7510 Volvo Car USA		<b>ISSUE DATE:</b> 2023-02-21	<b>STATUS DATE:</b> 2023-02-22
<b>FUNC GROUP:</b> 3234	<b>FUNC DESC:</b> Onboard charger, high voltage	Page 1 of 5

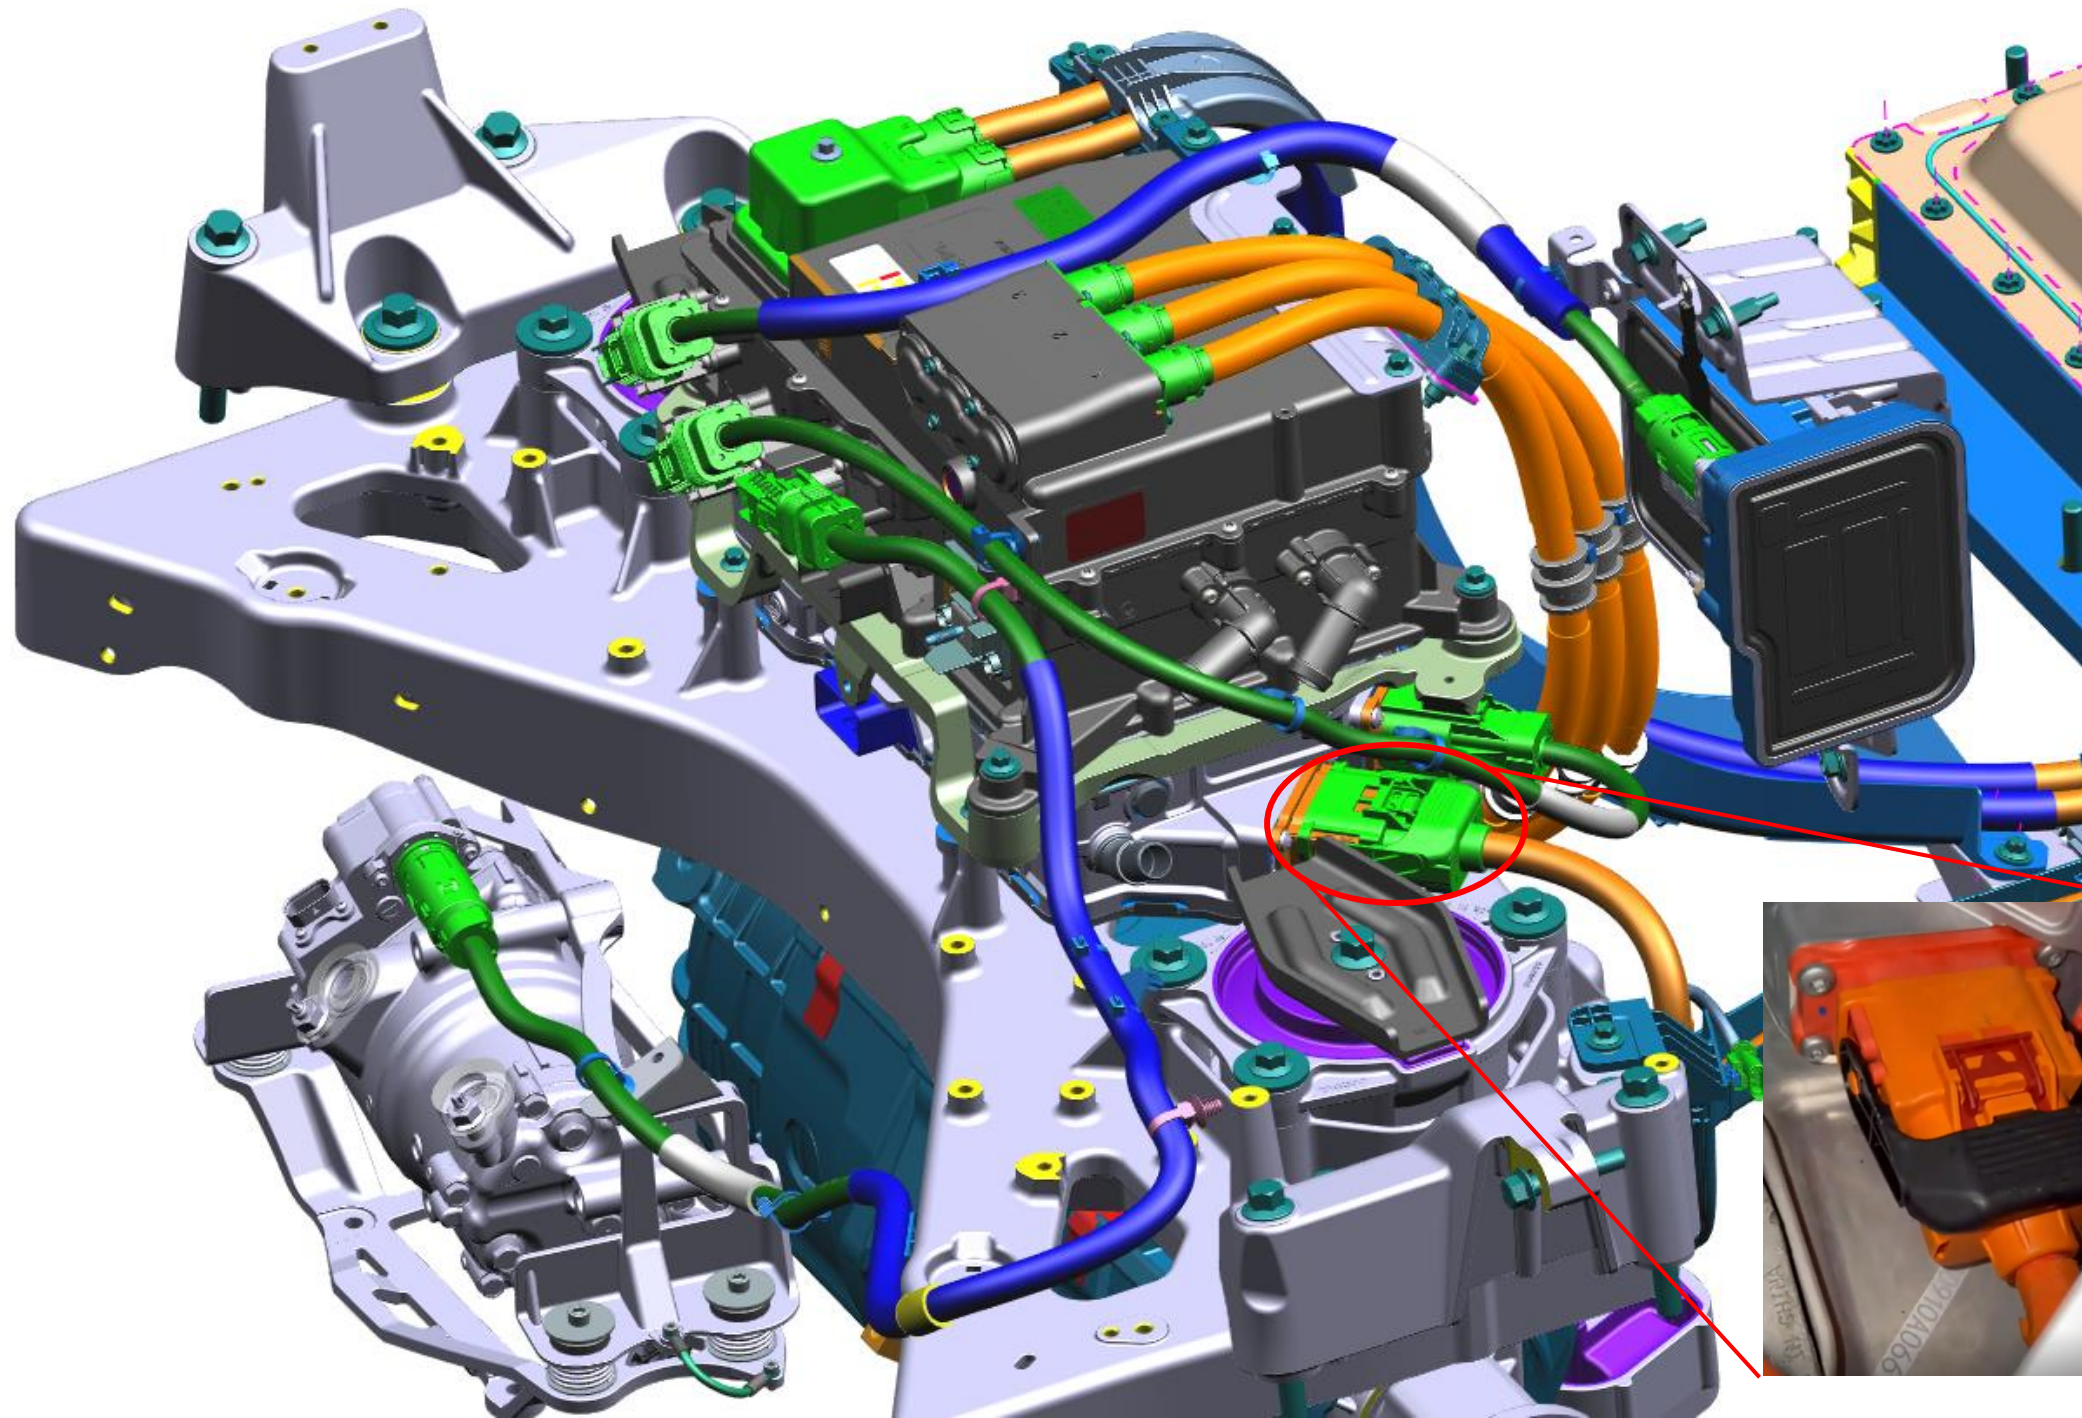
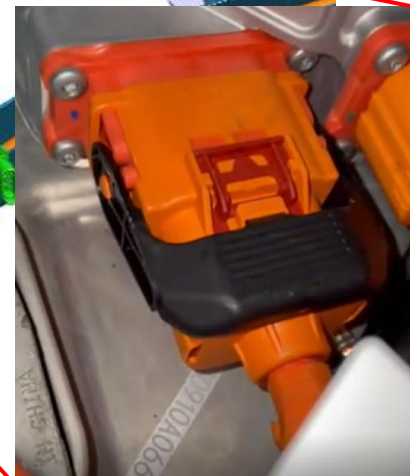
1

In occasional cases, connector catches of the AC HV connector at the OBC (to connect the HV cable harness from the EVI) are not properly closed by the plant. That leads to the effect that Mode 2 and Mode 3 AC charging is not possible.

See the attachment above for the connector location.

1. Fully disconnect AC HV connector EVI > OBC from the OBC  
The attached pdf file also shows how to release the two connector catches, that might be improperly closed, before disconnection
2. Ensure that the connector is in a proper condition and that no foreign objects are present
3. Reconnect the connector  
**Note:** It is of high importance ...
  - a. to push in the connector well.
  - b. to close the two connector catches. The attached pdf file shows the **release** of those catches, and for closure, **you must push in opposite direction than the arrows shown in the drawing.**
