94-23-01TT - Daytime Running Lamps / Parking Light Error in MFI with fault code C123B01

Applicable Vehicles Model(s) Year Eng. Code Trans. Code VIN Range From VIN Range To ID.4 2023 All All All All

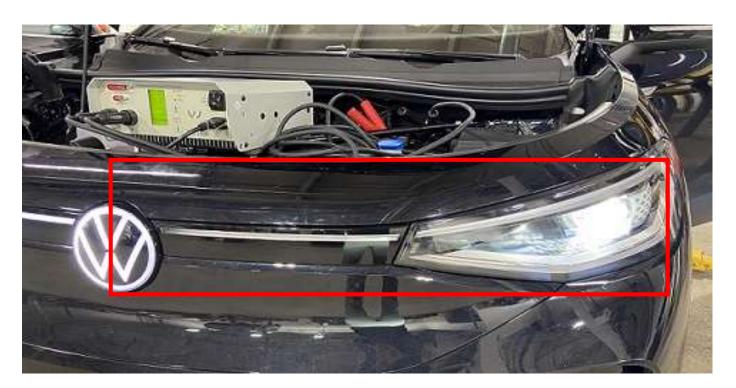
Half of the VW emblem, light strip in the grill, and the daytime running lights will no longer be illuminated on one side of the vehicle. (See illustration below). Fault code **C123B01** may be stored in AW-D6 or AW-D7.

With DTC **C123B01**- Bulb for parking light electrical error stored in AWD6/D7, and the DRL circuit inop on one side of the vehicle, inspect the VW emblem for operation and water condensation.

• If condensation is found and/or half of the emblem is not illuminated, cycle the ignition OFF and swap in a known good front emblem (if available) and retest. Cycle the key and if the DRL circuit (headlight, light bar and VW emblem) comes back on, replace the front VW emblem.

• If the concern is no longer present, water is found in the emblem, or a known good part is not available, it is recommended to replace the front emblem, clear the fault memory, and retest.
