GLOBAL SAFETY FIELD INVESTIGATIONS
DCS6504
URGENT - DISTRIBUTE IMMEDIATELY

Subject: N222391510 - Customer Satisfaction Program
Body Harness Missing Circuits

Models: 2023 Chevrolet Silverado 1500
2023 GMC Sierra 1500

N222391510 Body Harness Missing Circuits

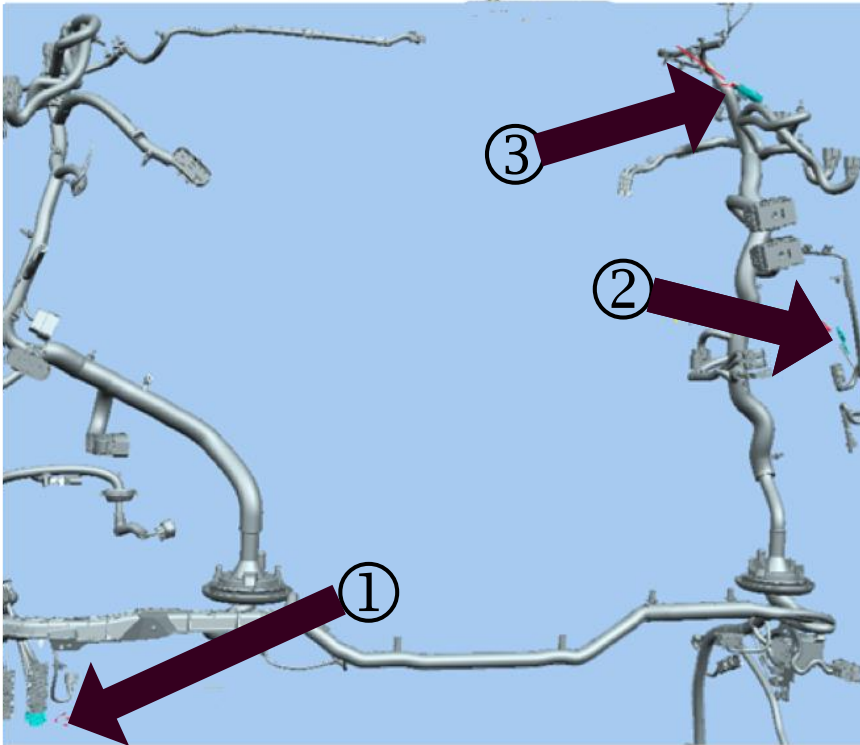
6302407

ELM A215 (1)

Ground G104 (2)

Body Wiring Harness to Front Object Alarm Sensor Wiring Harness (3)

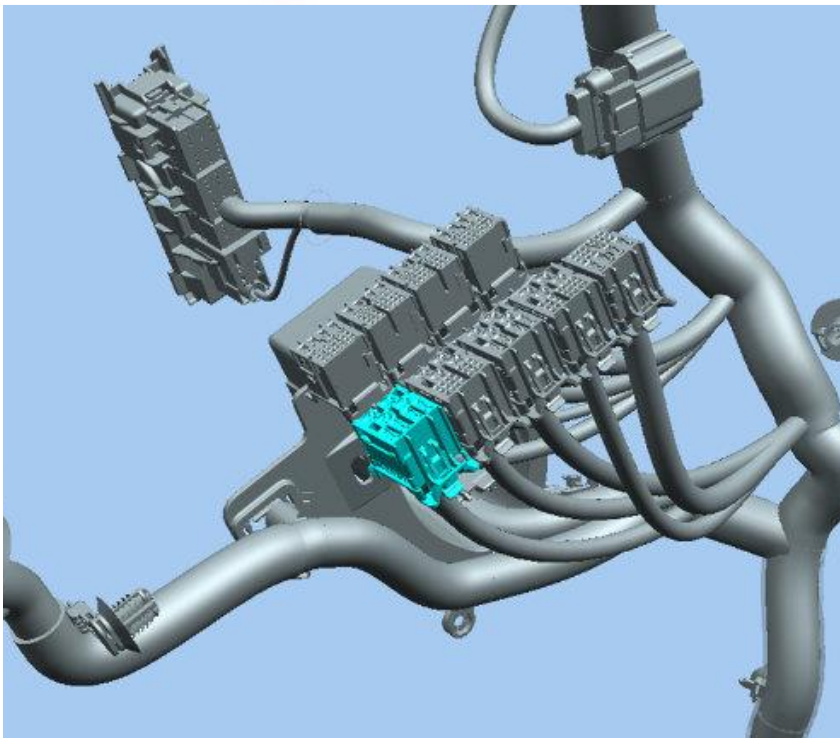
6302409

ELM A215 (Blue)

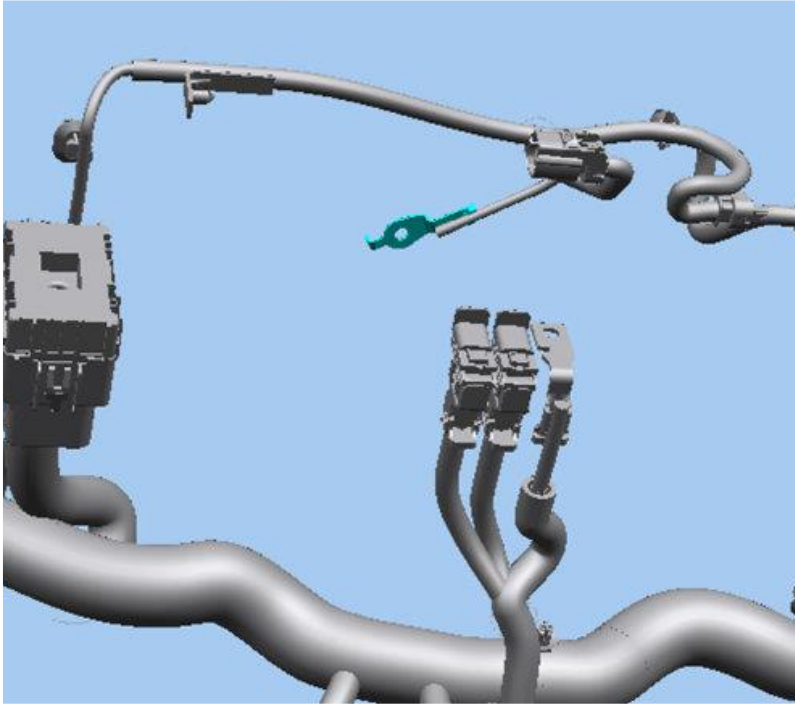
6302410

Ground G104 (Blue)

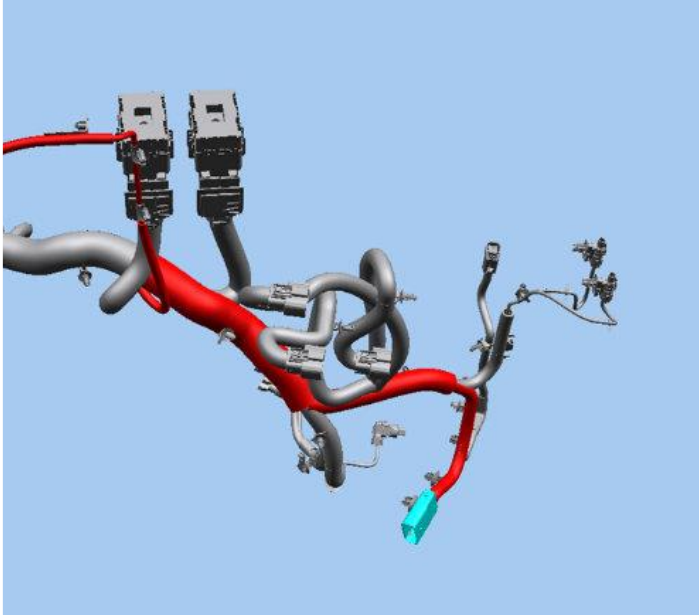
6302417

Body Wiring Harness to Front Object Alarm Sensor Wiring Harness (Blue)

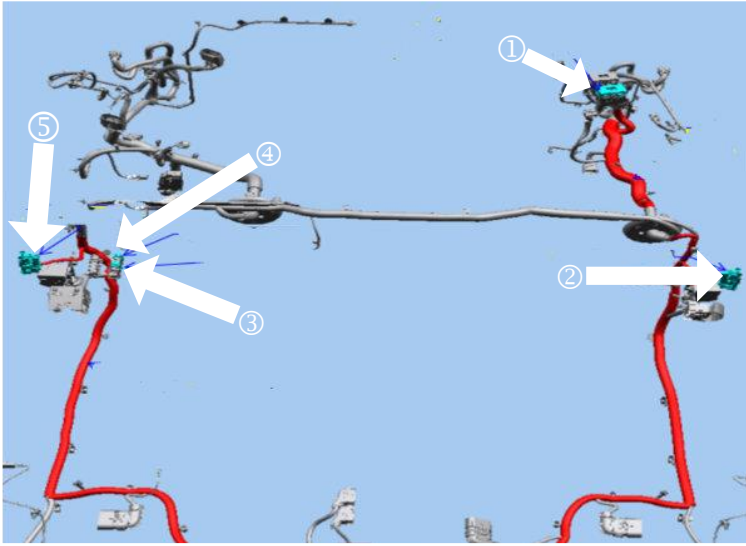
6302424

X600 X102 Connector (1)

X138 X600 Connector (2)

A215 X3 Connector (3)

A215 X5 Connector (4)

X138 X500 Connector (5)

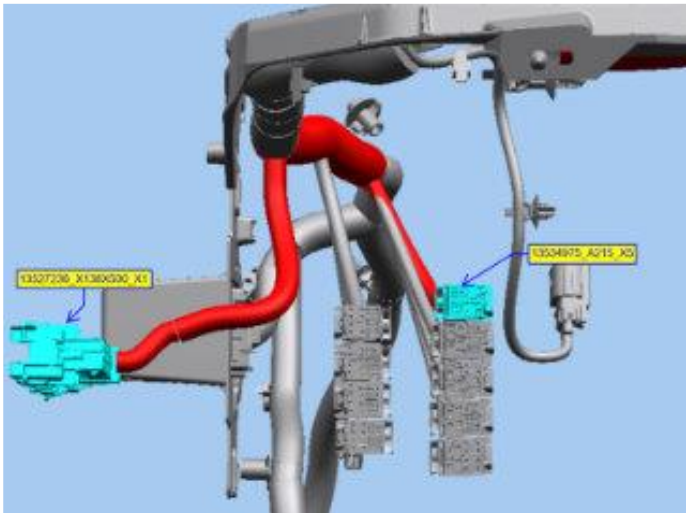
6302425

Add Circuit 2114

1. Remove the front floor panel carpet. Refer to *Front Floor Panel Carpet Replacement* in SI.
2. From Driver door in-line X500 cavity 16 to ELM A215_X5 cavity 10.

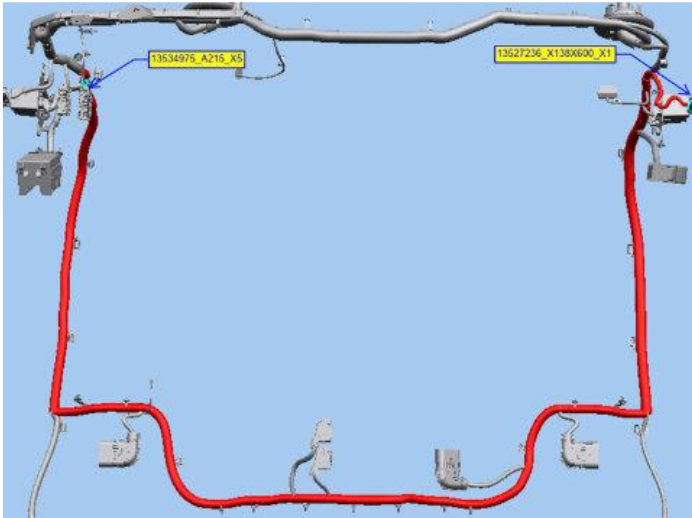
6302426

Add Circuit 2115

3. From passenger door in-line X600 cavity 13 to ELM A215_X5 cavity 9.

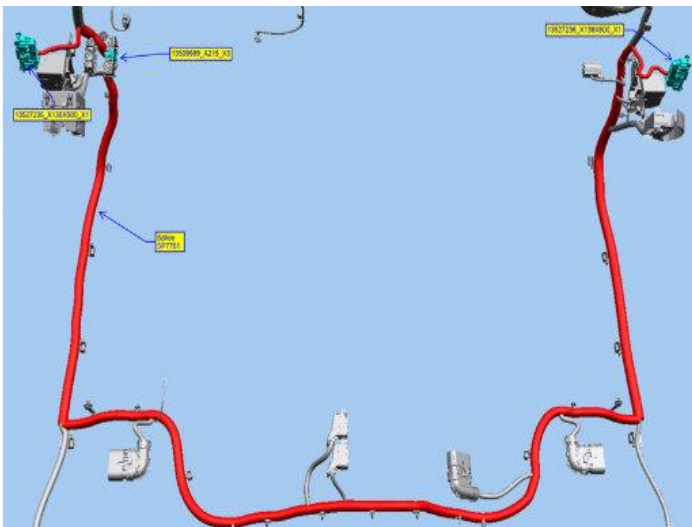
6302429

Add Circuit 7761

4. From ELM A215_X3 cavity 7 to driver door in-line X500 cavity 26 and passenger door in-line X600 cavity 26.

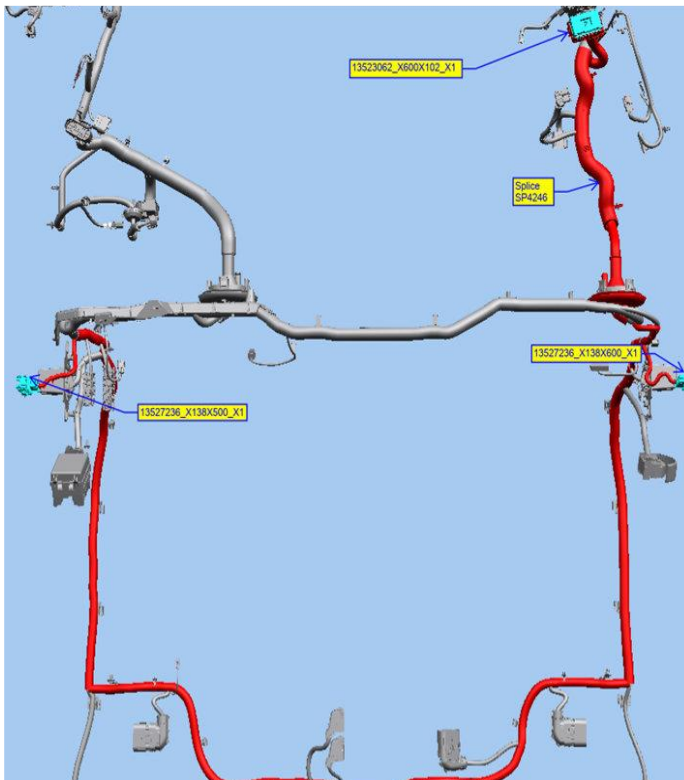
Add Circuit 4246

5. From Under Hood BEC X102 cavity G3 to driver door in-line X500 cavity 30 and passenger door in-line X600 cavity 31.
6. Reinstall the front floor panel carpet. Refer to *Front Floor Panel Carpet Replacement* in SI.
