Technical Service Bulletin

01 SFD authorization failed - 2.5 ltr. TFSI
01 23 48 2069530/1 March 15, 2023.

Model(s)	Year	VIN Range	Vehicle-Specific Equipment
RS 3	2022	All	Not Applicable

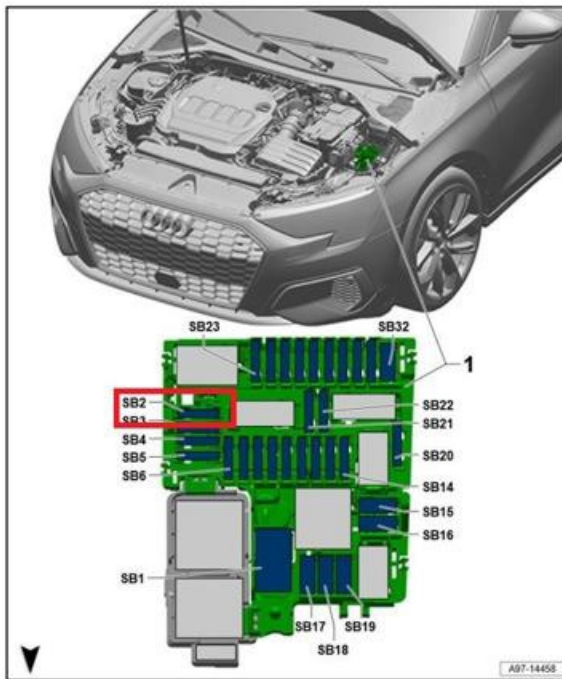
Figure 1: Fuse carrier B in engine compartment.

- Do not end the program on the tester.
- Switch off the ignition.
- Remove fuse SB2 on fuse carrier B in engine compartment (front left). Refer to figure 1.

- Put fuse back in after a few seconds.
- Switch the ignition on again.
- Run the active software update on the tester by pressing “Done/Continue/Next”.
- In rare cases, it may not be possible to continue running the program. In this case, restart the test program/the routine.
