13 Starter/generator drive belt is noisy or came off, DTC P2BA300 may be stored in the ECM 13 23 17 2061461/7 March 17, 2023. Supersedes Technical Service Bulletin Group 13 number 23-16 dated January 3, 2023, for reasons listed below.

Model(s)	Year	VIN Range	Vehicle-Specific Equipment
A6	2019 – 2023		
A4, A4 allroad, A5, A5 Cabriolet, A5 Sportback, Q5, and Q5 Sportback	2021 – 2023	All	Not Applicable

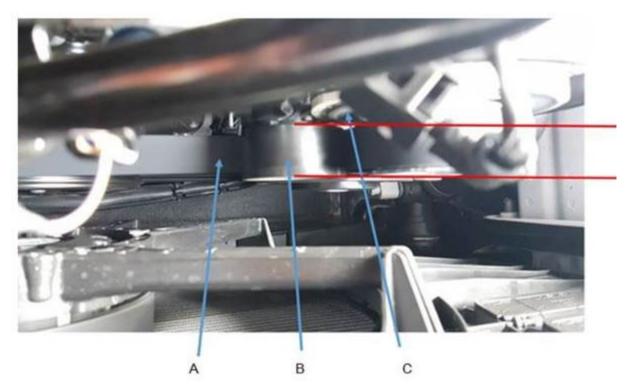
- 1. Run the engine at idle speed.
- 2. The belt must not protrude forward or backward over the roller edge of the tensioner (Figure 2, red marks).

Figure 2. Check to ensure that the poly V-belt is not protruding in either direction.

Explanation of Figure 2 (view from above into the engine compartment):

A = poly V-belt.

B = tensioning roller of the belt tensioner.

Check for correct belt running alignment after poly V-belt and tensioner replacement as follows:
