Technical Service Bulletin

50 Creaking noises heard when body twists during braking or steering maneuvers

50 23 12 2062633/2 March 17, 2023. Supersedes Technical Service Bulletin Group 50 number 21-06 dated March 19, 2021, for reasons listed below.

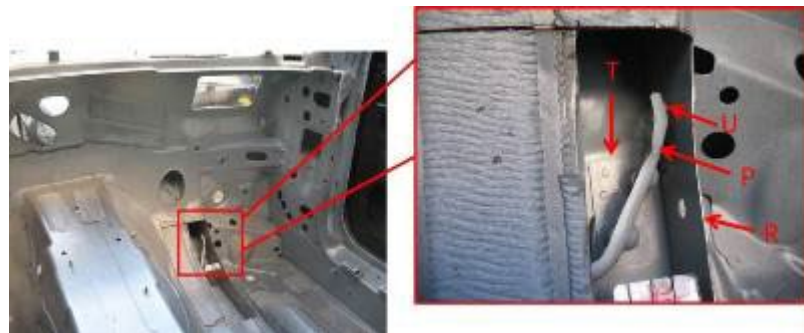
During a cornering or hard braking maneuver the longitudinal member reinforcement plate 'P' over the threaded console 'T' can make contact at point 'U' (Figure 1).

Figure 1. Cutaway view of the longitudinal member.

There has been an improvement in the construction of the longitudinal member assembly.

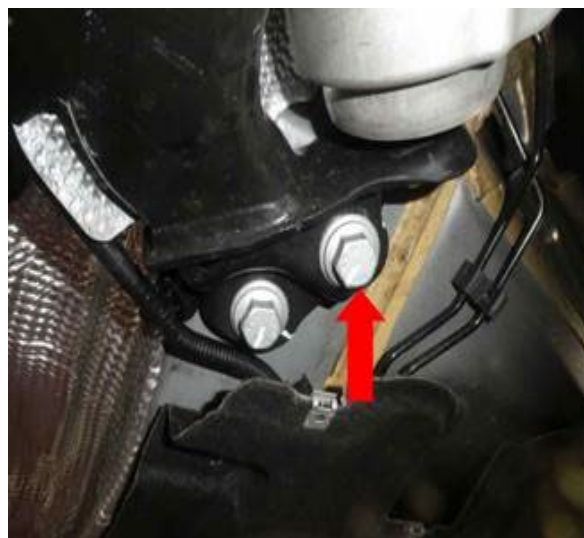
Figure 2. Front most bolt on subframe to be loosened.

As specified in the repair manual, it is necessary to replace all loosened subframe bolts at the conclusion of the entire repair.

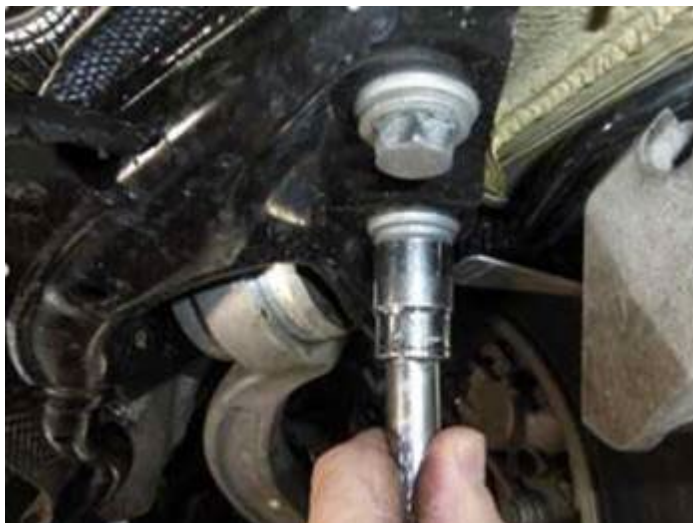
3. In many cases an audible 'cracking' noise can be heard in the course of loosening and tightening the subframe bolt (Figure 3).

Figure 3. Loosening the front most subframe bolt.

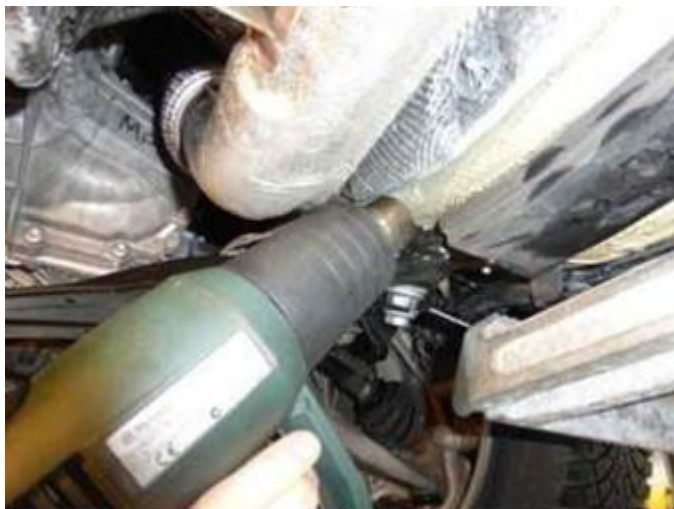
Figure 4. Warming the area of the body near the rear transverse link.

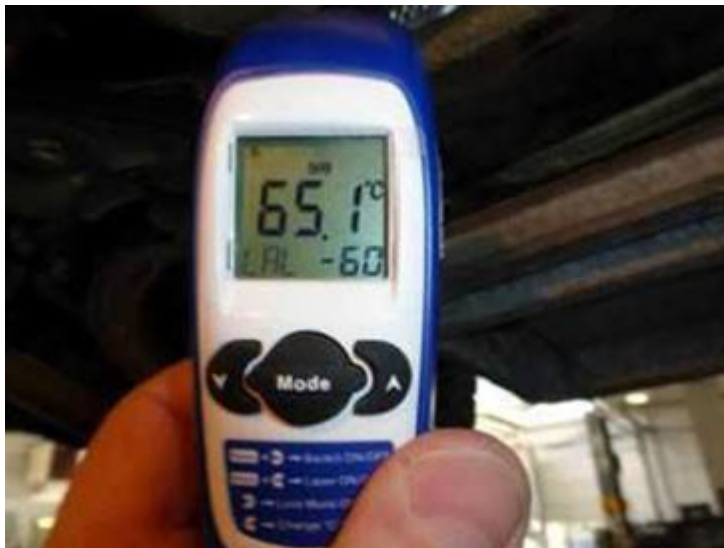
6. Warm the surface to approximately 65 °C (149°F) (Figure 5).

Figure 5. Surface temperature warmed to 65° C (149°F).

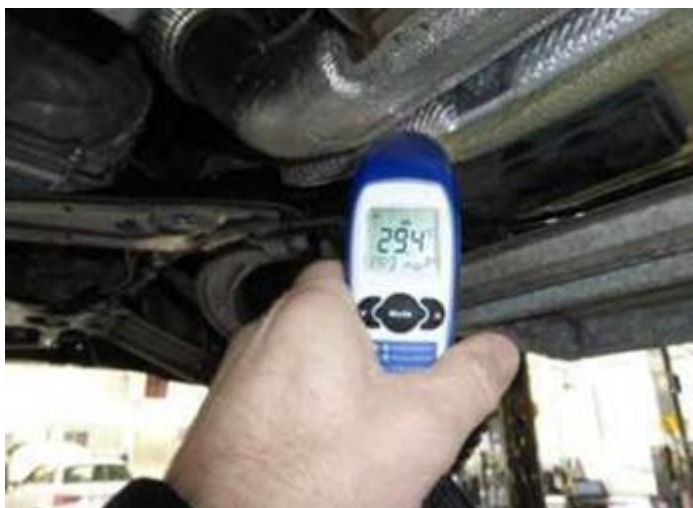
7. Allow the surface temperature to cool to approximately 30 °C (86°F) then test drive the vehicle again (Figure 6).

Figure 6. Surface temperature cooled to approximately 30° C (86°F).

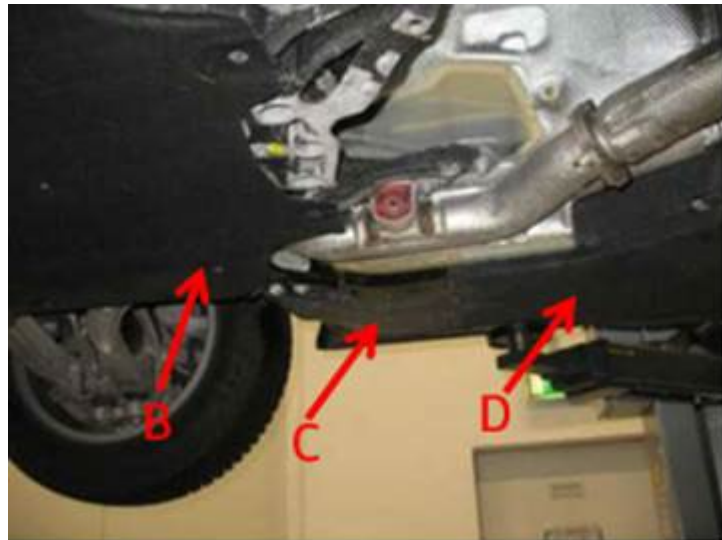
Figure 7. Underbody trim to be removed.

9. With the symptom confirmed, remove the front middle underbody trim 'B', front underbody trim 'C', and the underbody trim 'D' (Figure 7).

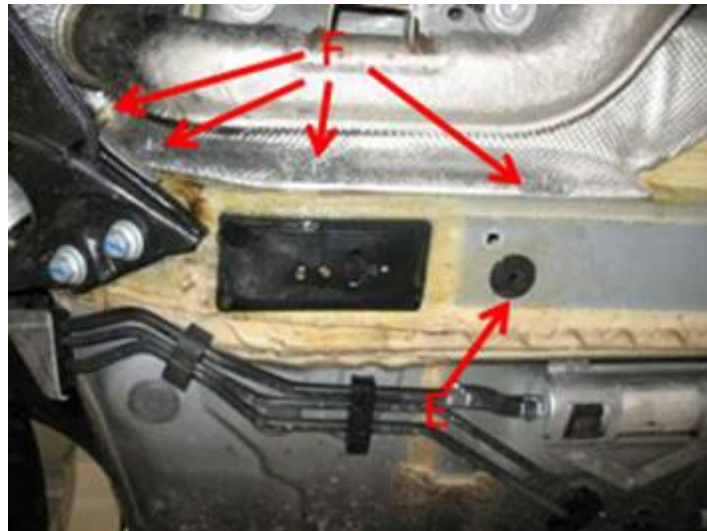
Figure 8. Gaining access to the longitudinal member.

10. In order to provide appropriate access to the affected area inside the longitudinal member begin by unscrewing the four sheet nut fasteners 'F' for the heat shield from their studs. Bend the heat shield slightly away from the longitudinal member (Figure 8). Remove grommet 'E'.

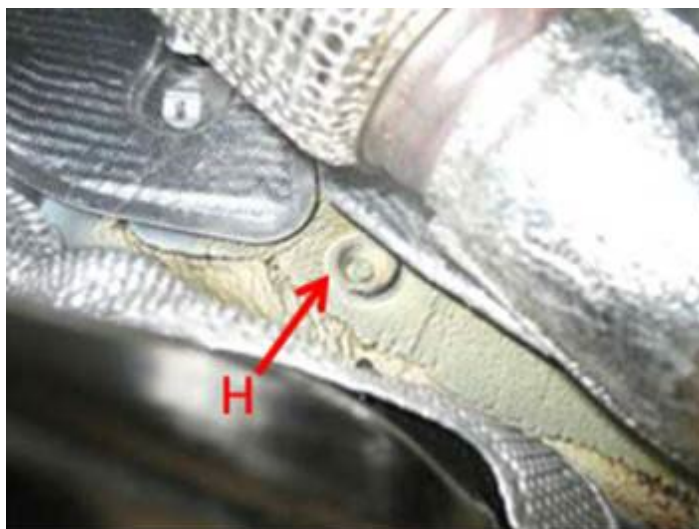
Figure 9. Remove grommet 'H'.

11. Remove grommet 'H' from the longitudinal member (Figure 9).

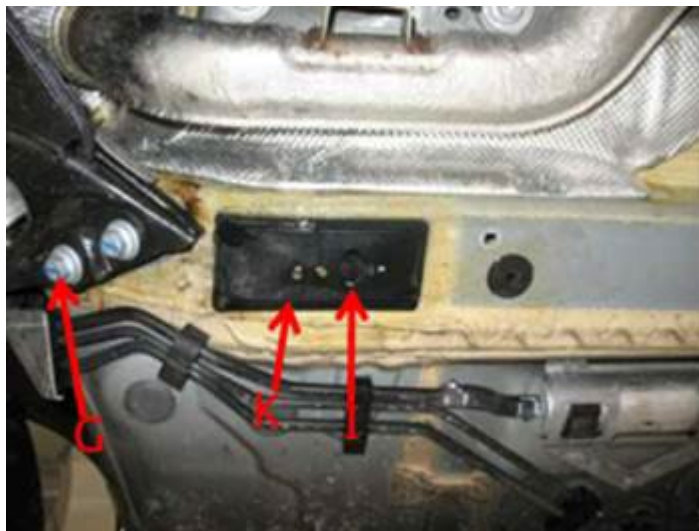
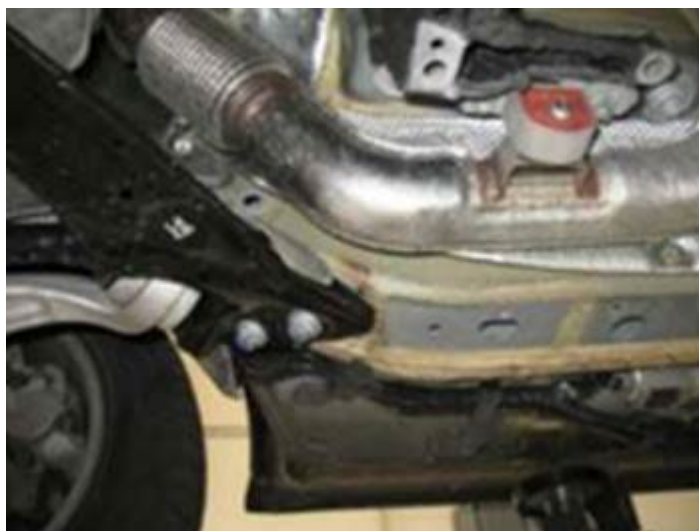
Figure 10. Remove impact protector.

Figure 11. *Impact protector removed.*

12. Because bolt 'G' was loosened in the diagnosis process it must be replaced. Replace bolt 'G' using the installation and tightening procedure in ElsaPro. Remove the impact protector 'K'. Pry out clip 'I' from the impact protector and remove it from the longitudinal member (Figures 10 - 11).

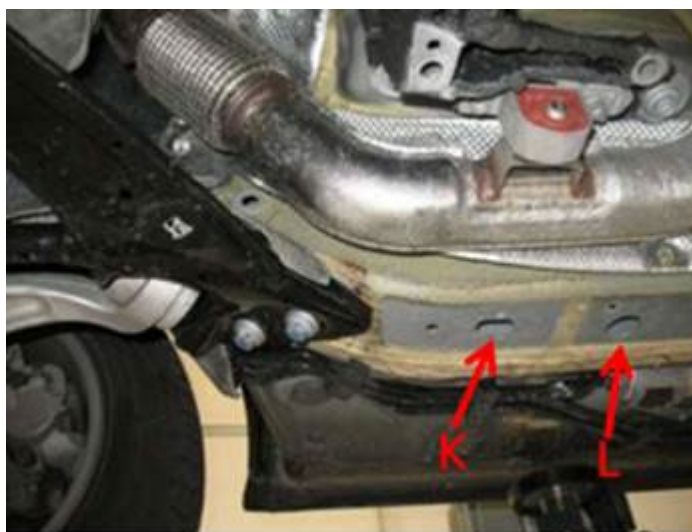
13. By shining a flash light through the opening 'K' from the now removed impact protector you can see the upper round hole 'M' (Figure 12) in the longitudinal member reinforcement plate 'N' (Figure 13) when viewed through hole 'L' (hole from grommet 'E' from Figure 8).

Figure 12. *Access for improvised tool.*

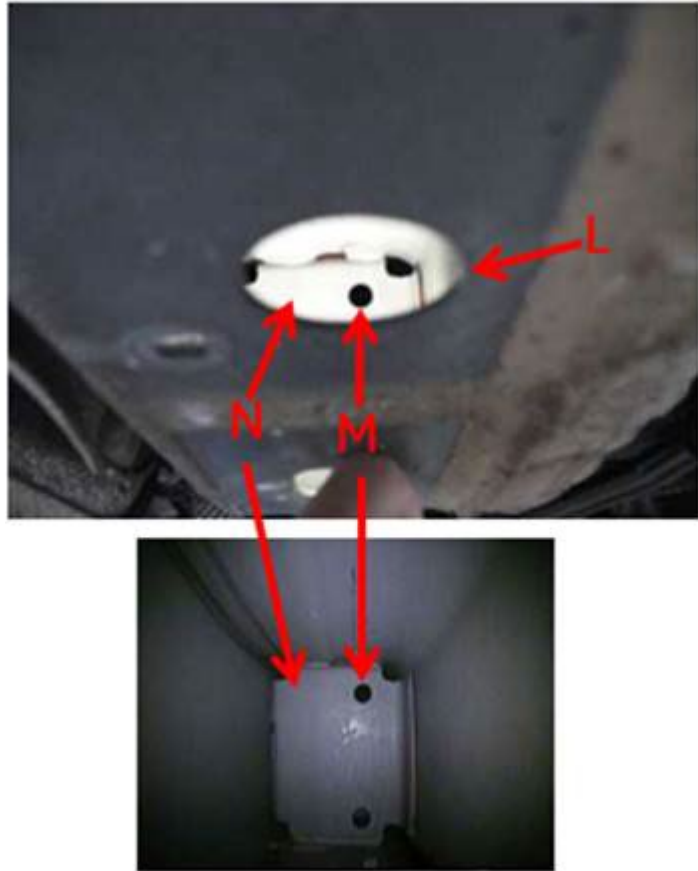
14. Figure 13 shows the view through hole 'L' when illuminated through hole 'K' (Figure 12). This is the path through which you will insert an improvised chisel.

Figure 13. Access hole 'M' and access hole in longitudinal member reinforcement.

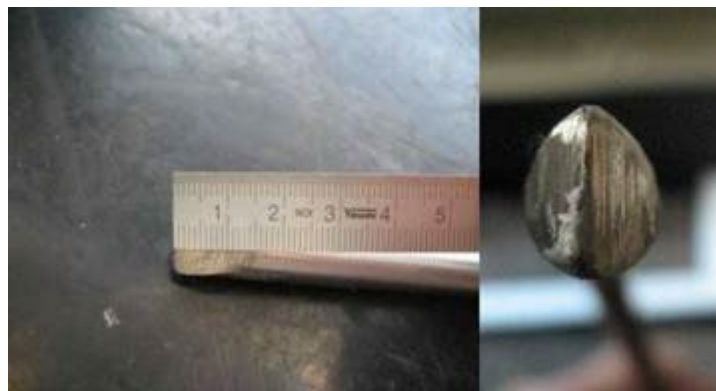
Figure 14. Ground tip of steel rod.

15. An improvised tool for this modification will be necessary. Begin fabricating this tool by obtaining a steel rod 10mm in diameter and 50cm long (Figure 14). Grind the tip of one end of the rod into a chisel shape. The length of the grind should be 15mm +/-3mm on each side as shown in Figure 14.

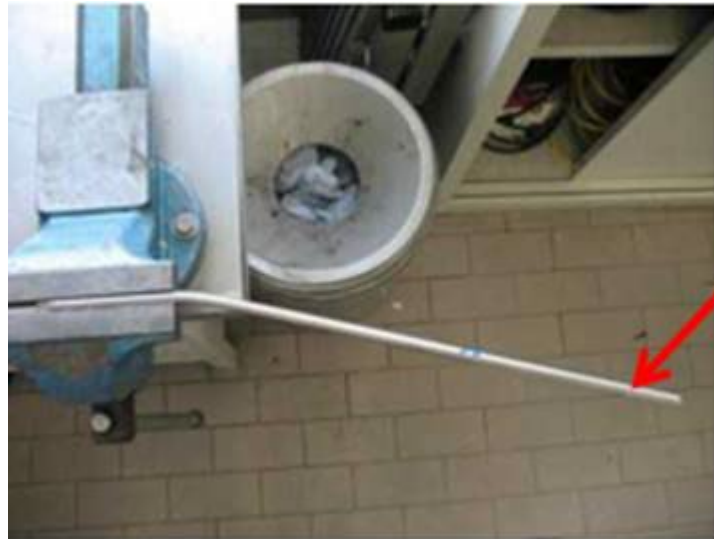
Figure 15. 50cm long x 10mm steel rod.

16. Mount one end of the rod into a vice 11cm deep with the chisel shape parallel to the ground (Figure 15).

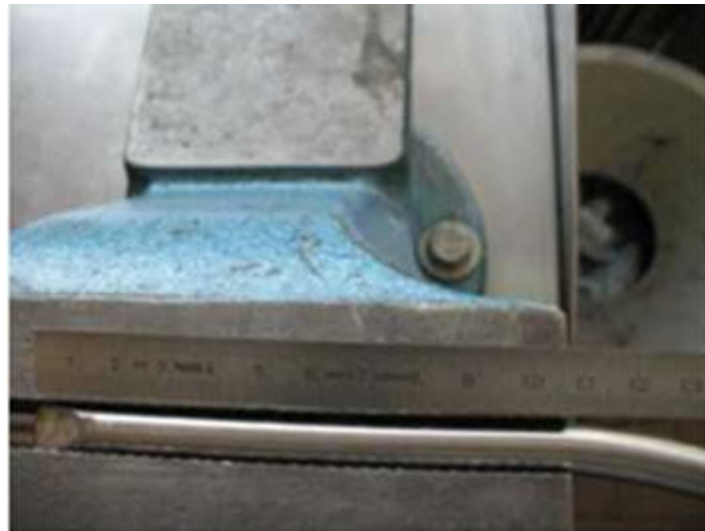
Figure 16. Rod inserted in a vice 11cm from the chisel end.

17. A bend will be created 11cm deep from the chisel end (Figure 16).

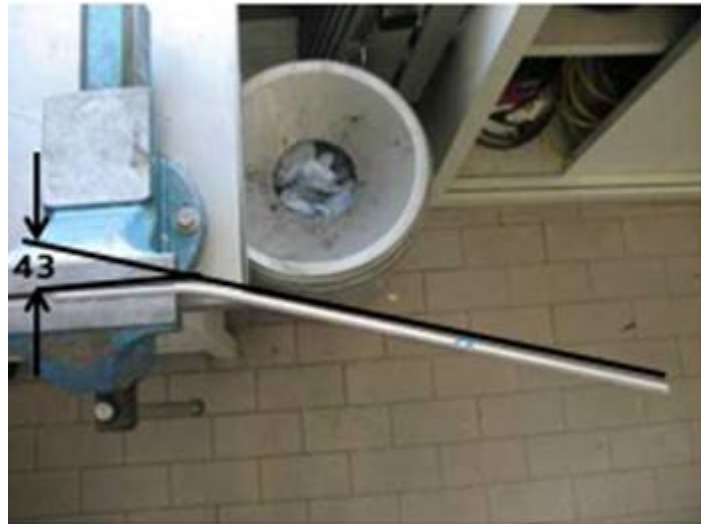
Figure 17. Bend created 43mm from the axis of the long end of the steel rod.

18. Bend the steel bar at the 11cm apex until a distance of 43 mm +/- 3 mm is created between the axis of the longer end of the rod and the axis of the shorter end of the rod at its tip (Figure 17).

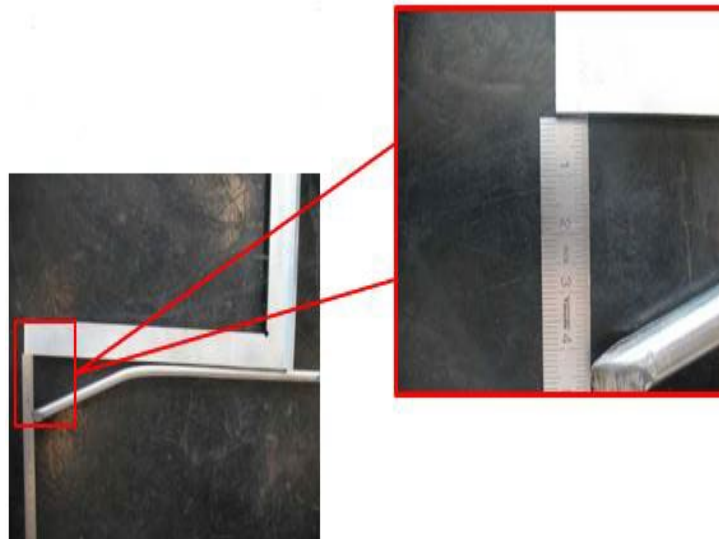
Figure 18. Verifying distance of 43mm in the bend.

19. Measure and verify this distance (Figure 18).

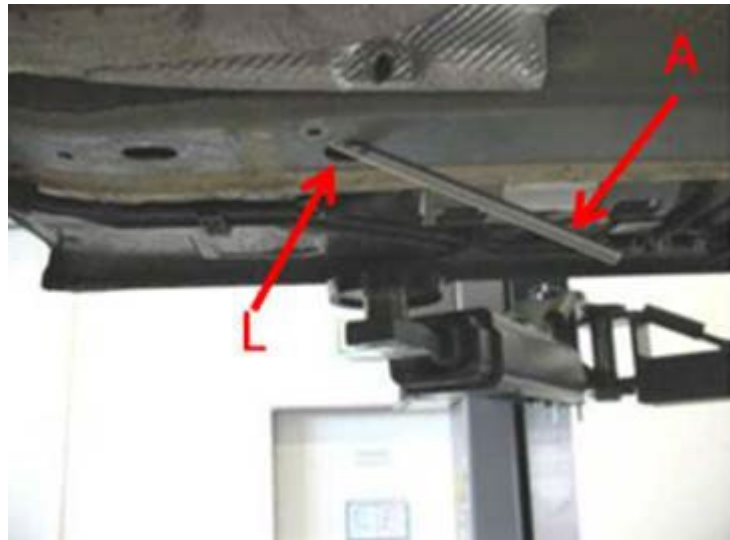
Figure 19. Insert the steel rod.

20. Insert the chisel end of the steel rod 'A' into the body opening 'L' in the longitudinal member (Figure 19).

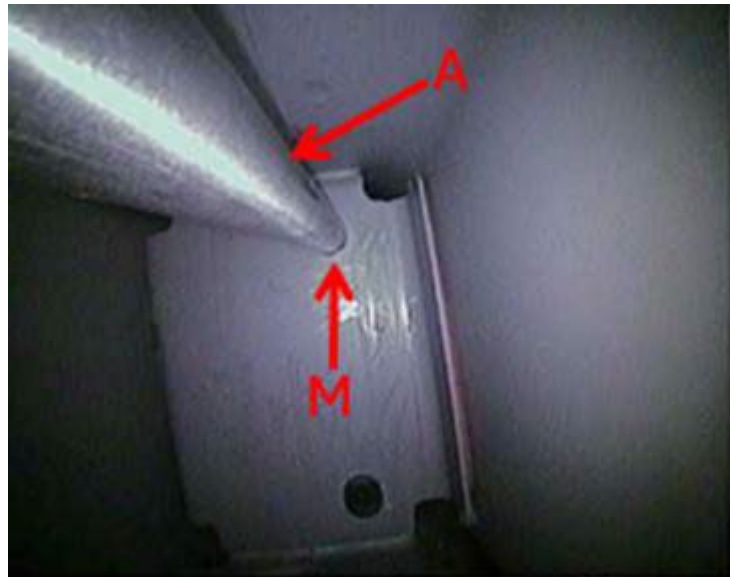
Figure 20. Feeding the steel rod through the reinforcement plate.

21. Now feed steel rod 'A' through hole 'M' (upper hole) in the reinforcement plate (Figure 20).

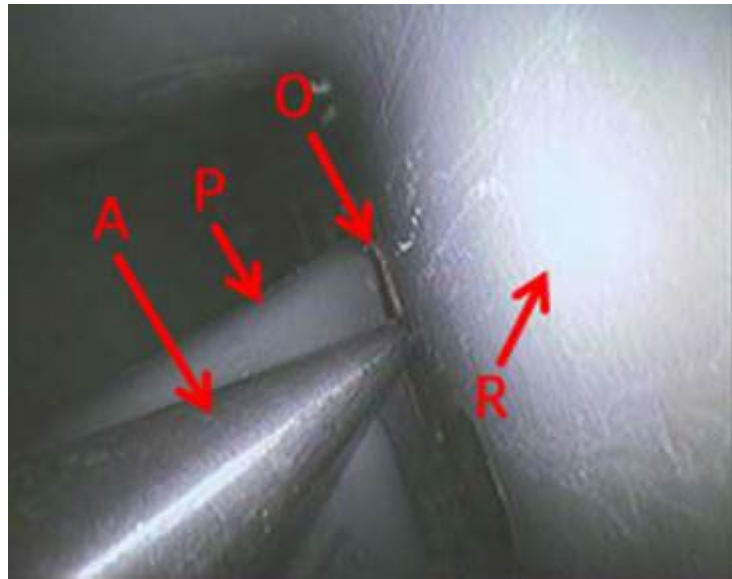
Figure 21. Engaging the chisel end of the steel rod inside the longitudinal member.

22. The chisel end of the steel rod is to be fed far enough to engage the front reinforcement plate 'P' at point 'O' such that it is lodged into the gap between reinforcement plate 'P' and the wall of the longitudinal member 'R' (Figure 21).

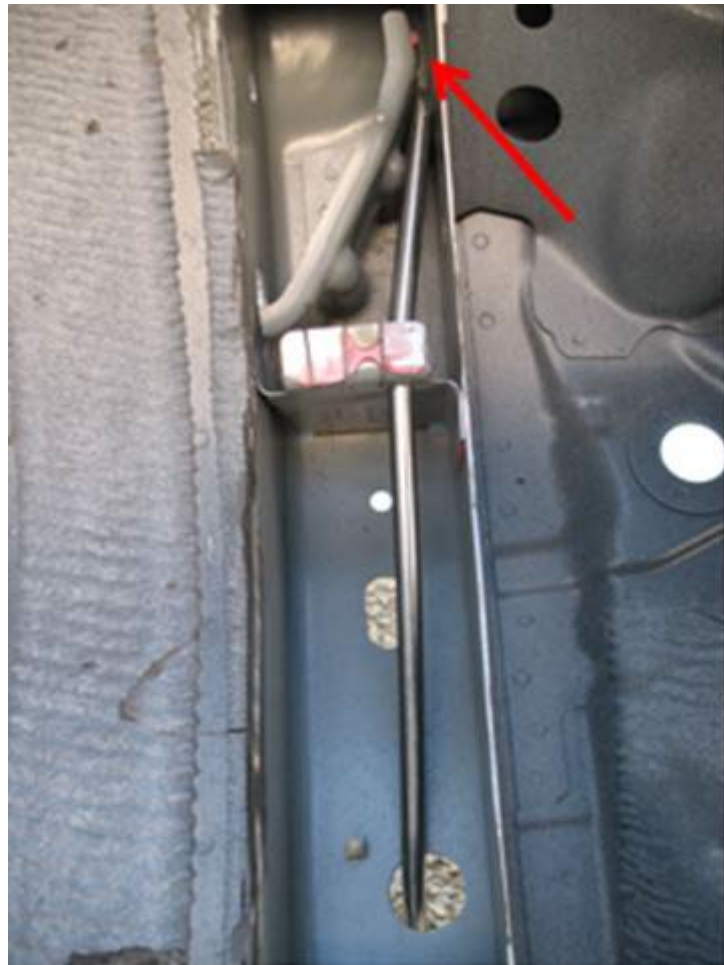
Figure 22. Cutaway view of the longitudinal member illustrating the steel rod positioning.

23. If the steel rod bend angle and chisel point orientation are created as described the tool will reach the appropriate point of contact when it is guided into the holes in the longitudinal member as described (Figure 22).

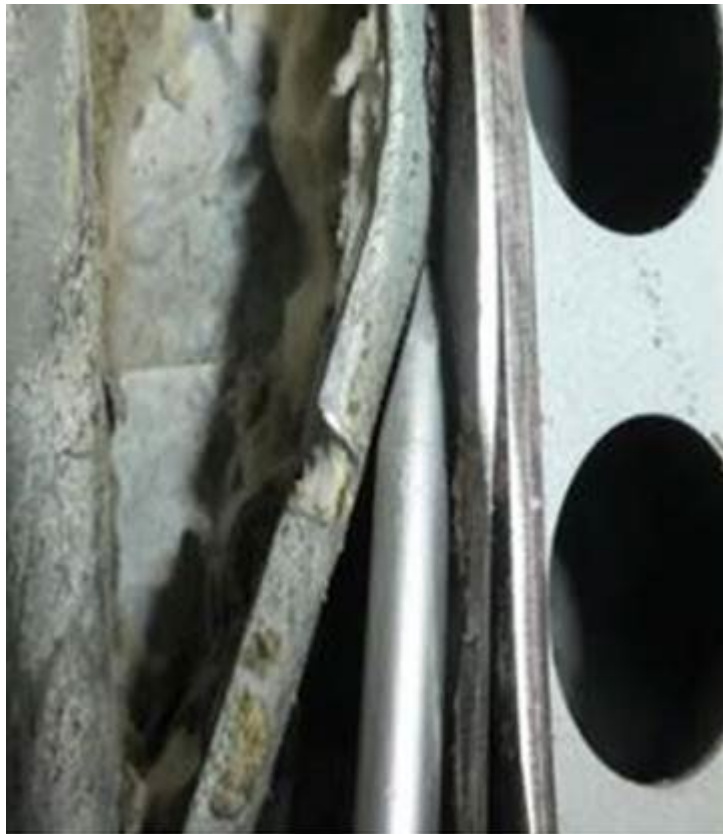
Figure 23. The chisel end of the steel rod properly engaged with the reinforcement plate.

24. The chisel end of the steel rod must be inserted as shown in Figure 23 with the wedge engaged consistent with the space formed by the longitudinal member support to the longitudinal member housing.

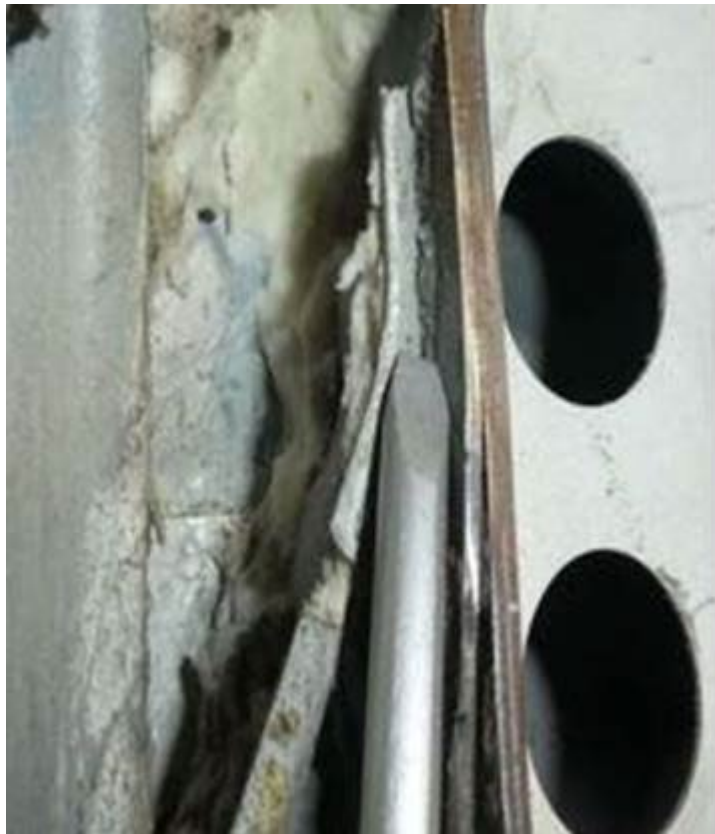
25. Figure 24 shows an incorrect engagement of the chisel end.

Figure 24. Incorrect engagement of the chisel end.

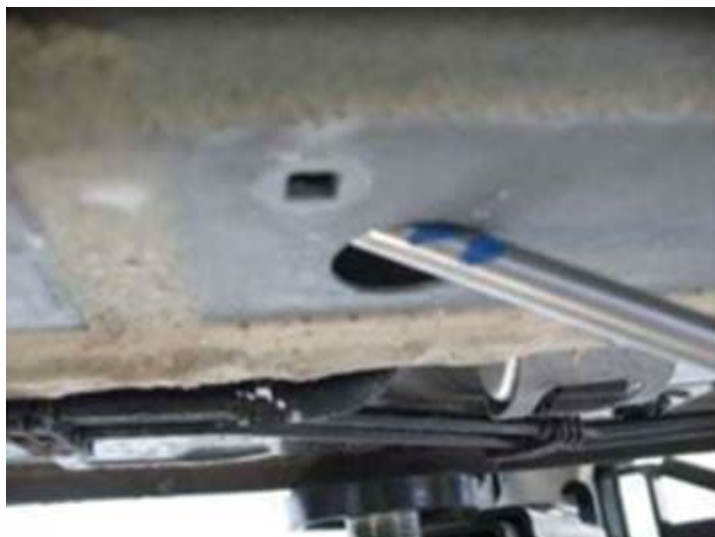
Figure 25. Marking the steel rod.

26. Using a marker mark the point at which the steel rod makes contact with the longitudinal member. Then make a mark 10mm – 15mm rearward of that contact point on the steel rod (Figure 25).

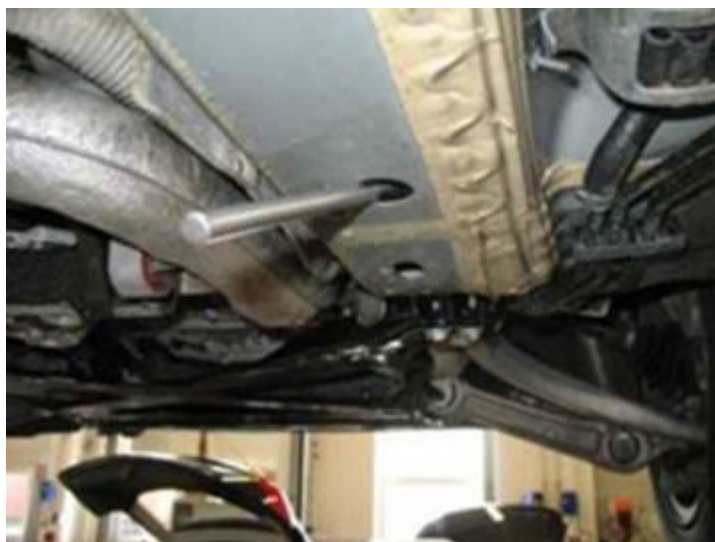
Figure 26. Steel rod driven forward at least 10mm.

27. Using a hammer drive the steel rod a distance of 10 mm. Then pull the bending tool out of the longitudinal member again (Figure 26).

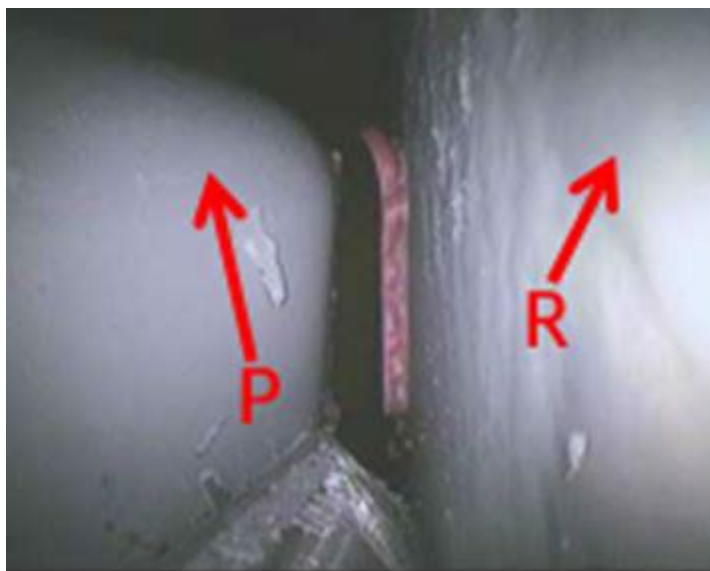
28. As a result, a distance of approximately 3 mm is created between reinforcement plate 'P' and the longitudinal member 'R'. Separating this point of contact eliminates the noise generation (Figure 27).

Figure 27. 3mm gap created between reinforcement plate and longitudinal member.

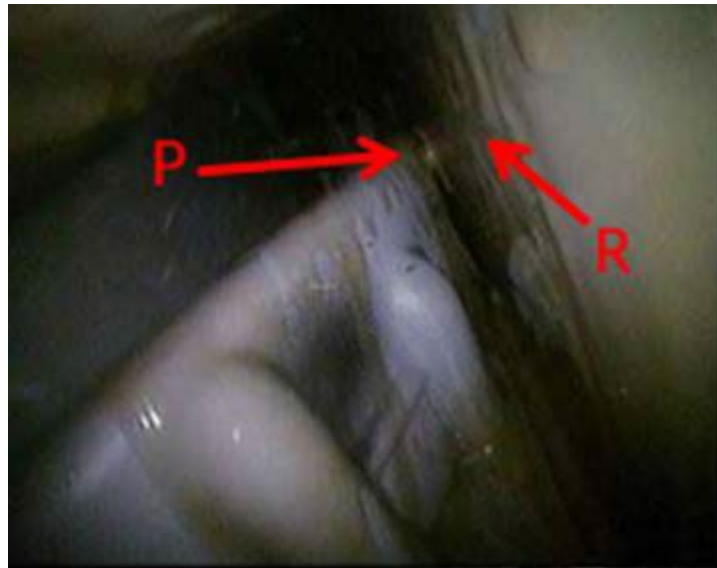
29. All points that were contacted and / or struck are likely have had their corrosion protective layer compromised. Because of this thoroughly coat all areas with cavity wax way (Figure 28).

Figure 28. Cavity wax applied.

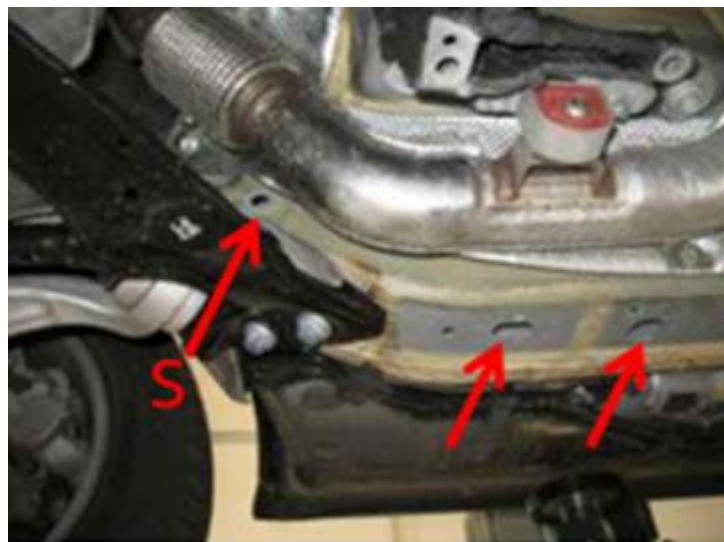
Figure 29. Access opening for cavity wax application.

30. Cavity wax can be applied through the openings shown in figure 28. The separation point in the longitudinal member can be accessed through hole 'S' (Figure 29).
