Service Bulletin

Bulletin No.: 15-06-01-002O

Subject: Engine Misfire/Tick Noise, Malfunction Indicator Lamp (MIL) Illuminated - DTC P0300 Set

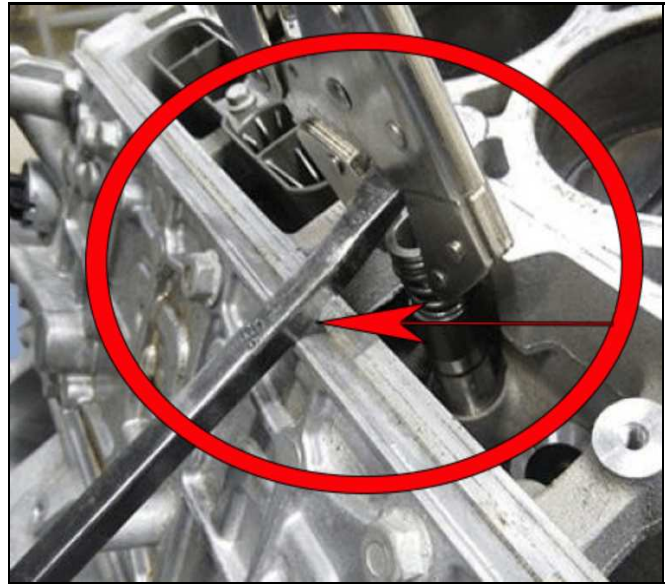
4921302

Note: Be sure **NOT** to pry on the sealing surface of the block, as shown in the illustration above.

2. Use vice grips with a small pry bar.
