Service Bulletin

Bulletin No.: 18-NA-383

Subject: Water Found in Rear Interior of Cab, Water Leak at Rear Sliding Window

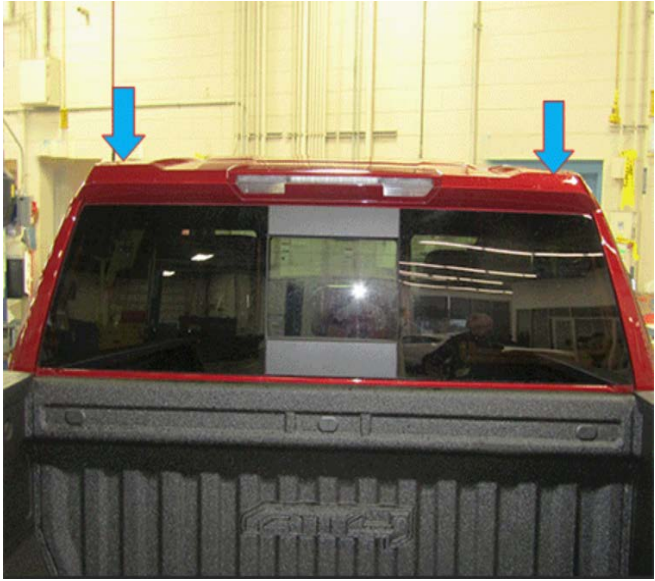
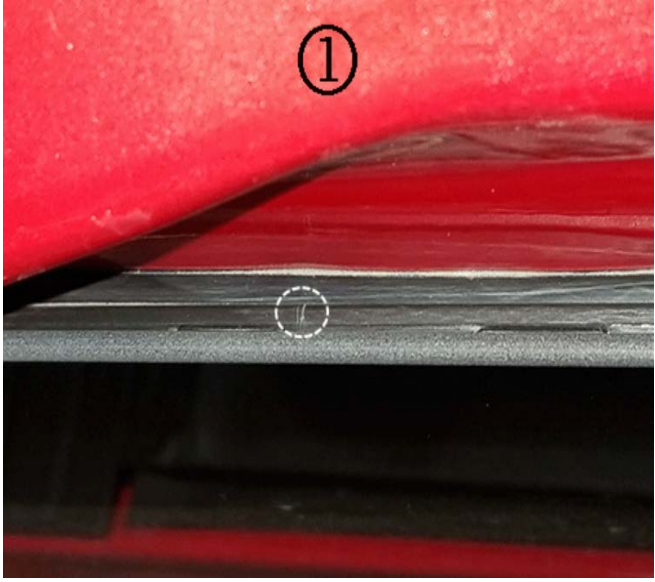
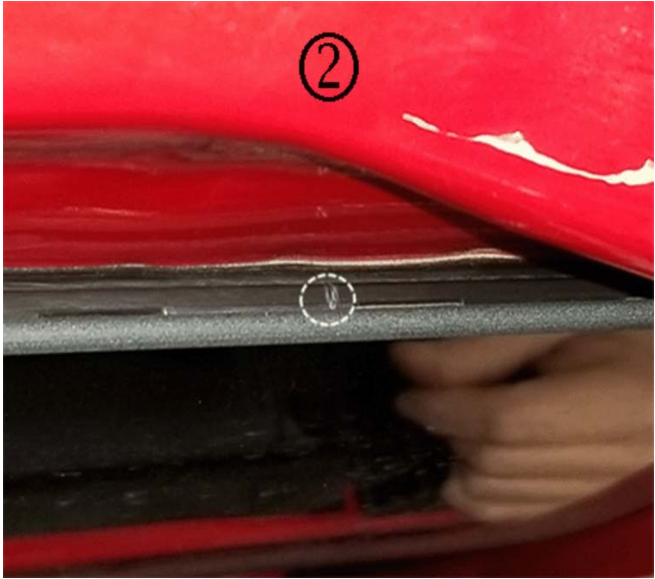
<p style="text-align: right;">5201855</p> <p>Note: The cracks can be in the left and/or right side of the rear sliding window plastic upper rail glass guide which is covered by the roof rear spoiler. Examples of a left (1), then right side (2) visual crack (with the spoiler removed) are shown in the graphics above.</p> <p>The cause of the condition may be cracking in the rear sliding window plastic upper rail glass guide. The plastic upper rail glass guide may develop small fractures/cracking which allows water to pass through on the glass side of the urethane that attaches to the vehicle body.</p>
<p>Correction</p>	<p>Important: When verifying this condition, ensure that the water leak path is due to cracks in the rear sliding window plastic upper rail glass guide, and NOT a leak in the primary urethane seal, between the window and the body; or from the spoiler attachments to the truck cab which are in the same area. Please indicate power sliding rear window crack in warranty claim verbiage.</p> <p>A leak in the primary urethane seal should be addressed by removing and resealing the window, using the standard service procedure from SI.</p> <p>R & R the roof rear spoiler and apply seam sealer to the rear sliding window top encapsulate, following the steps in the Service Procedure below.</p> <p>Note: If the vehicle underwent this bulletin repair, was released to the customer and later returned for the same concern, replace the rear sliding window assembly. Refer to <i>Rear Window Replacement</i> in SI, AND ensure that during application of the urethane to the new window, that the urethane covers the complete length of the top encapsulation of the window.</p>
