Service Bulletin

Bulletin No.: 20-NA-074

Subject: Front Fascia Paint Chipping at Headlamp Opening

Brand:	Model:	Model Year:		VIN:		Engine:	Transmission:
		from	to	from	to		
Cadillac	XT4	2019	2023	—	—	All	All

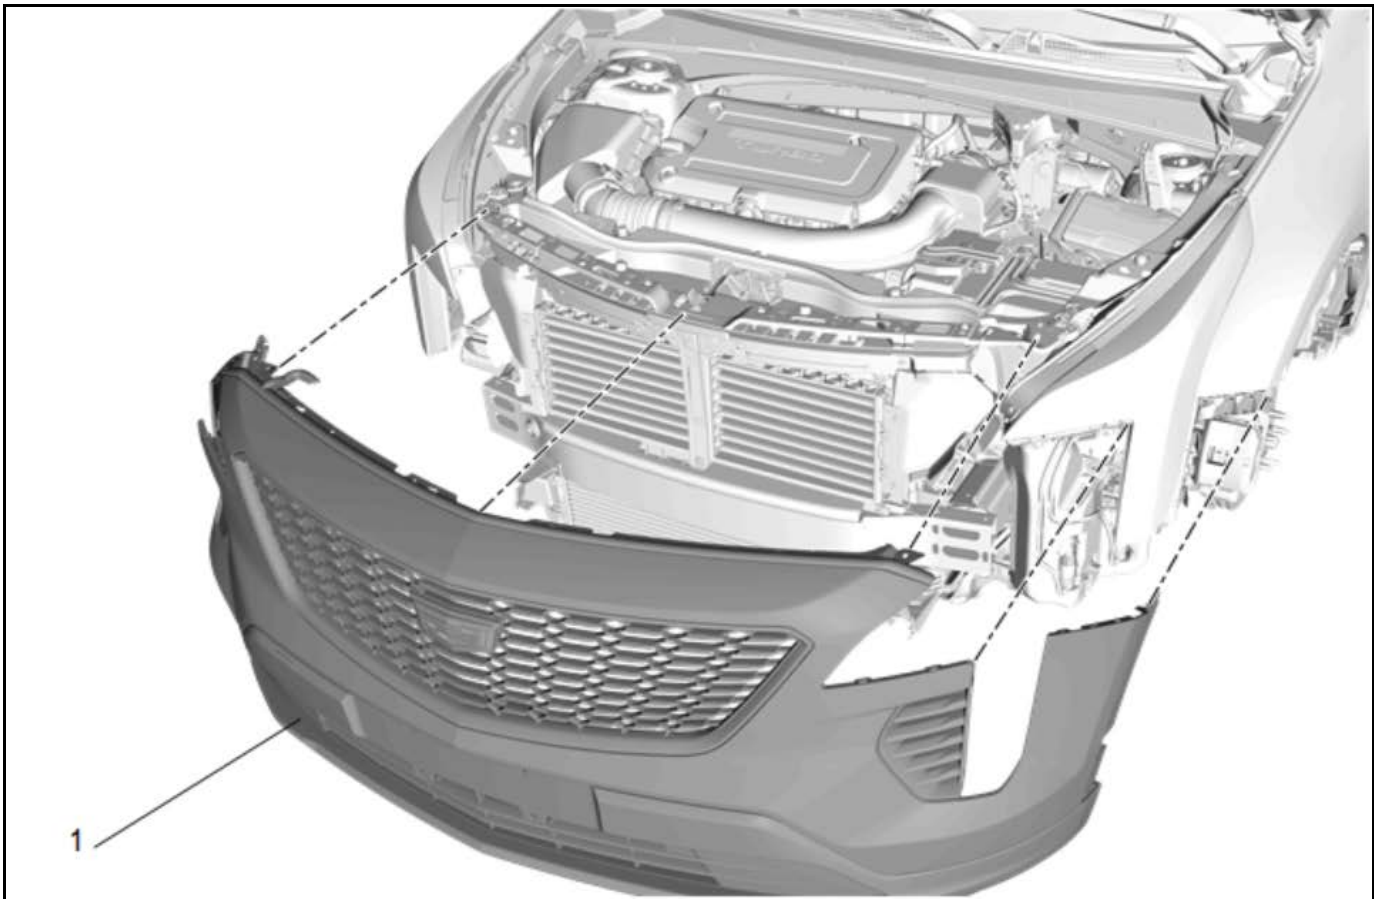
5069634

Involved Region or Country	North America, Europe, Middle East
Condition	Some customers may comment on seeing the paint chipping on either, or both sides, of the front fascia at the headlamp opening.
Cause	The cause of the condition may be a tight, or interference, condition between the headlamp and fascia.
Correction	<p>Important: Bulletin can only be referenced and claim made once the vehicle has been sold to the customer. Vehicles in Dealers stock inventory cannot be repaired.</p> <p>Note: Do NOT replace the headlamps on a vehicle with this condition.</p> <p>Remove and reinstall the front fascia, repair fascia paint as necessary and add protective tape to BOTH headlamps, following the steps in the Service Procedure below.</p>

1. Remove the front fascia (1). Refer to *Front Bumper Fascia Removal and Installation* in SI.
