# Service Bulletin

Bulletin No.: 23-NA-035

**Subject: Instrument Cluster RPO UDV 162.2 Software Update – Multiple Updates**

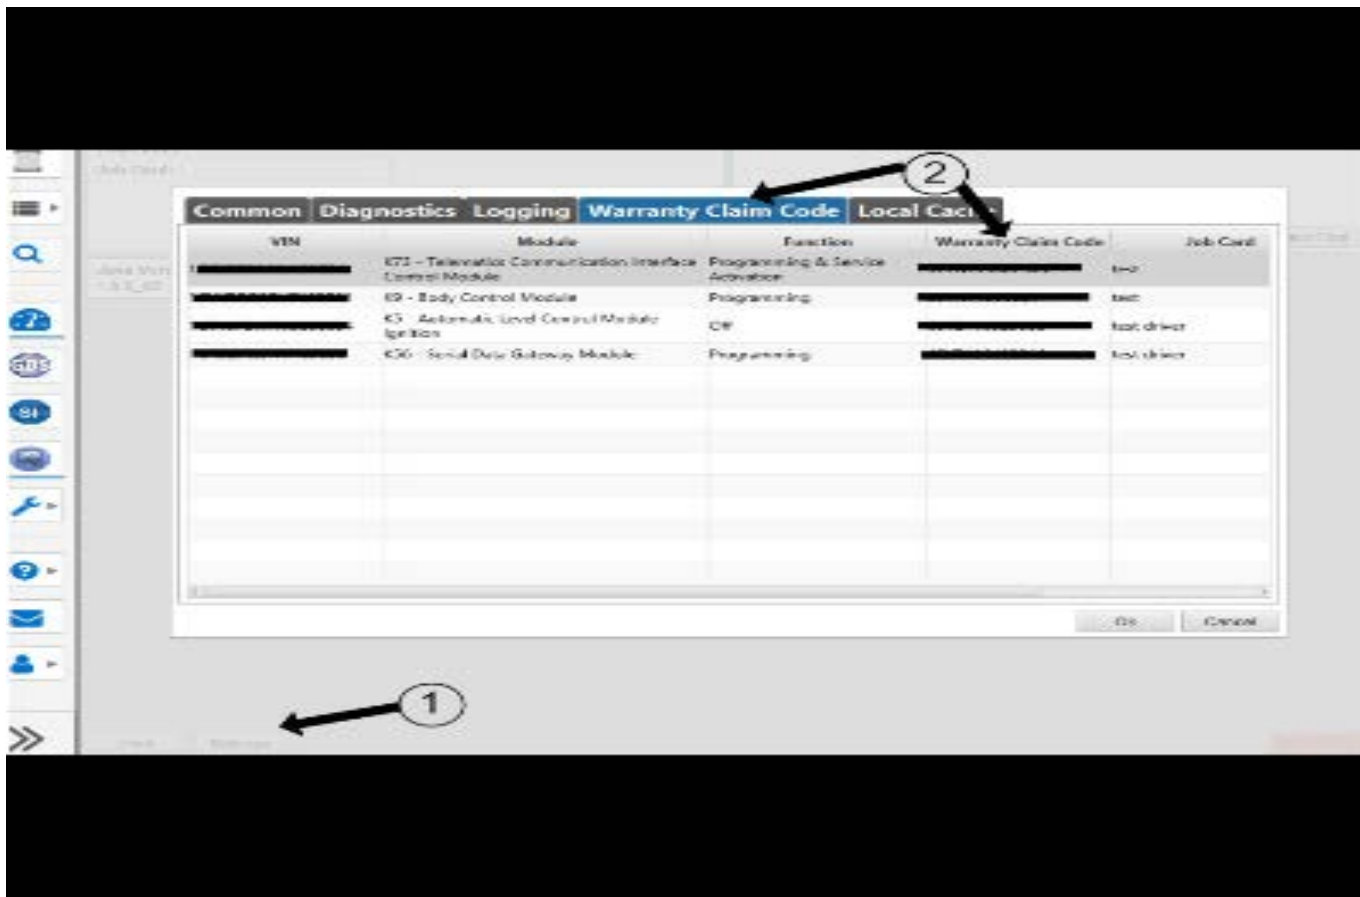
6125774

If the Warranty Claim Code was not recorded on the Job Card, the code can be retrieved in the SPS2 system as follows:

1. Open TLC on the computer used to program the vehicle.
2. Select and start SPS2.
3. Select Settings (1).
4. Select the Warranty Claim Code tab (2).
