# Service Bulletin

Bulletin No.: 23-NA-036

**Subject: Diagnostic Aid: Amber Light on Dual Level Portable Charge Cord Set**

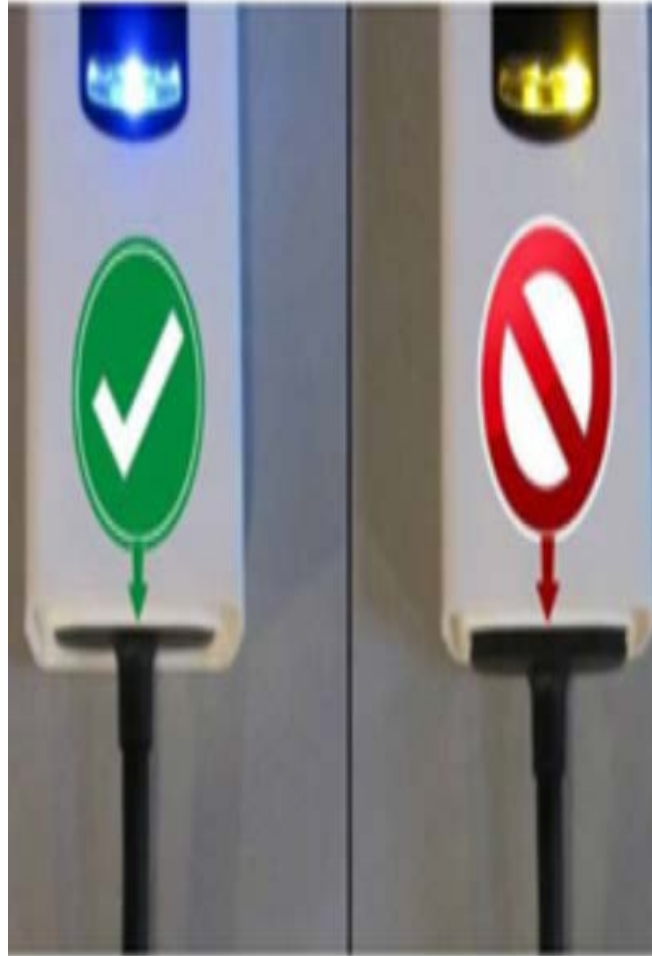
6288337

<b>Involved Region or Country</b>	North America, Brazil, Middle East, GM Korea Company
<b>Condition</b>	Some customers may comment on an amber LED light on the body of the portable charge cord when attempting to charge the vehicle.
<b>Cause</b>	The cause of the condition may be that the swappable grid plug may not be fully seated.

When an amber light is observed, please first check that the grid plug is fully seated into the body as detailed in the images. An additional click will be heard when the plug is fully seated into the body of the connector.

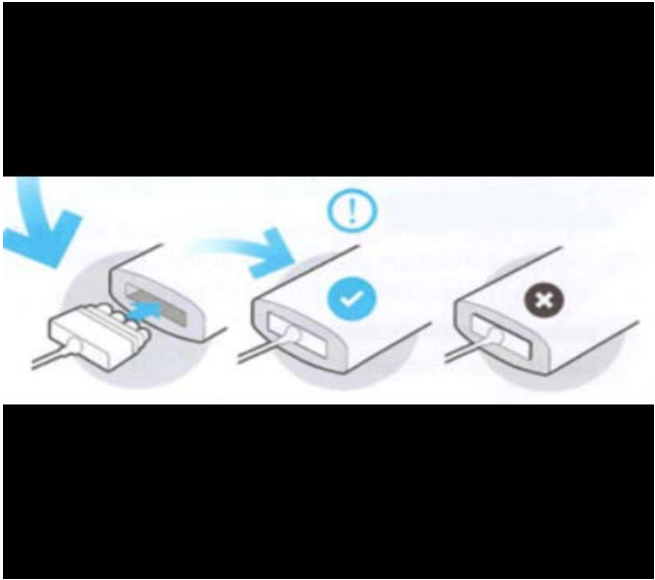
6288342
<p>The plug must be fully inserted or the charge cord will not allow charging.</p>
