01 MIL on, DTC P045600 stored in the ECM; small EVAP leak

01 23 50 2044156/5 March 23, 2023. Supersedes Technical Service Bulletin Group 01 number 18-69 dated May 10, 2018, for reasons listed below.

Model(s)	Year	VIN Range	Vehicle-Specific Equipment
A6	2016	000001 – 111348	3.0 TFSI

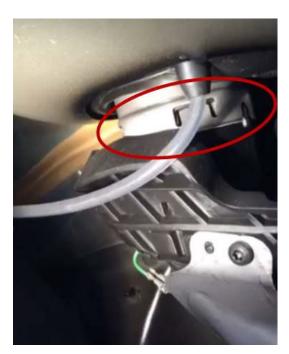
Rubber O-ring at tank filler neck is out of position.

Figure 2. Check for smoke escaping around the filler neck.

Improved rubber O-ring support.
