03/07/2023
CAL FTL 31-005

**Subject: 114SD Steering Gear Frame Rail Relief
Hole Inspection**

**Models Affected: 114SD vehicles built from July 27, 2022,
through January 11, 2023.**

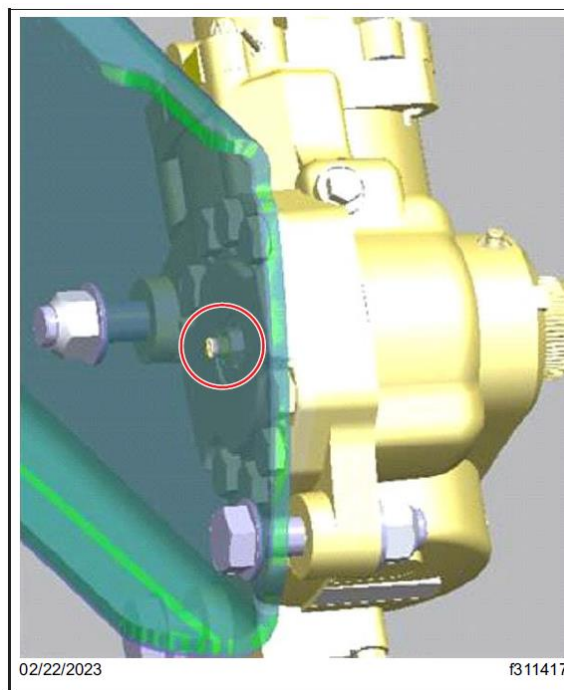
Fig. 1, Relief Hole Location on the Frame Rail

1. Park the vehicle on a level surface, shut down the engine, and set the parking brake. Chock the tires.
2. Raise the hood, and rotate it to the fully raised position.
3. Inspect the inner side of the left-hand side frame rail web surface, at the steering gear mounting for a relief hole. If there is a relief hole on the frame rail at the location indicated in [Fig. 1](#), no further action is required.

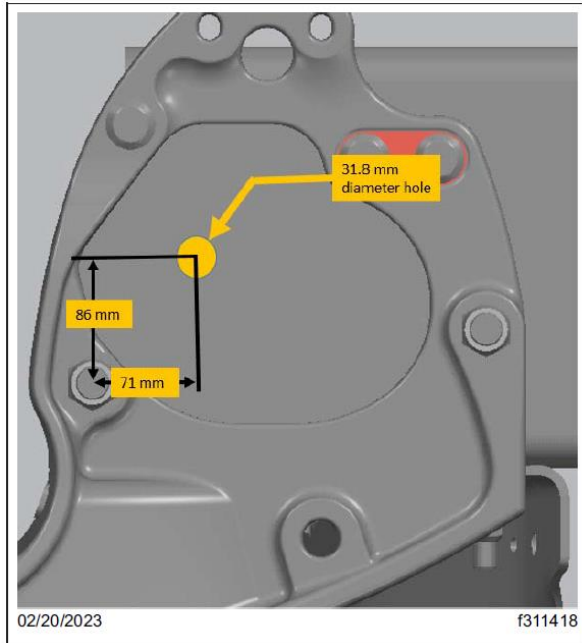
Fig. 2, Drilled Hole Location

- 5.2. Inspect the left-hand side frame rail for a 31.8 mm diameter relief hole in the location shown in [Fig. 2](#).
 - 5.3. If the relief hole is missing, a hole needs to be drilled before the steering gear is installed.

- 5.4. Carefully inspect the surface of the frame rail for any witness marks. If there is a witness mark on the surface indicating the steering gear adjustment screw contacted the frame rail, **the steering gear must be replaced**.

- 5.5. Drill a 31.8 mm diameter hole on the web of the frame rail at the location shown in [Fig. 2](#). Make sure any components on the inside of the frame rail are clear of the path of the drilling tool. Deburr the hole edges and apply touch-up paint to protect the parts.
