03/15/2023
CAL FTL 54-028

**Subject: Business Class M2 and 108SD/114SD BCA
Fuse Mounting Nuts Torque Inspection**

**Models Affected: Business Class M2 and 108SD/114SD vehicles
built from August 1, 2022, through October 24, 2022.**

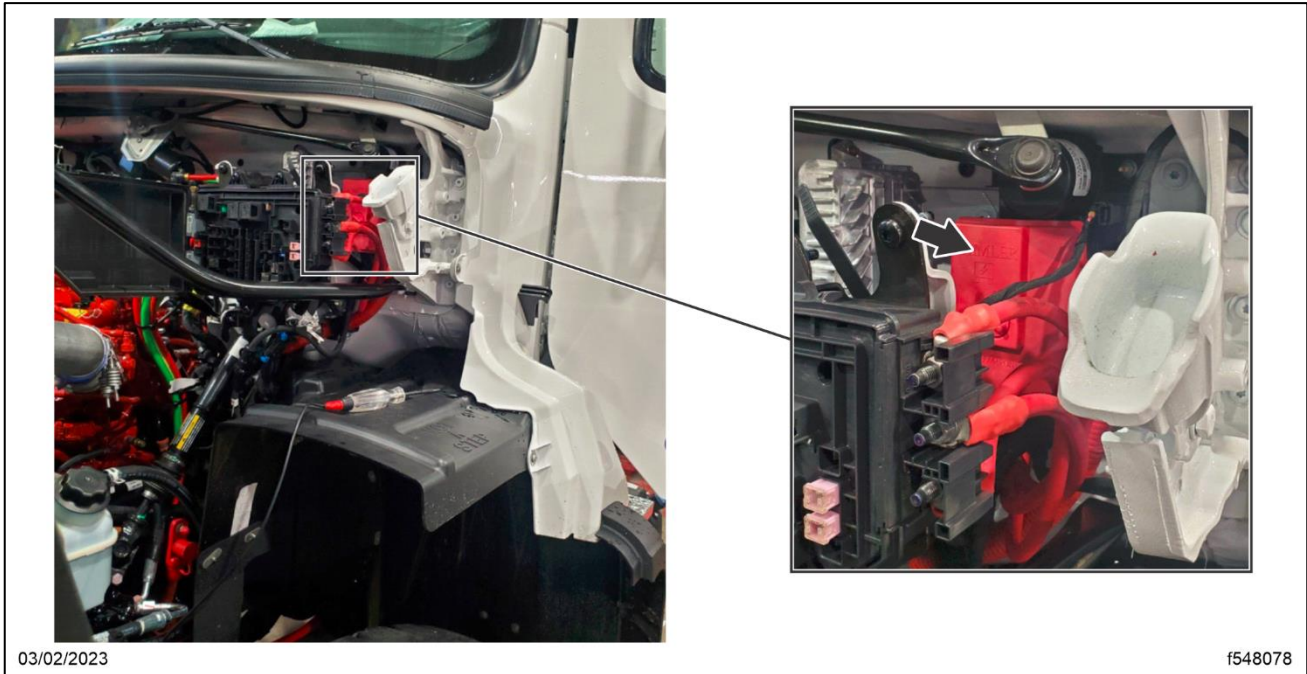
Fig. 4, BCA Fuse Location

5. Inspect the BCA torque fuse as follows.
 - 5.1. Locate the BCA fuses on the driver's side of the engine bay. See [Fig. 4](#).

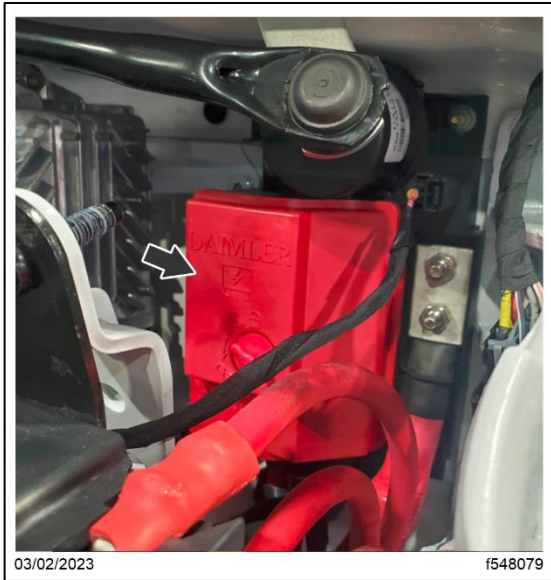
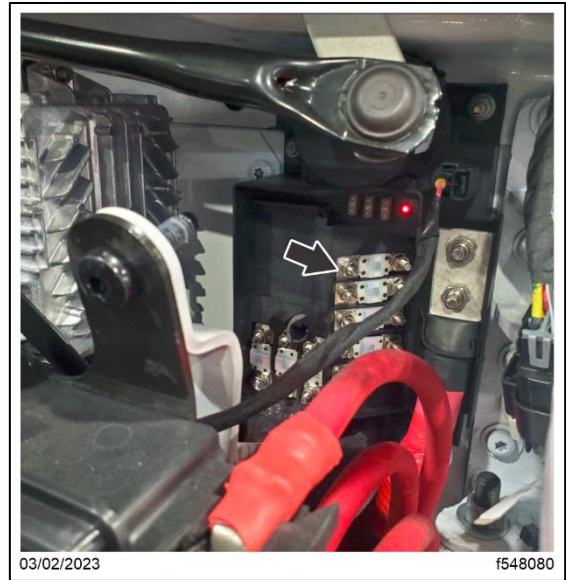
- 5.2. Remove the red cover to access the fuses. Check for the red light illumination. See [Fig. 5](#) and [Fig. 6](#).

Does the red light located above the fuses glow?

YES → Do not tighten the fuse mounting nuts yet. Check and disconnect the batteries, if not properly disconnected already.

NO → Go to step 6.
