TECHNICAL SERVICE BULLETIN

Bulletin No.: TSB-046

Subject: VP ¾" and 1" Fuel Line Leaks

Models: 2022 MY Quantum 40 Series VP Trailers

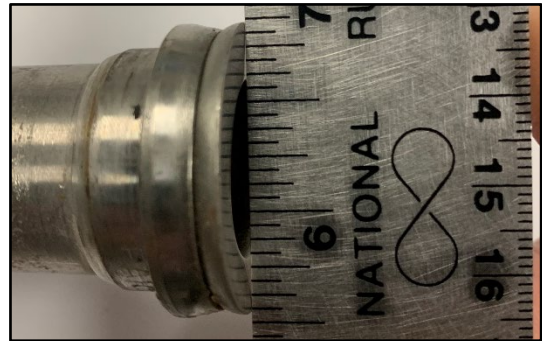
- Flatness:** Lay a small straight edge across the surface of the Parflange®, if the surface of the Parflange® is visibly concave or convex the pipe assembly should be replaced

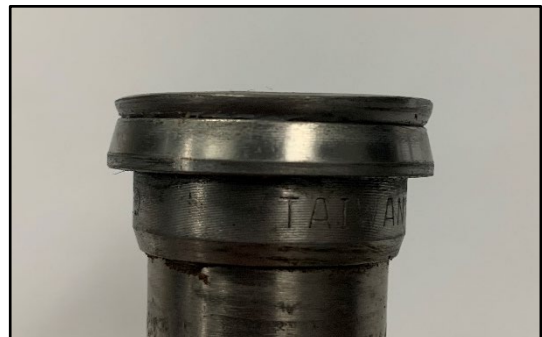
- Uneven Flange Thickness:** Slide the nut away from the Parflange® surface and view the Parflange® from the side, if the flange surface is visibly uneven the pipe assembly should be replaced.

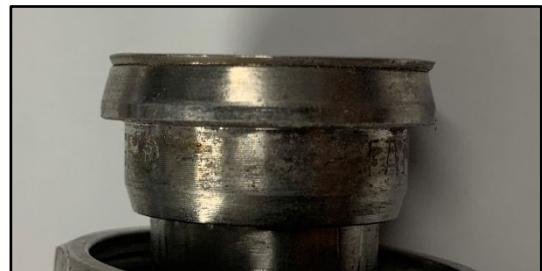
The overall Parflange® thickness should also be inspected, if the Parflange® thickness is even but appears thin compared to similar Parflange® assemblies being inspected, the pipe assembly must be replaced.

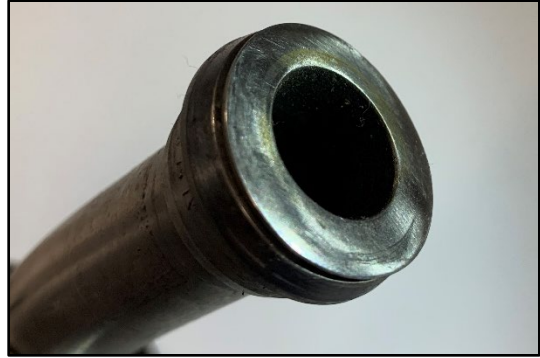
- **Irregular Flange Surface:** Visually inspect the Parflange® surface, if the Parflange® surface is visibly uneven or the witness marks from the fitting indicate intermittent contact to the Parflange® face, the pipe assembly should be replaced.

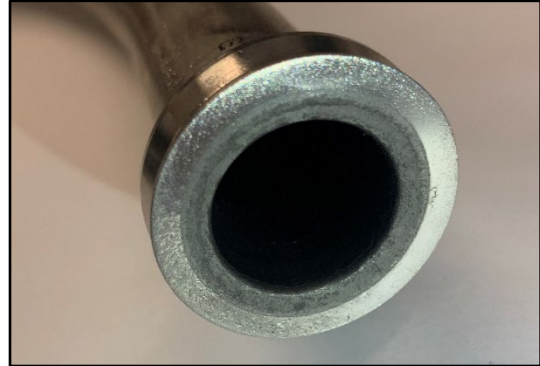
- **Rough Flange Surface:** Visually inspect the Parflange® surface, if the Parflange® surface is visibly rough or shows signs of pitting or galling, the pipe assembly should be replaced.

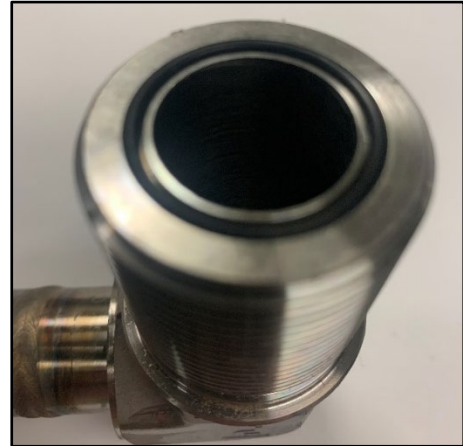
- **Damage:** Inspect the surface of the fitting for any obvious damage or debris that may affect the sealing area of the fitting or the ability of the fitting to properly seat.

Damage to the outer edge of the fitting face may not directly affect the sealing area, but it may not allow the Parflange® to properly seat against the fitting face and seal.

If any damage is observed, replace the pipe assembly.

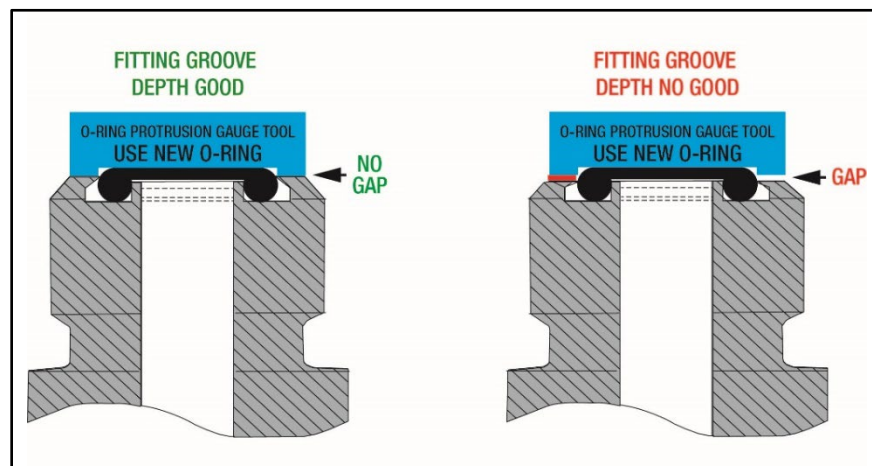
- **O-ring Groove Depth:** Inspect the surface of the fitting for any obvious damage or debris that may affect the use of the tool for gauging the O-ring protrusion from the fitting.
1. Remove the O-ring if still present and clean the O-ring groove in the fitting.
 2. Lubricate a new O-ring with Krytox® oil and install the new O-ring in the fitting. Verify the O-ring is properly seated in the O-ring groove.
 3. Rub your finger across the top of the O-ring, if the O-ring will not remain in place and falls out of the O-ring groove, the O-ring groove in the fitting is improperly formed. Replace the pipe assembly.
 4. Using the Parker O-ring protrusion gauge as illustrated below, verify the O-ring protrusion is in the correct range. If a gap is observed, replace the pipe assembly.
