HYUNDAI Technical Service Bulletin	GROUP STEERING	NUMBER 23-ST-001H
	DATE MARCH 2023	MODEL(S) PALISADE (LX2) SANTA FE HYBRID (TM HEV) SANTA FE PLUG-IN HYBRID (TM PHEV)
SUBJECT: PALISADE (LX2), SANTA FE HYBRID & PLUG-IN HYBRID (TM HEV/PHEV), COLUMN TORQUE RESET

Description: This bulletin describes the procedure to reset the steering system torque value to balance uneven steering feel when steering left vs right on some Palisade (LX2), Santa Fe Hybrid (TM HEV), and Santa Fe Plug-In Hybrid (TM PHEV) vehicles.

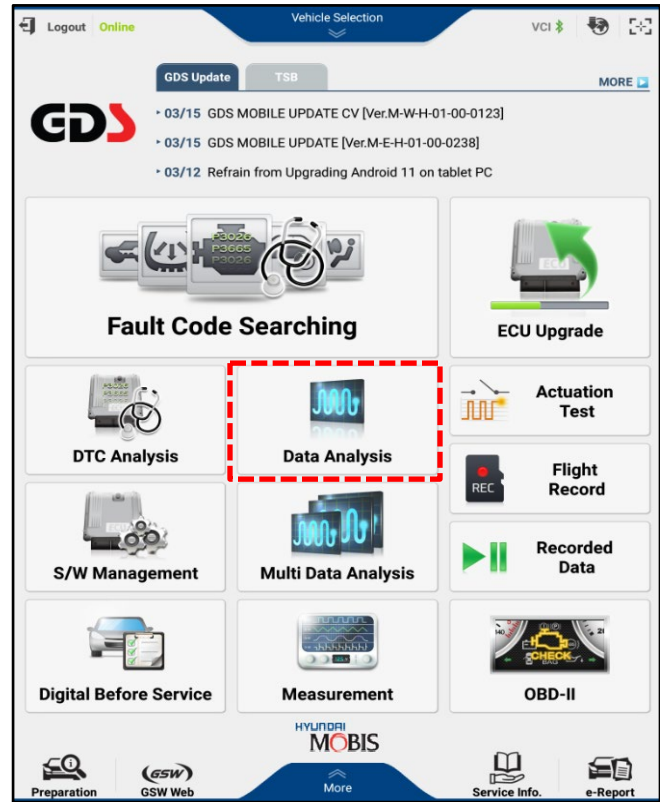
- Check and record the “Column Torque” value.

If the column torque value is above 0.7 Nm, or below -0.7 Nm, it will be necessary to apply some torque to the steering wheel by hand in the service procedures below.

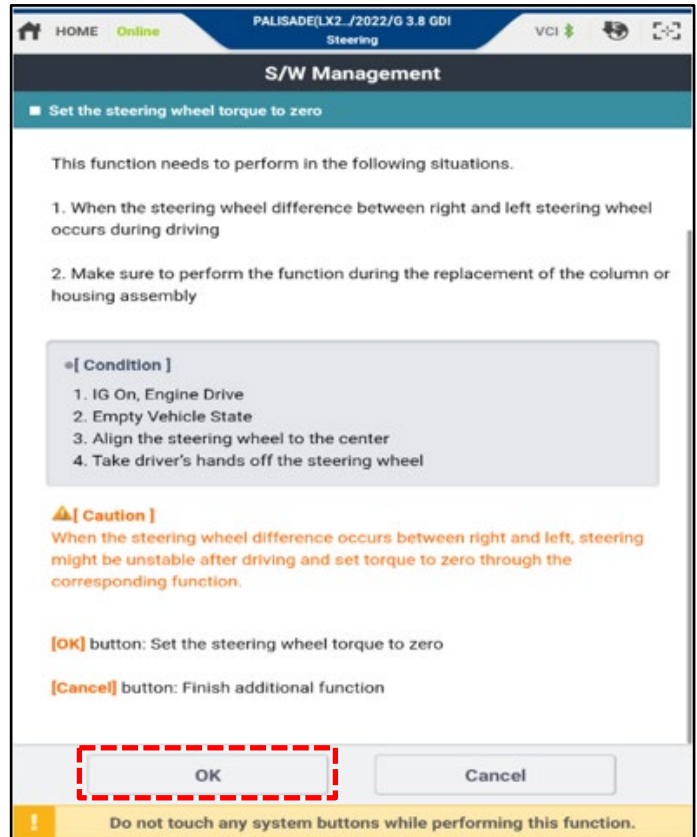
6. Note the Column Torque value.

- A) If the column torque value is:
 $-0.7 \text{ Nm} < \text{column torque} < 0.7 \text{ Nm}$
 - Press **OK** without touching the steering wheel.

- B) If the column torque value is:
 $-0.7 \text{ Nm} > \text{column torque}$
 $0.7 \text{ Nm} < \text{column torque}$
 - Apply a small amount of force to the steering wheel by hand until the value is less than 0.7 Nm, or greater than -0.7 Nm. Then press **OK** while holding the steering wheel in place.

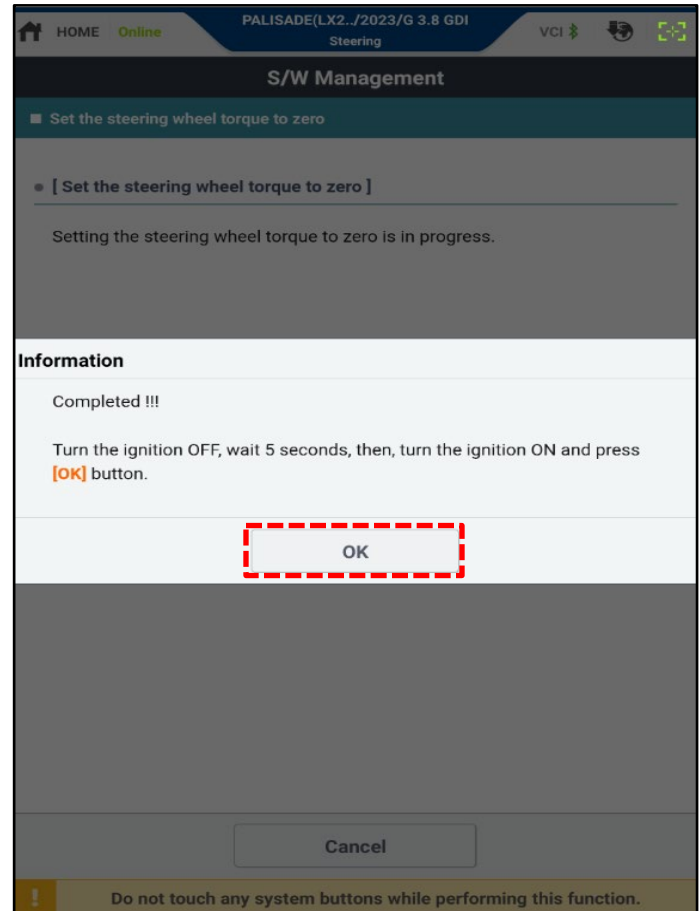
8. Upon completion of the function, note the new value of the column torque.
- If the value is within the range below, the torque zeroing function is complete.

If the value is outside of the range below, perform the zeroing function again until it is within specification.

$-0.3 \text{ Nm} \leq \text{column torque value} \leq 0.3 \text{ Nm}$
