Technical Service Bulletin

GROUP	NUMBER
BODY ELECTRICAL	23-BE-003H
DATE	MODEL(S)
MARCH, 2023	Tucson (NX4a) Santa Cruz (NXT)

SUBJECT: TUCSON/SANTA CRUZ EXTERNAL AMPLIFIER REPLACEMENT

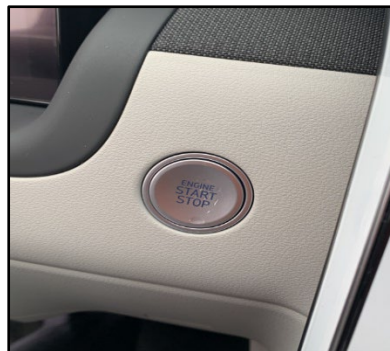
Ensure engine OFF to begin.

3. For **Tucson (NX4a)**
Refer to shop repair procedure Tucson (NX4A) [2022-2023] > Body Electrical System > AVN System > External Amplifier > Repair procedures for complete repair breakdown.

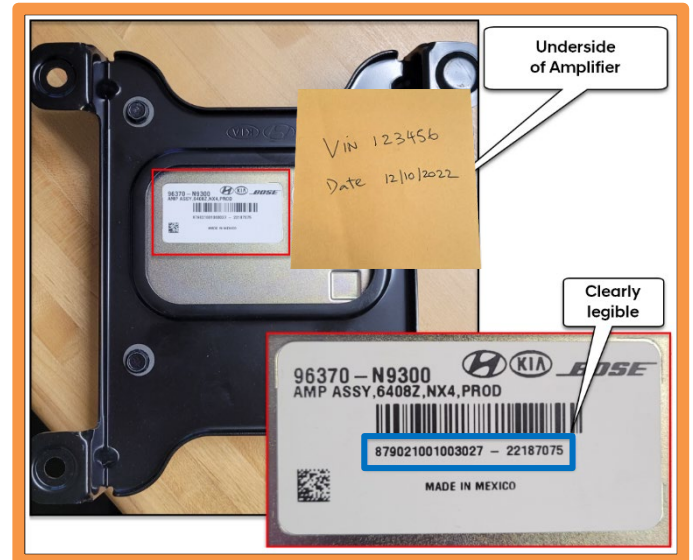
Using STUI, take a photo of the underside of amplifier clearly showing the blue box along with the last 6 digits of the VIN and the date of repair on a piece of paper.

Upload the photo to STUI.
