Volvo Chassis - Unable To Program VECU: Error Code 155; Possible EMS DTC U000188 CAN Communication Backbone 2 Net - VECU5 Only

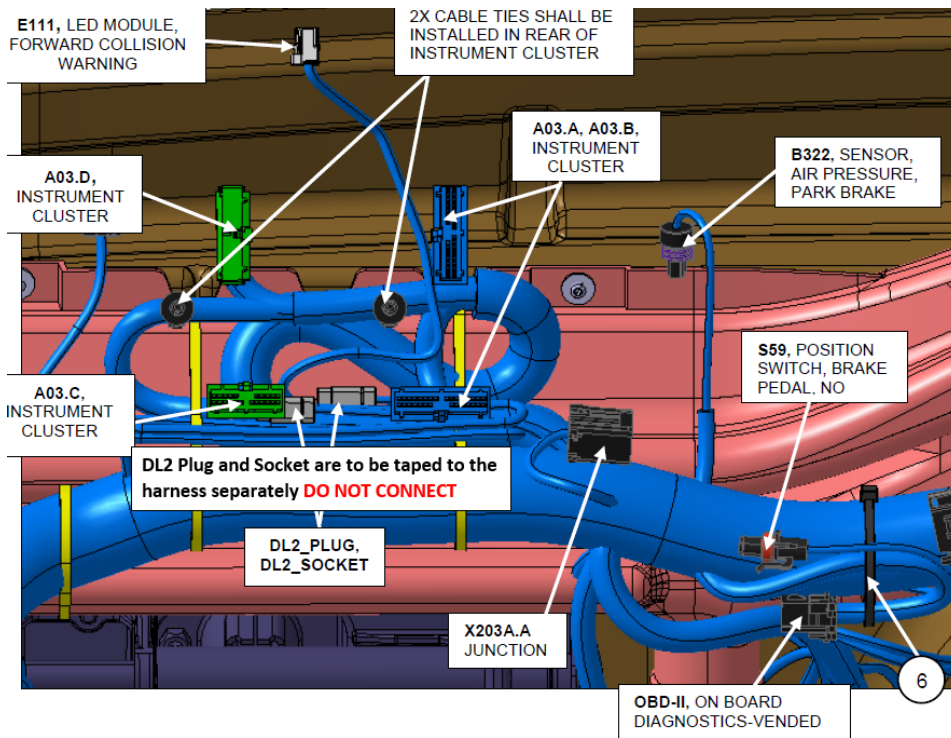
For vehicles exhibiting these symptoms, there is an interconnect located behind the instrument panel that connects the instrument panel to the DL2 backbone. The current instrument panel does not support DL2 and when hooking it up to the DL2 there will be intermittent operations on the network.

A quick way to identify if the innerconnect has been connected is to take an ohm reading between Pins 6 and 14 of the OBD diagnostic connector. If the resistance is around 40 ohms, pull the instrument cluster per [3811-03-02-10 Instrument Cluster, Replacement](#) and see if the Deutsch two way connector has been connected. If they have, disconnect and tape each connector to the main harness separately.
