Bracket, Door Harness, Replacement

M-831-001

All Mack MR, TE Trucks built with heated mirrors

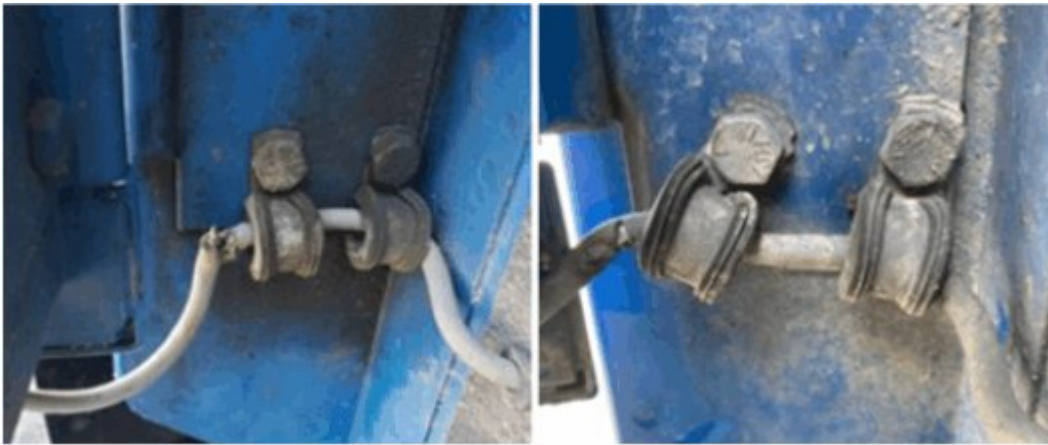
Certain Mack MR, TE trucks could experience breakage of the heated mirror cable at the bottom of the door where it goes through the clamps. In certain instances, it is possible for the door to pinch the harness at the clamp causing damage to the harness. A new bracket has been developed to secure the harness in a way that stops binding and pinching. Follow the instructions outlined in the document to remove the old clamps, Install the new bracket and reroute the heated mirror cable.

Part Number	Description	Quantity
24412667	Bracket	1 per side
948211	Cable tie	2 per side
