Technical Service Bulletin

60 Panoramic sunroof opening outer perimeter seal is loose

60 23 64 2063187/3 March 31, 2023. Supersedes Technical Service Bulletin Group 60 number 23-61 dated January 9, 2023 for reasons listed below.

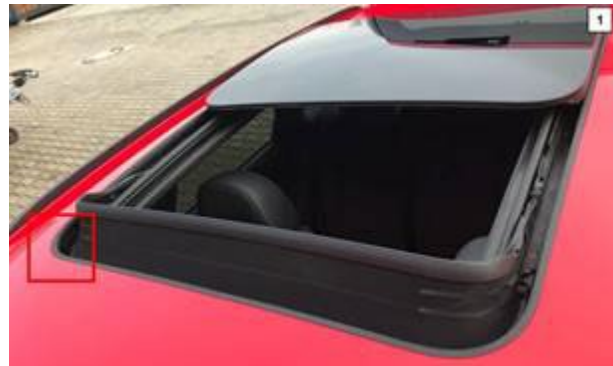
1. Begin the inspection of the sunroof opening perimeter seal adhesion by fully opening the front sunroof glass panel (Figure 1).

Figure 1. Front sunroof panel open.

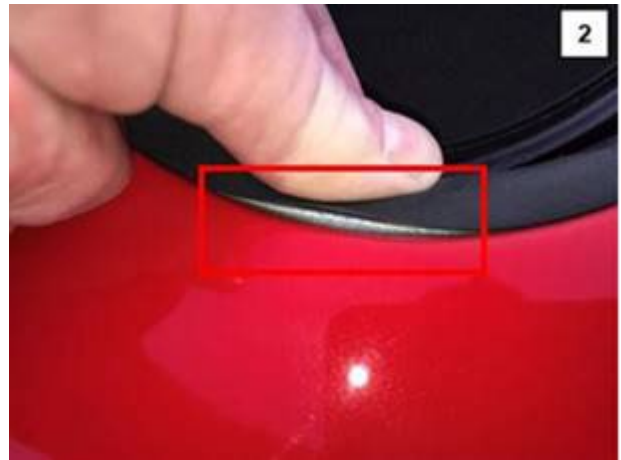
2. Press the seal downwards and inwards with your fingers until the adhesive tape for the seal is visible (Figure 2). The foam adhesive tape may be stretched but it must not be loose or detached from the roof panel to any degree.

Figure 2. Checking the adhesion quality.

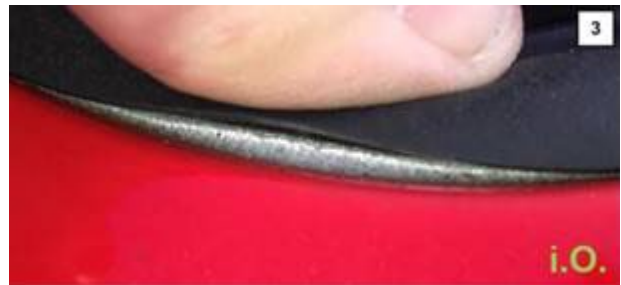
3. Figure 3 shows a properly adhered adhesive band.

Figure 3. A properly adhered perimeter seal.

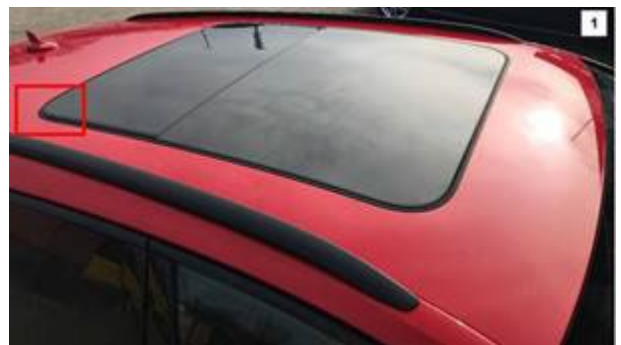
4. Repeat this procedure centimeter by centimeter over the entire length of the front sunroof opening. When this is completed, close the front sunroof panel.
5. Using the same inspection principle used in the inspection of the front portion of the sunroof opening perimeter seal check the seal adhesion in the rear portion of the sunroof opening (Figure 4).

Figure 4. Begin inspection of the rear portion of the perimeter seal.

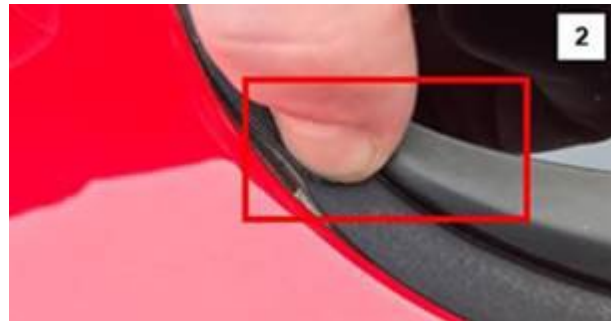
6. Figures 5 - 8 clearly show that the adhesive tape has come loose from the vehicle body. The obvious color and shape difference at the point of contact revealing the gaps is evidence of detachment.

Figure 5. Clear evidence of adhesive detachment.

7. A gap in the attachment is revealed in the examples in Figures 5 - 8.

8. The locations where the adhesion is compromised or has failed is a possible entry point for water into the cabin. The area directly below these openings is outside the area of the sunroof drainage. If any adhesion is found to be compromised or failed to any extent replace the sunroof opening perimeter seal. Follow the procedure in ElsaPro explicitly to ensure proper seal adhesion paying particularly close attention to the adhesion surface preparation.
9. Remember to set the sunroof panel and rollershade end stop adaptation after reassembly using the sunroof panel and rollershade switches. Refer to TSB 2054505: *60 Sunroof glass panel or sunroof rollershade do not operate* for instructions.

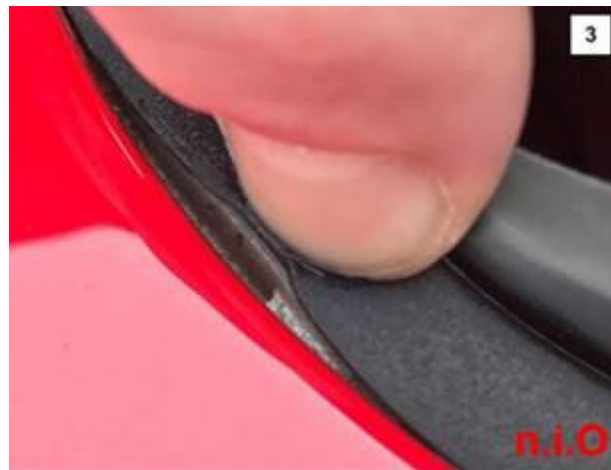
Figure 6. Seal adhesive band detachment revealed.

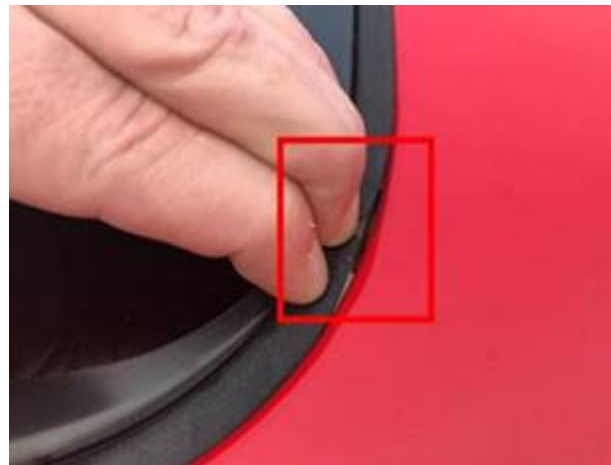
Figure 7. Adhesive band detachment.
