Service Alert

CRACKED REAR DIFFERENTIAL (REVISED)

Service Alert No.: SA-007/23

2017-2022 CX-3 AWD 2017-2022 CX-5 AWD 2017-2022 CX-9 AWD

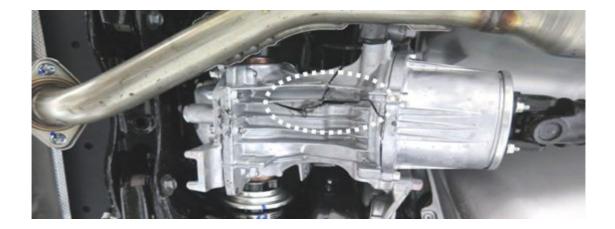
The rear differential case could develop a crack in the case, as shown below.

- 1. If the vehicle belongs to a customer, request the customer to fill out the questionnaire attached below. If the vehicle is a rental (AVIS, Enterprise, etc.) or a used car without a known history, note this on the repair order and let the MASH agent know, no questionnaire is needed.
- 2. Take photos of rear differential damage.
- 3. Contact MASH for differential approval. Have photos available for quick approval.
- 4. Replace the rear differential assembly according to MGSS.

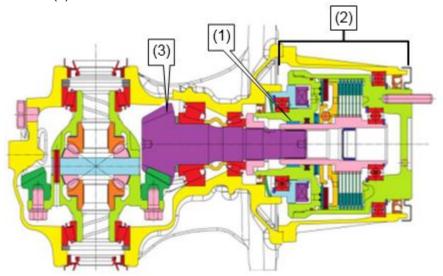
This concern is caused when the sliding bearing (1) in the coupling (2) is seized and causes the coupling component to fit loosely. The pinion shaft head (3) then contacts the differential case and causes a crack.
