Subject: ABNORMAL NOISE WHEN OPENING OR CLOSING THE FRONT DOOR	Service Alert No.: SA-019/23
	Last Issued : 03/31/2023

2024 CX-90

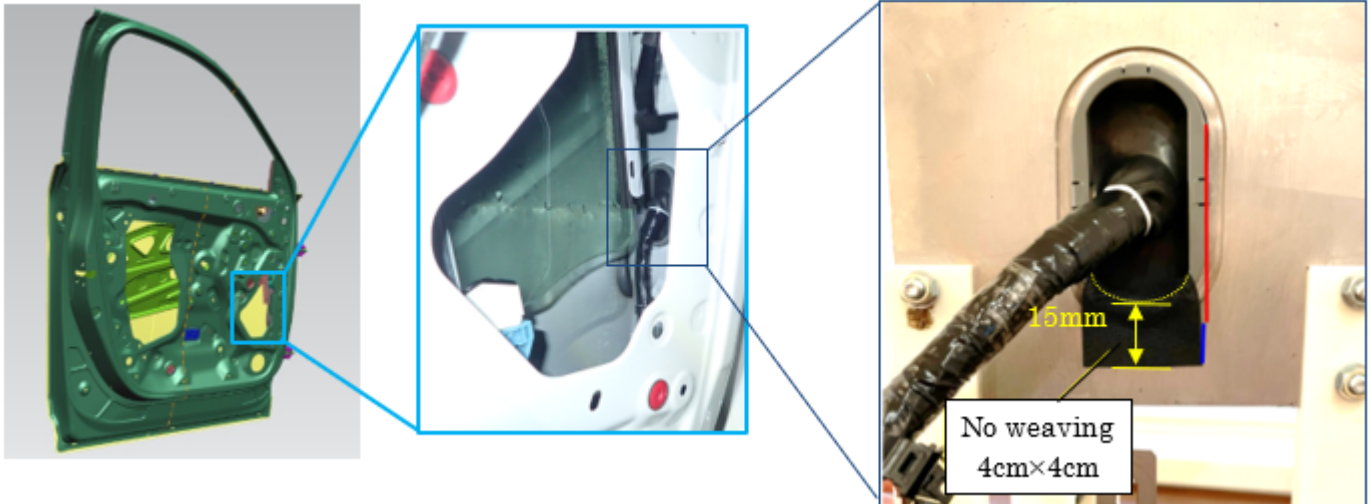
Some customers may report that the front door(s) makes a noise at the front when moving the door to open or close it. When a front door is opened and closed, an abnormal noise is heard with the movement. This is caused by the closing operation, the harness and door to rub against each other, causing abnormal noise.

1. Verify the customer concern.
2. Disassemble the door to access the harness inside the door using the instructions in MGSS:
 - DRIVER-SIDE FRONT DOOR TRIM REMOVAL/INSTALLATION
 - PASSENGER-SIDE FRONT DOOR TRIM REMOVAL/INSTALLATION
3. Cut the thinnest felt tape in the kit into 4 cm × 4 cm pieces.
4. Clean and dry the surface.
5. Attach the cut pieces to the interference site as shown below.

- The image above shows the window open. The repair can be done with the window in any position, but it is easier if the glass is fully closed.
- The tape should align towards the inner side of the harness grommet (in the example below it aligned with the red line).
- Attach 15mm (1.5cm) from the bottom edge of the grommet, and paste the remaining 25mm (2.5cm) into the grommet.
