## TECHNICAL SERVICE BULLETIN

### Fuel Filling Issues, Engine Stalls After Start - Built On 18-Jul-2022 And Through 04-Aug-2022

**23-2028**20 March  
2023**Model:**

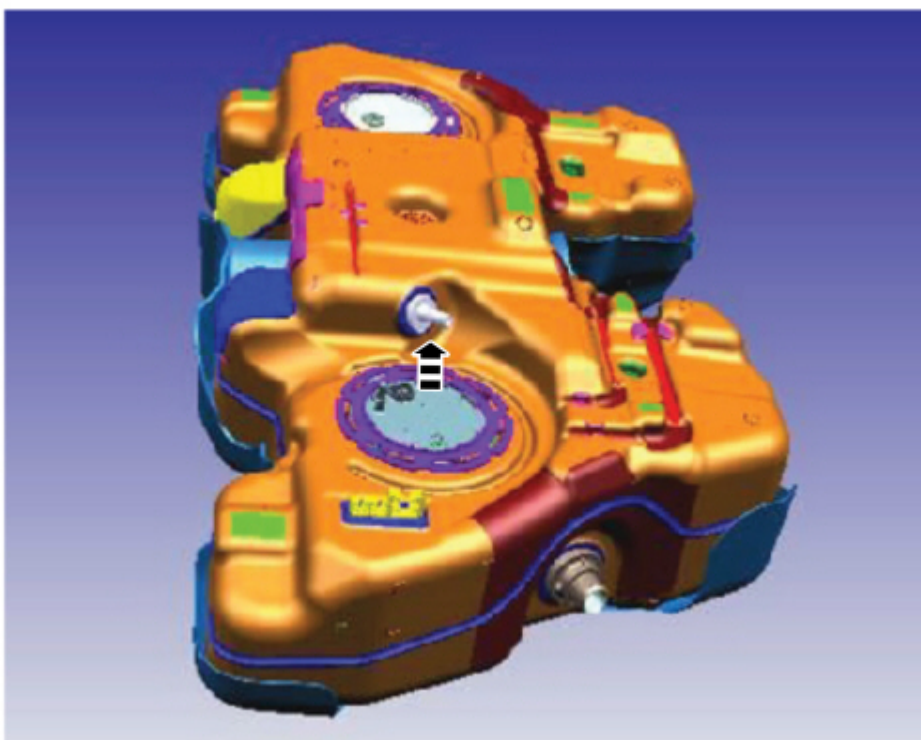
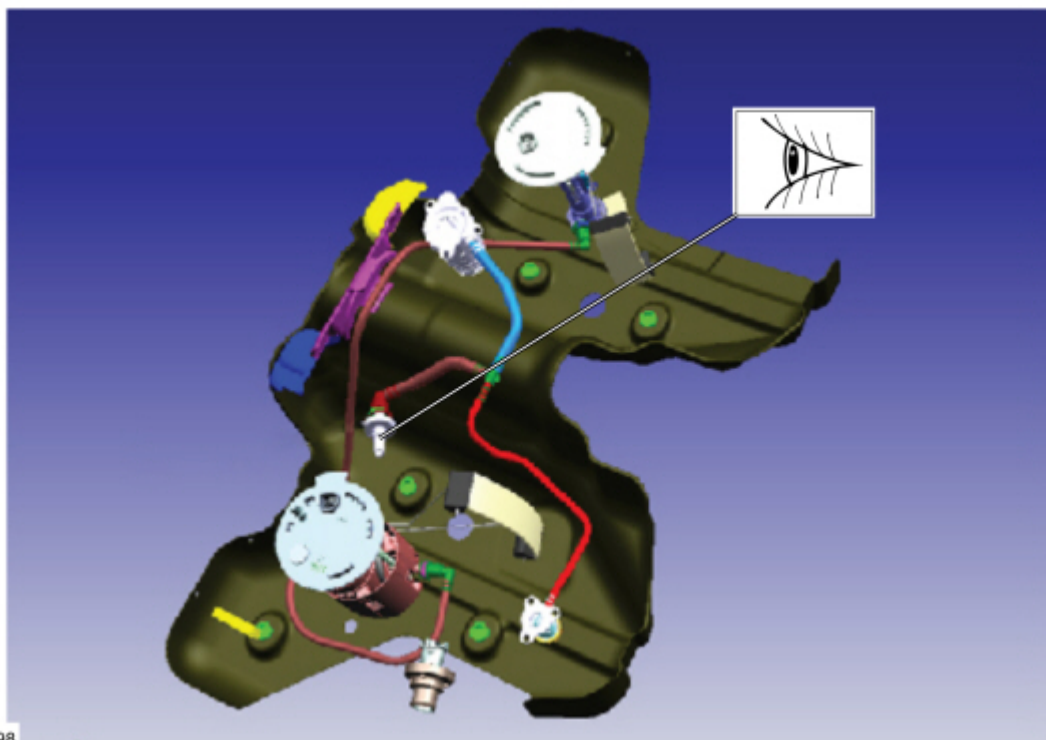
1. Remove the fuel tank assembly. Refer to the Workshop Manual (WSM), Section 310-01A, Removal and Installation, Fuel Tank
2. Remove fuel pump and sender unit. Refer to the WSM, Section 310-10A, Removal and Installation, Fuel Pump and Sender.
3. Inspect the inside of the tank for a disconnected fuel vapor hose. (Figures 1-2)

**4. Is the hose disconnected?**

- (1). Yes - reattach the hose. Proceed to Step 5.
- (2). No - reassemble vehicle and refer to the WSM for normal diagnostics outside of this article.

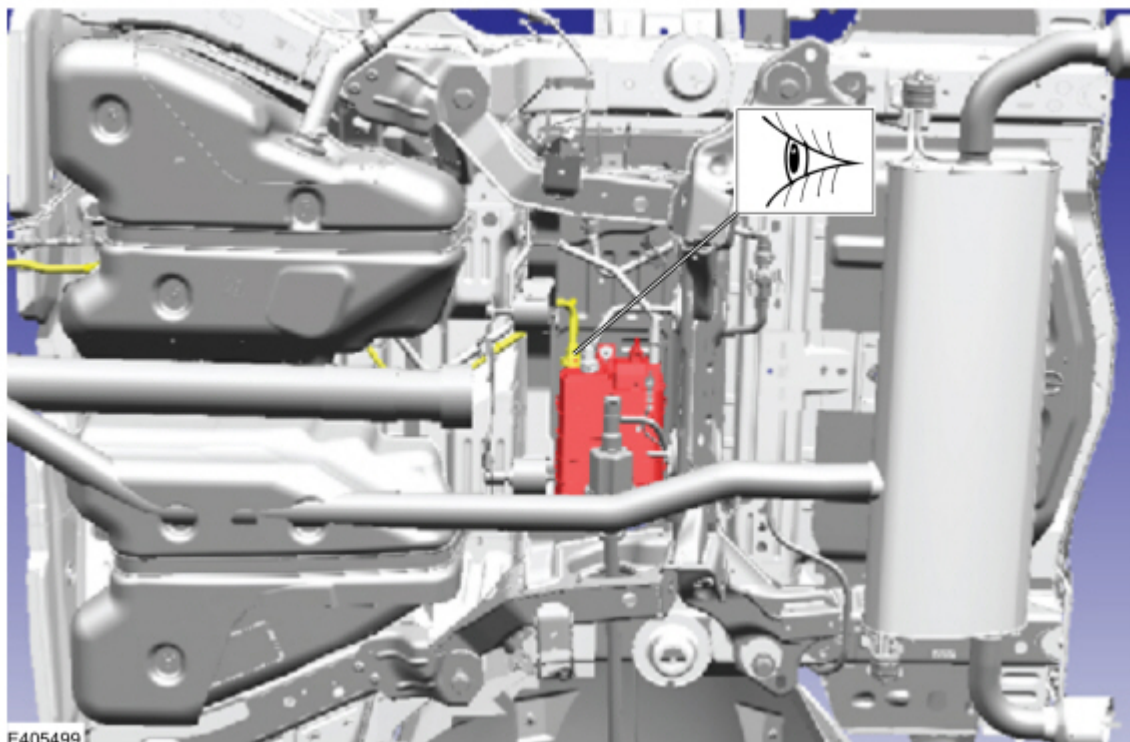
Figure 3

**5. Disconnect the vapor line quick connect at the evaporative emissions (EVAP) canister and inspect for signs of liquid fuel contamination. Is liquid fuel contamination present? (Figure 3)**

- (1). Yes - replace the EVAP canister. Refer to WSM, Section 303-13A, Removal and Installation, Evaporative Emission Canister. Proceed to Step 6.
- (2). No - reattach the quick connect. Proceed to Step 6.
