Subject: N222390620 - Service Update
Engine Wiring Harness

Models: 2022 – 2023 Cadillac CT4

Service Update

N222390620 Engine Wiring Harness

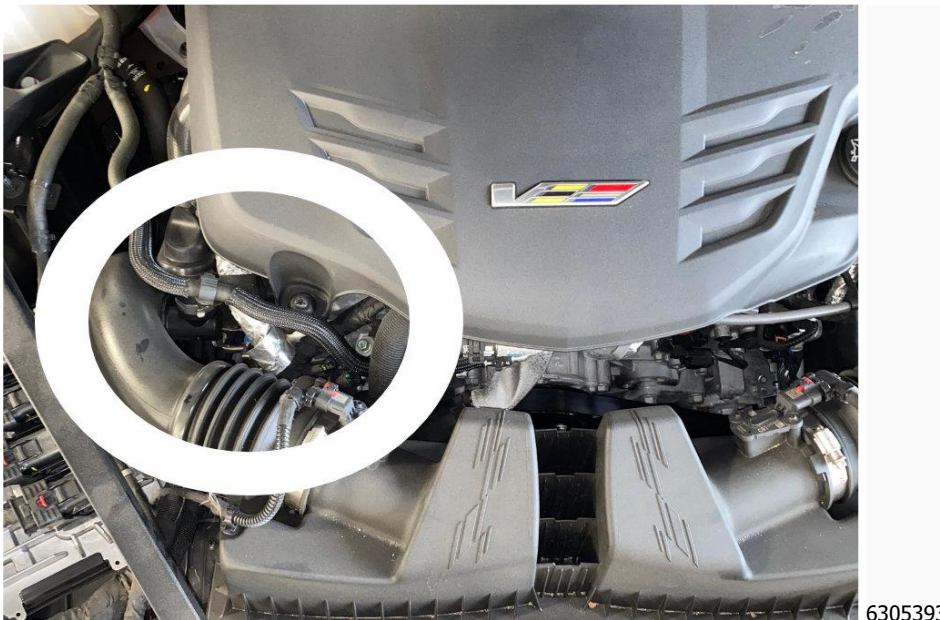
6305393

1. Open the hood and locate the area highlighted above.

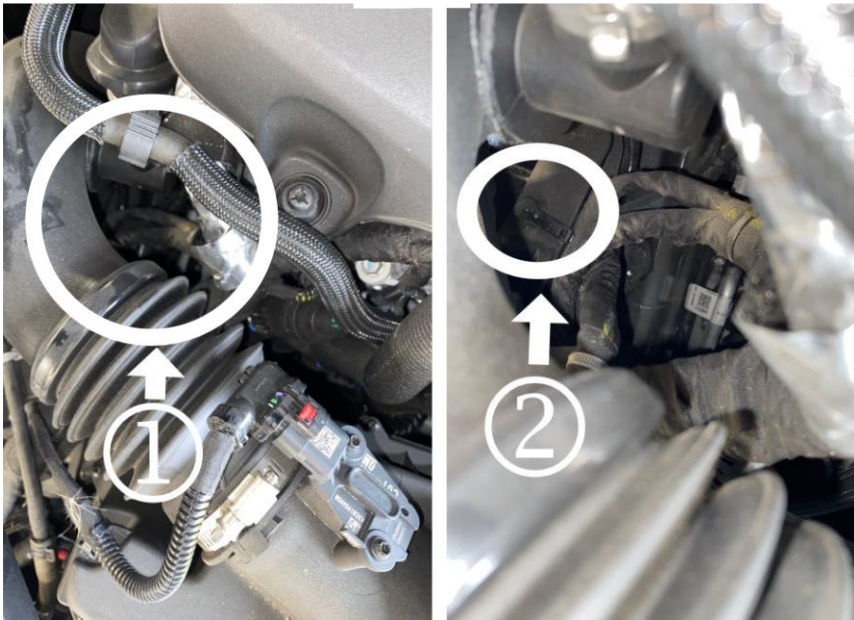
6305402

2. Locate area 1.
3. Locate the wire harness retainer (2) within area 1.

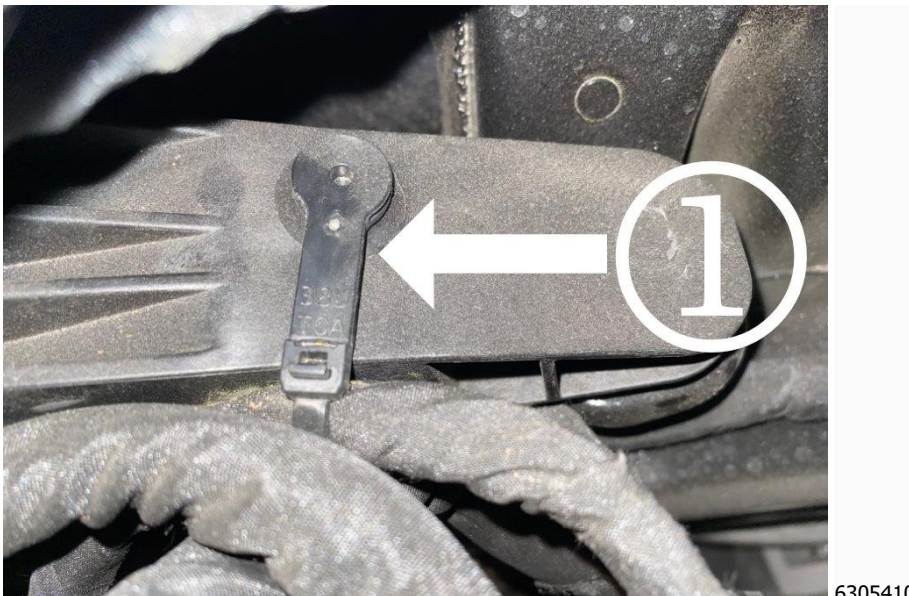
6305410

4. Verify the wire harness retainer (1) is properly seated, as shown above.
 - If the wire harness retainer (1) is properly seated, no further action is required. Proceed to step 7.
 - If the wire harness retainer (1) is not properly seated, proceed to step 5.

Note: An improperly seated wire harness retainer can cause the wire harness to rub on the Accessory Drive Primary Belt. Ensure the wire harness is inspected along the entire section that could come in contact with the Accessory Drive Primary Belt.

5. Inspect the wiring harness for damage.
 - If no damage is found, proceed to step 6.
 - If any damage is found, repair the wire harness. Refer to *Wire to Wire Repair* in SI. Proceed to step 6.
