# Service Action

## Code: 93P7

<b>Subject</b>	HV Battery Cell Module(s)															
<b>Release Date</b>	March 29, 2023															
<b>IMPORTANT!</b> <b>Battery Cell Evaluation/Replacement</b>	<ul style="list-style-type: none"><li><b>Vehicles with CRITERIA 02 in ELSA</b> have already been identified by the factory as requiring battery cell module replacement(s). Owners of these vehicles <b>MUST</b> schedule this service action directly with a certified Volkswagen battery repair dealer.</li><li><b>Vehicles with CRITERIA 04 in ELSA</b> can be scheduled for battery cell evaluation with any authorized Volkswagen dealer; however if the evaluation indicates battery cell replacement(s) is needed, the dealer performing the replacement(s) <b>MUST</b> be a certified Volkswagen battery repair dealer.</li></ul>															
<b>Affected Vehicles</b>

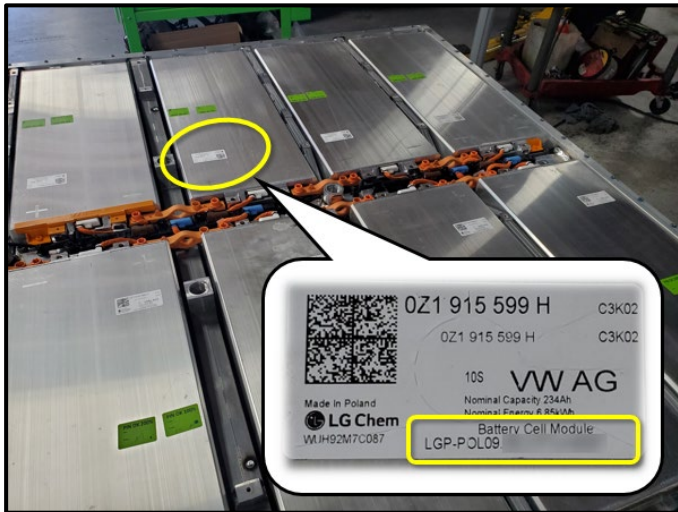
### Identify cell module which requires replacement:

- Identify the module that requires replacement and clearly mark its location.
