90 Overhead view camera (TopView) calibration fails

90 23 13 2069670/1 March 15, 2023.

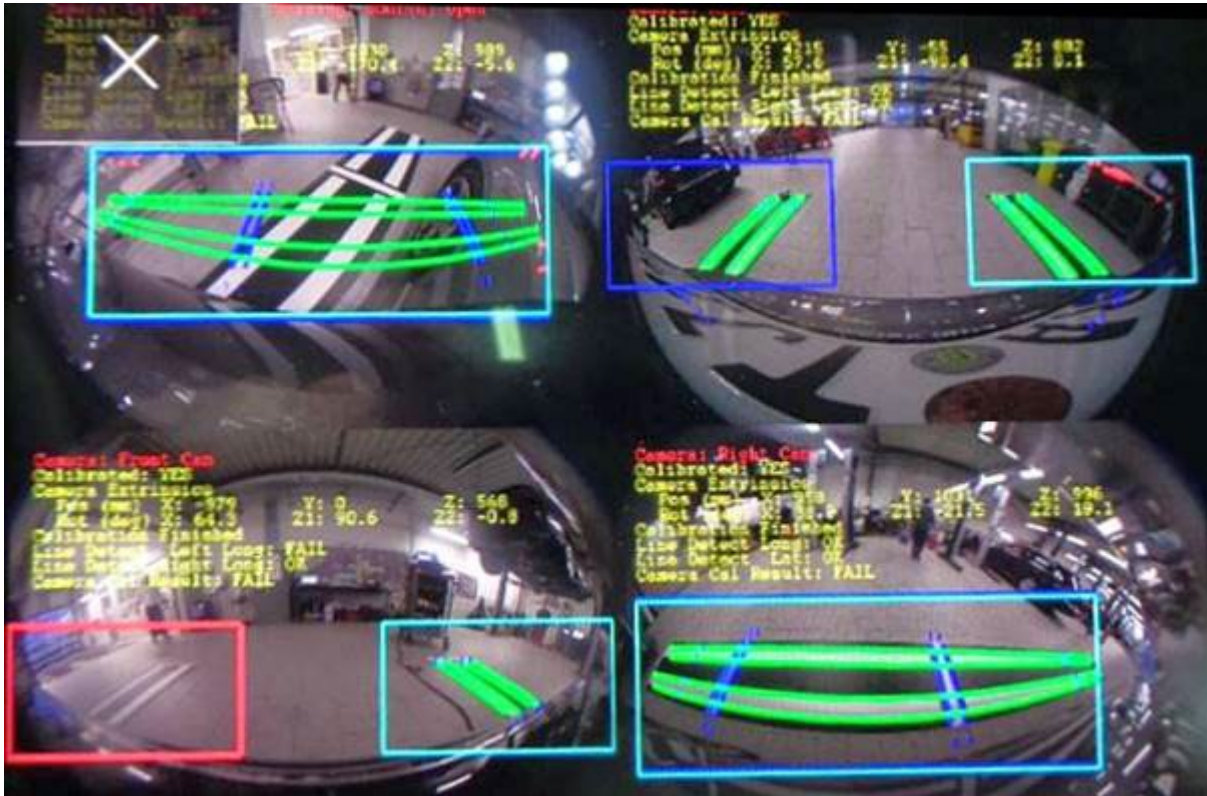
1.1 Calibration unit not set up properly

The diagnostic tester and the MMI calibration screen indicate that not all areas of the calibration unit have been identified correctly (see **Figure 1**).

The calibration was not successful.

Figure 1: Camera calibration as displayed on the MMI screen

- Check whether the calibration unit has been set up as specified in the Workshop Manual and correct the setup if necessary.

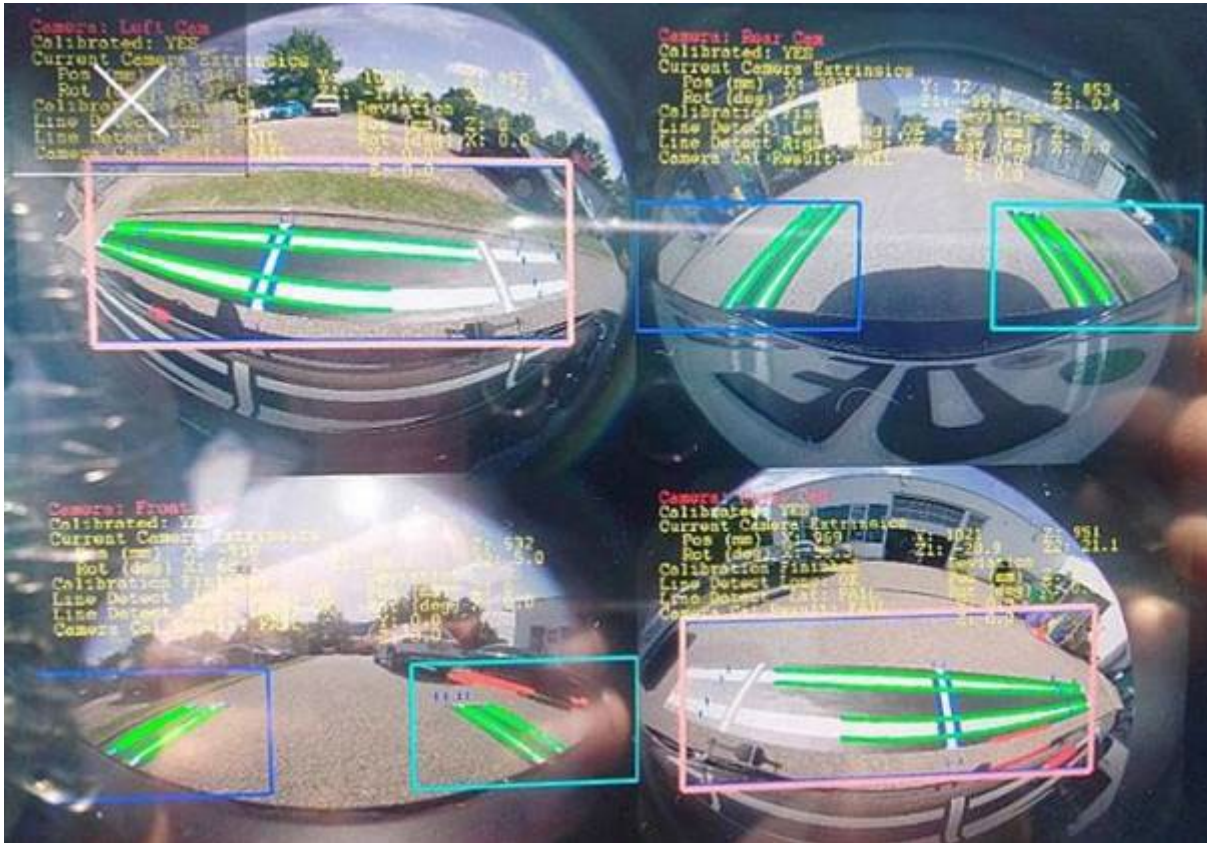
1.2 Insufficient lighting

The diagnostic tester and the MMI calibration screen indicate that not all areas of the calibration unit have been detected correctly (see **Figure 2**).

Calibration was not successful.

Figure 2: Camera calibration as displayed on the MMI with insufficient or excessive lighting

- When the corresponding camera image appears on the MMI, no reflections or shadows must be visible on the calibration unit. All the lines of the calibration unit must be clearly recognizable. If this is not the case, adjust the lighting.

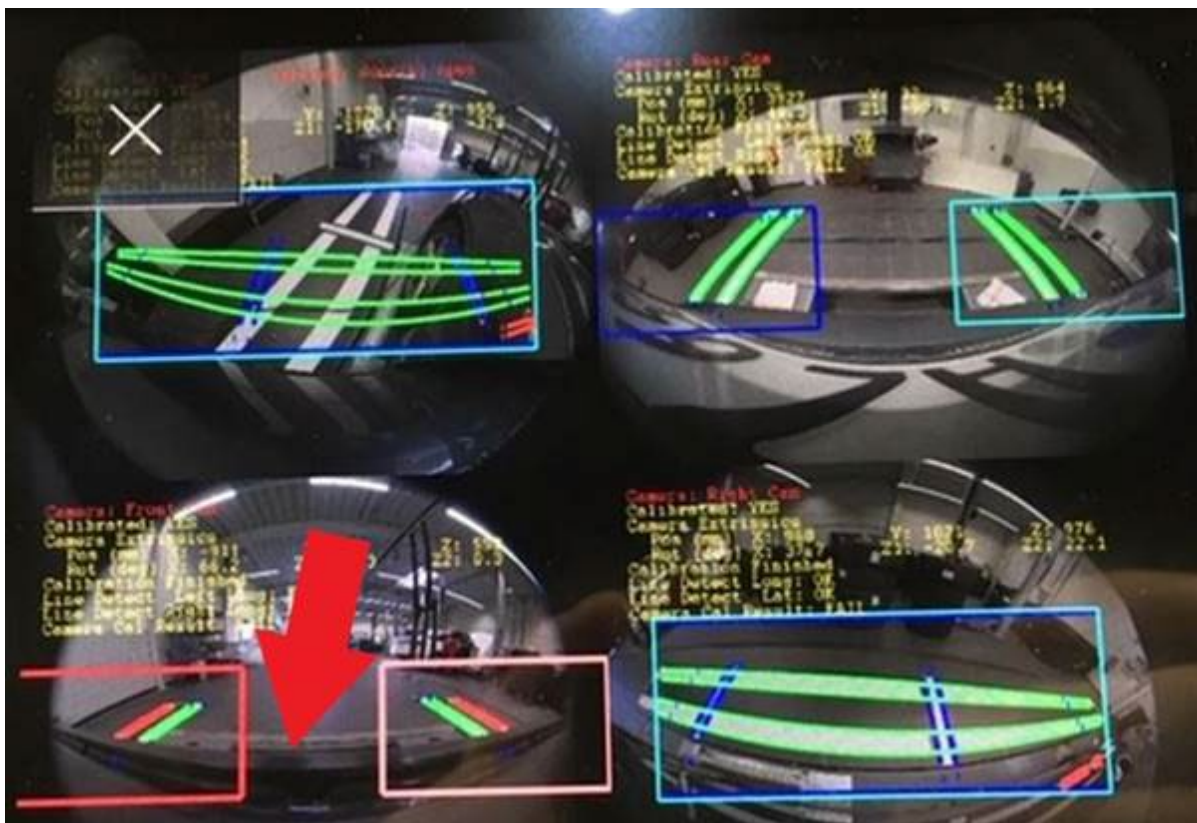
1.3. License plate frame and/or license plate in field of vision of the front camera

The diagnostic tester and the MMI calibration screen indicate that not all areas of the calibration unit have been detected correctly (see **Figure 3**).

Calibration was not successful.

Figure 3: Camera calibration as displayed on the MMI with license plate visible

- If the license plate frame or the license plate itself interferes with the calibration of the cameras, the license plate and its frame should be removed while performing the calibration procedure.

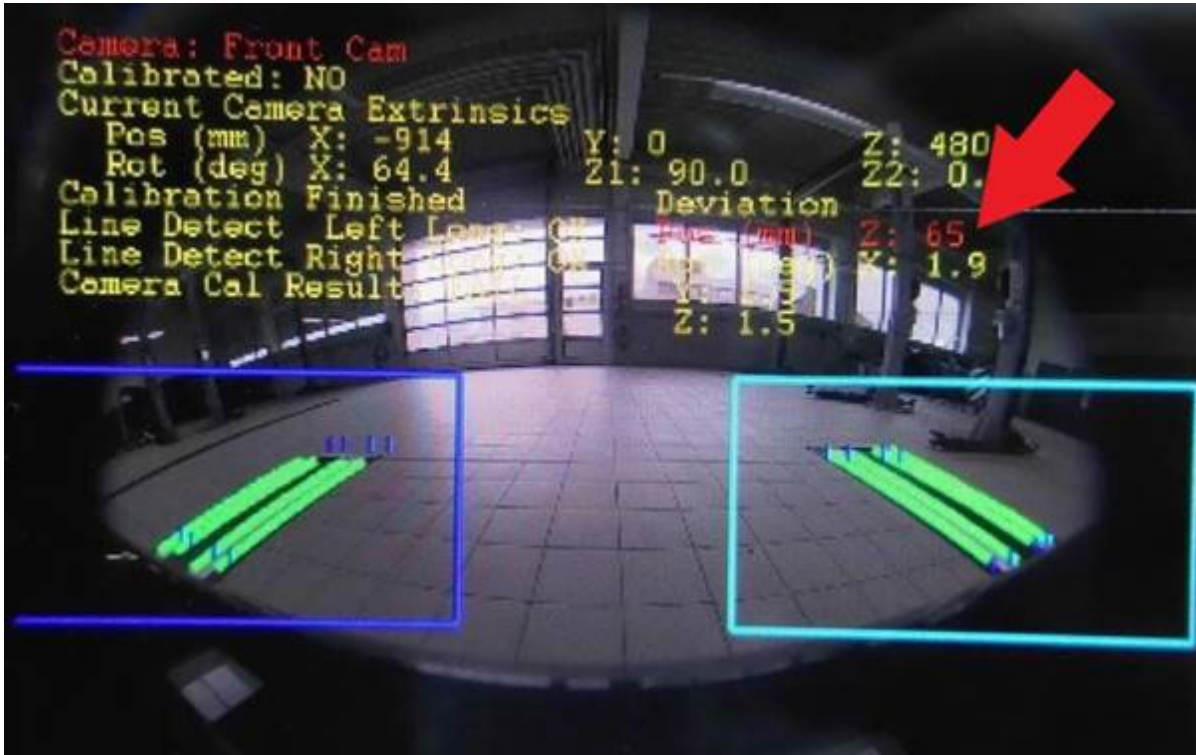
2.1. Camera not installed correctly

The diagnostic tester and the MMI calibration screen indicate that all areas of the calibration unit have been detected correctly.

However, calibration was still not successful.

The MMI calibration screen indicates that the correction values of the camera (X, Y, Z) are outside the tolerance (see **Figure 4**).

Figure 4: Camera calibration as displayed on the MMI with incorrectly installed camera

- Check the camera installation (e.g. camera position in camera bracket and camera bracket in bumper not level/not engaged or similar) and correct the installation position in the event of discrepancies.

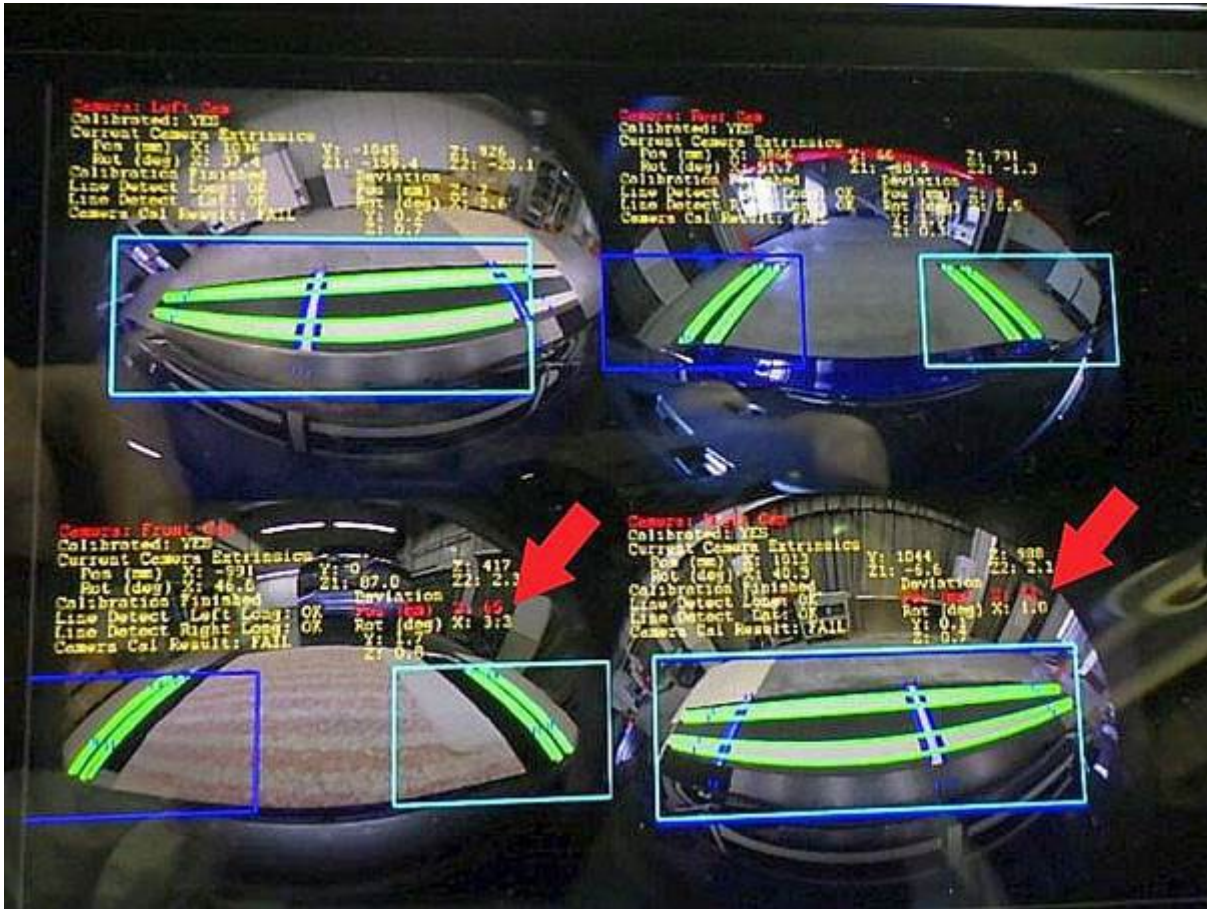
2.2. Insufficient vehicle ride height

The diagnostic tester and the MMI calibration screen indicate that all areas of the calibration unit have been detected correctly.

However, calibration was still not successful.

The MMI calibration screen indicates that the height correction values of the camera (Z) are outside the tolerances (see **Figure 5**).

Figure 5: Camera calibration as displayed on the MMI with insufficient ride height

- Check the vehicle's ride height at both the front and rear wheel arches (e.g. transport locks fitted, tire pressure too low) and correct any discrepancies.
- Check that the vehicle level sensors are installed correctly and correct the installation in the event of any discrepancies.
- If the camera still doesn't calibrate due to insufficient ride height, run the plan item "Headlight basic setting" in "Guided Functions".
Re-calibrating the headlights will also re-calibrate the level sensors.
With the corrected values for the vehicle's ride height, the calibration of the overhead view (TopView) camera system will usually become possible.
