GROUP	MODEL
BOD	2023MY Telluride (ON)
NUMBER	DATE
315	March 2023

TECHNICAL SERVICE BULLETIN

SUBJECT: SERVICE ACTION: CRASH PAD CENTER SPEAKER GRILL INSPECTION/REPLACEMENT (SA528)

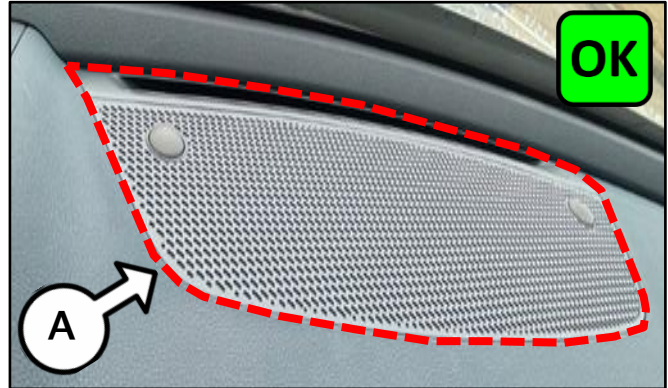
- Speaker grill cover is properly seated (OK). No further action required.

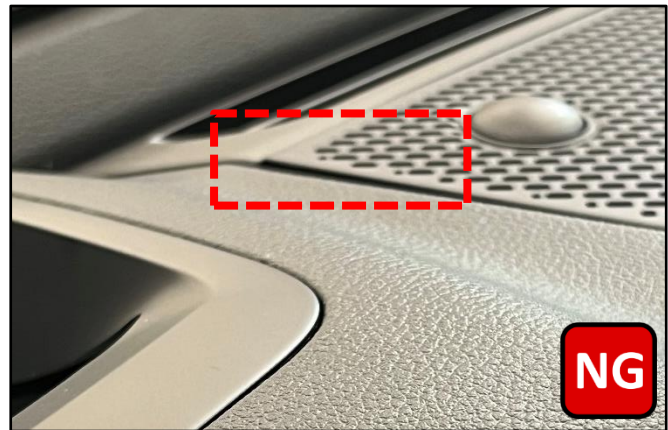
- Speaker grill cover LH corner is sticking up (NG). Proceed to 'Replacement Procedure' on page 3.

Replacement Procedure:

1. Disconnect the negative (-) battery terminal.
2. Remove crash pad center speaker grill cover (A).
