GROUP	MODEL
ELE	2022MY EV6 (CV)
NUMBER	DATE
276 (Rev 2, 03/14/2023)	December 2022

## TECHNICAL SERVICE BULLETIN

### SERVICE ACTION: EXTERNAL AMP REPLACEMENT FOR NOISE/NO SOUND ISSUES (SA520)

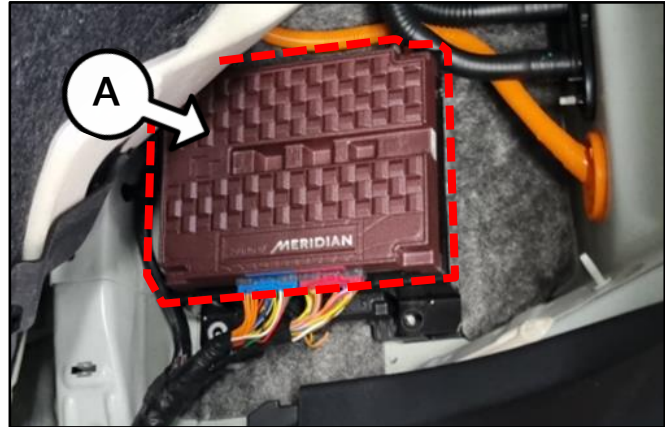
This bulletin provides the procedure to replace the external amplifier on some 2022MY EV6 (CV) vehicles produced from November 17, 2021 through January 7, 2022, that may exhibit symptoms of "noise", "no sound", "intermittent noise", and/or "intermittent no sound". Follow the procedure outlined in this publication to replace the external amplifier. If the vehicle does not exhibit the symptoms, the external amplifier still needs to be replaced if it is included in the list of affected VINs. Before conducting the procedure, verify that the vehicle is included in the list of affected VINs.

1. Replace the External AMP (A) by referring to “Body Electrical System → Audio/AVNT System → External AMP → Removal and Installation” in the applicable Shop Manual on KGIS.
