# TECHNICAL SERVICE BULLETIN

DA19-012D
 ITB19-013D
 March 9, 2023

#### AUTOMATIC EMERGENCY BRAKING WARNING LIGHT BLINKING

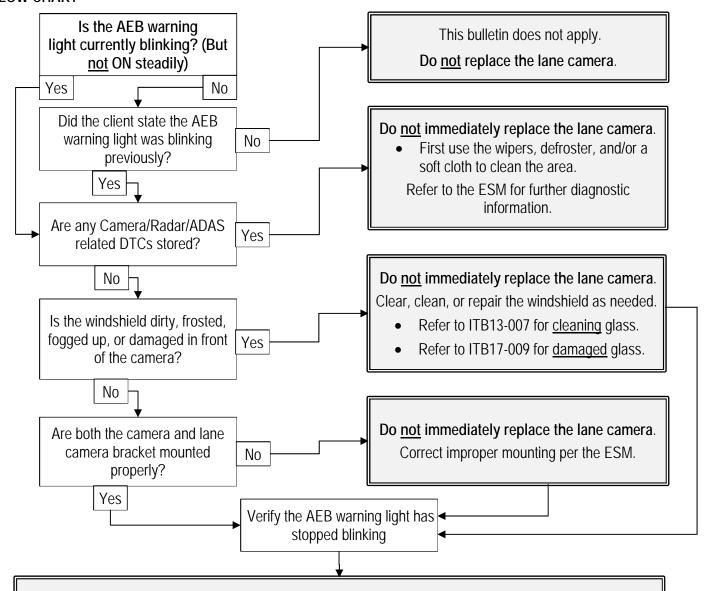
Figure 1

**APPLIED SYSTEMS:** Vehicles equipped with a lane camera (see Figure 1)

- When contamination or foreign material adhere to the lane camera viewing window on the windshield.
- When driving while it is snowing or when frost forms on the lane camera viewing window on the windshield.
- When the lane camera viewing window on the windshield is temporarily fogged up.

If the Automatic Emergency Braking (AEB) warning light or local or local or local is blinking (but not illuminated steadily) or the client states it is blinking, and there are no related DTCs, inspect the windshield.

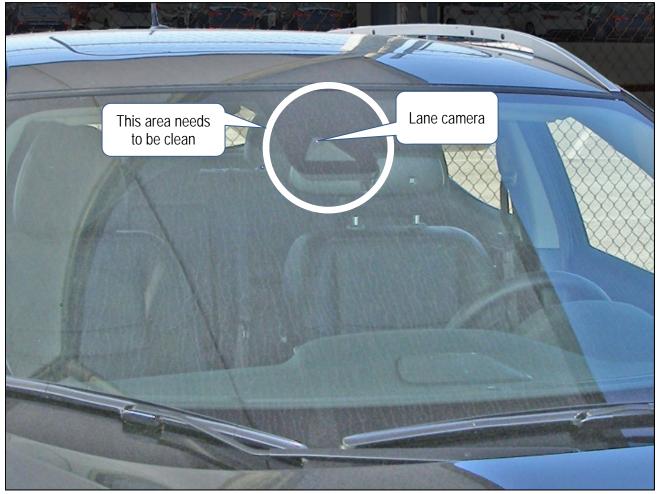
Figure 2

- Heavy rain or thick fog may cause the light to blink. Good use of wipers and keeping the windshield clean will mitigate some of the issue.
- When contamination or foreign material adhere to the lane camera viewing window on the windshield.
- When driving while it is snowing or when frost forms on the lane camera viewing window on the windshield.
- When the lane camera viewing window on the windshield is temporarily fogged up
