TECHNICAL SERVICE BULLETIN

Classification: RS19-005C	Reference: ITB19-024C	Date: March 9, 2023
------------------------------	--------------------------	------------------------

DTC B00A0-00 STORED

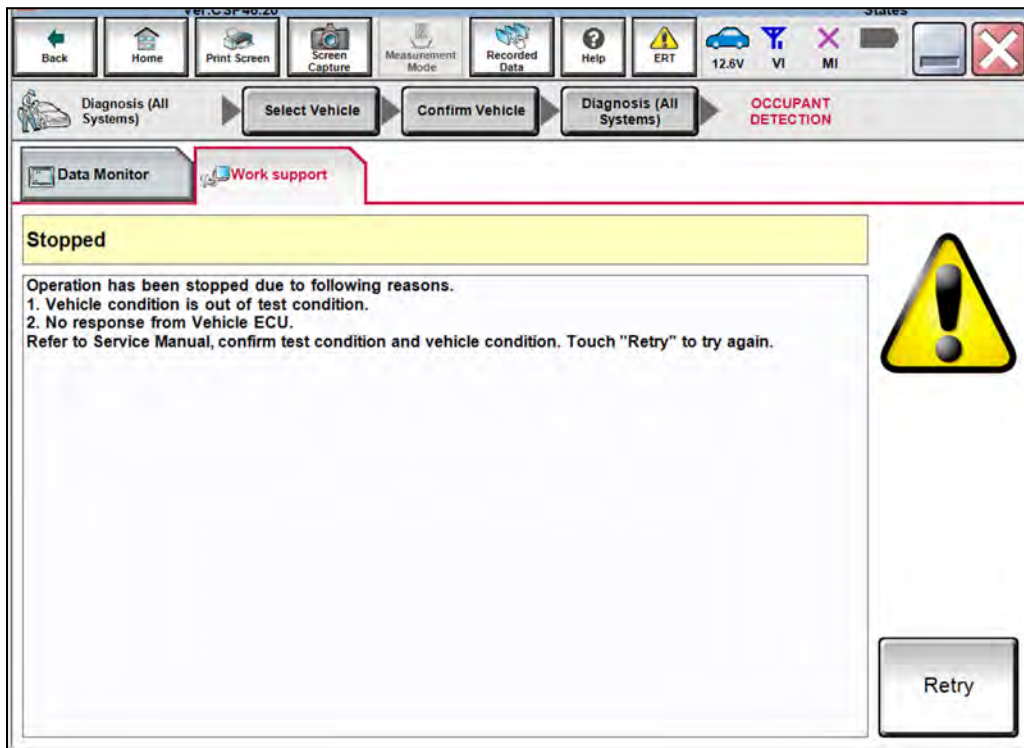
Figure 1

DTC B00A0-00 (OCCUPANT DETECTION SENSOR UNIT) is stored,

OCS zero point reset cannot be performed,

The following screen displays:

1. Check the Occupant Classification System (OCS) control unit using the ODS Analysis tool software.
 - Refer to **SERVICE PROCEDURE** on page 4.

HINT: "OCS" also may be referred to as "ODS".
2. Perform "75-Zero RESET".

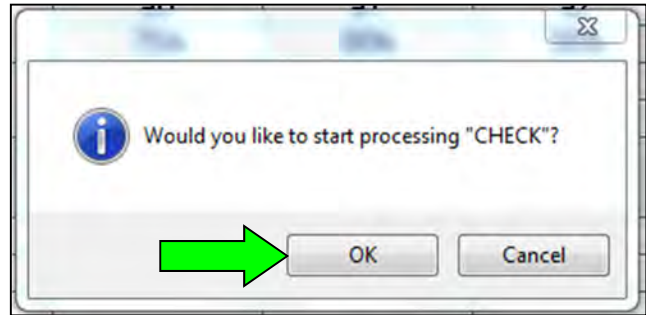
Figure 5

11. Check for code "75h" to show under **CURRENT FAILURE CODE**.

- If code "75h" shows under **CURRENT FAILURE CODE**, go to step 12.
- If code "75h" does not show under **CURRENT FAILURE CODE**, STOP HERE. This bulletin does not apply. Refer to ASIST and the ESM for further diagnostic assistance.

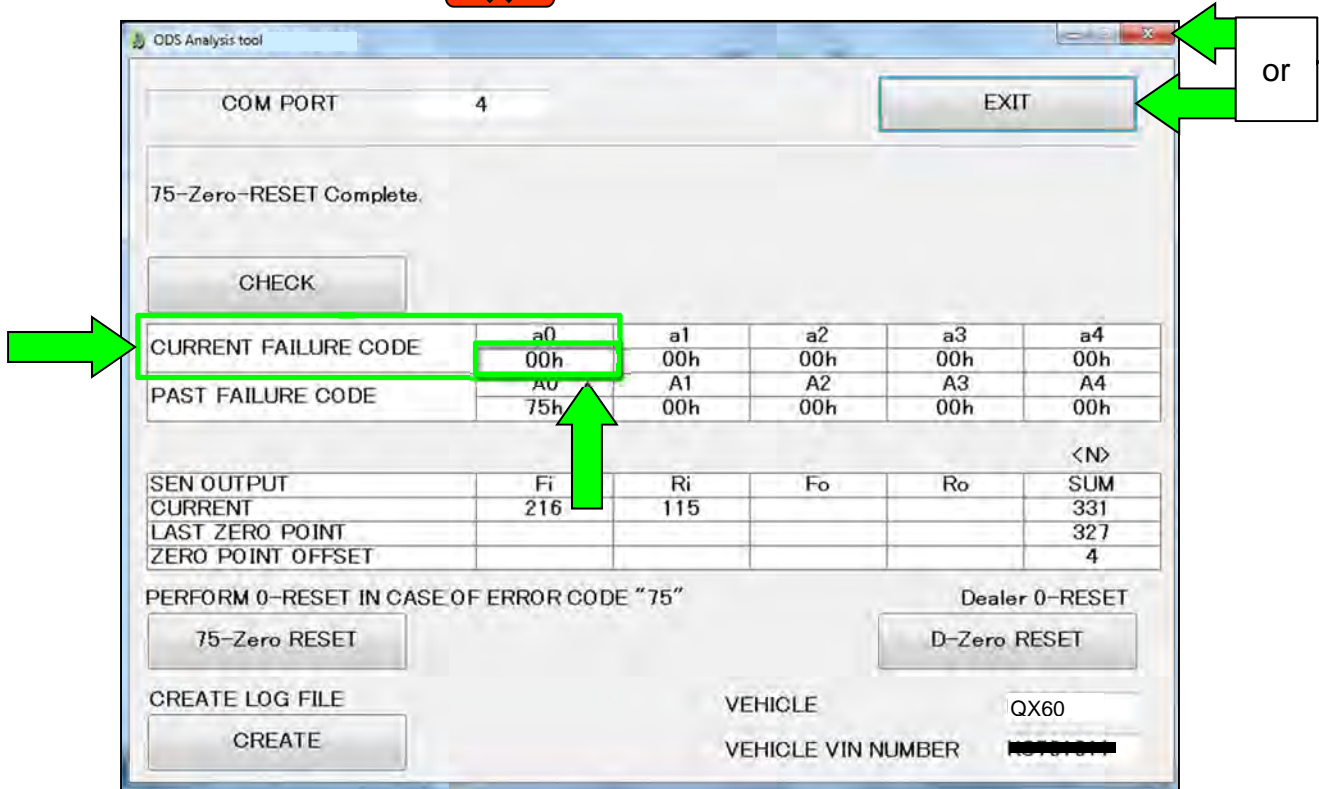
16. When the screen in Figure 9 displays, the 75-Zero reset process is complete.
 - Verify code “75h” is not displayed under **CURRENT FAILURE CODE**.
17. Select either **EXIT** or the

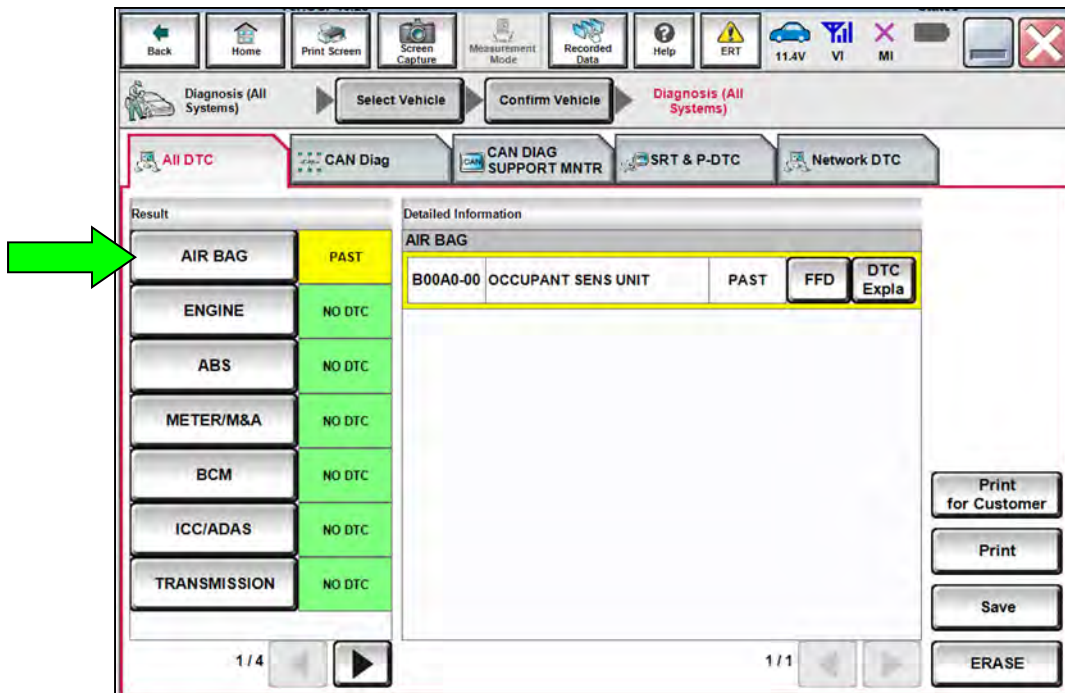
Figure 12

- DTC B00A0-00 should be the only DTC displayed.
- If DTC B00A0-00 is not the only DTC displayed, perform diagnosis and repairs as needed.
