Service Alert

Mazda North American Operations
Irvine, CA 92618-2922

Subject: CONNECTED VEHICLE SYMPTOM TROUBLESHOOTING	Service Alert No.: SA-009/23
	Last Issued : 03/28/2023

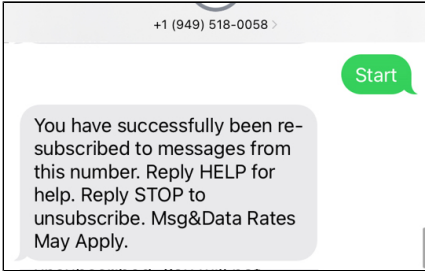
Connected Vehicle Troubleshooting			
	Symptom	Cause	Action
1	The customer is not able to create a MyMazda account. The customer receives the following error: MyMazda App - Internal Usher SDK error.	Customer inadvertently texted "Stop" to 1-949 518-0058 (Twilio SMS for Mazda)	1. Text "Start" to 1-949 518-0058 (Twilio SMS for Mazda) 2. Retry to create a MyMazda account. NOTE: USA and Canada only

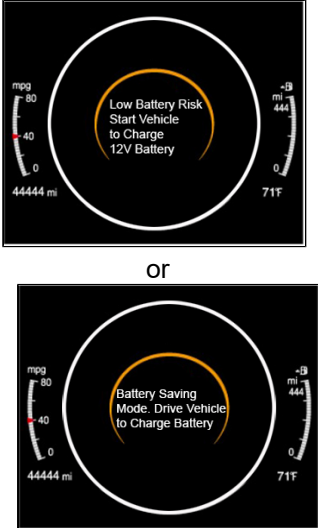
<p>Enrollment error</p>	<p>Go to SSPC1</p>
<p>8</p>	<p>2021 Mazda3, CX-30, CX-50, and MX-30 functions inoperative</p> <ul style="list-style-type: none"> • Vehicle Status Alert • Remote Engine Start / Stop • Remote Door Lock / Unlock • Remote Hazard Lights ON / OFF • Vehicle Finder (vehicle location mapping function is available) 	<p>Vehicle's electrical control area network (CAN) is in "Sleep Mode"</p>

<p>or</p> <p>No dealer visit is required. Sleep Mode can be reset by starting the engine and idling or driving for 5 minutes or longer.</p> <p>Go to 09-010/22.</p>
<p>9</p>	<p>First remote control attempt fails, second attempt works fine.</p> <ul style="list-style-type: none"> • Engine Start / Stop 	<p>Improper telematics communication unit (TCU) software.</p>	<p>Go to TSB 16-002/20.</p>
