MAZDA DEALER EMAIL

Subject: Notification of Special Service Program (SSPC8) - 2023 CX-9, 2023 Mazda3, 2022-2023 MX-30 - Remote Tuner Concern

Special Service Program (SSPC8)

2023 CX-9, 2023 Mazda3, 2022-2023 MX-30 – Remote Tuner Concern

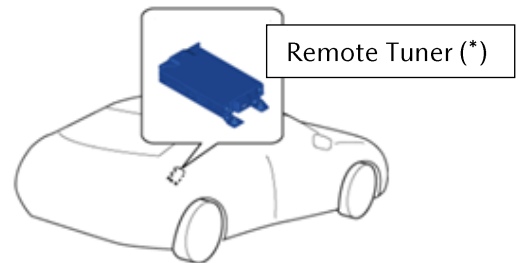
Certain Remote Tuners in subject vehicles, may have incorrect software. The power shutdown processing may not be completed due to the incorrect software. In this condition, if the vehicle is left unused for an extended period the 12V battery may discharge and finally run out.

(*) Remote Tuner:
Controls the audio signal from the entertainment related system.

Your Mazda dealer will update the Remote Tuner software in your vehicle. It will take approximately one half hour to complete the repair; however, your Mazda dealer may need your vehicle for a longer period of time.

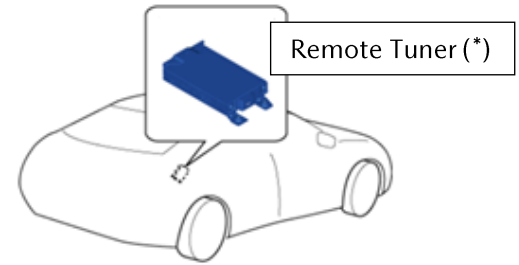
On certain Remote Tuners of subject 2023 CX-9, 2023 Mazda3 and 2022-2023 MX-30 vehicles, the power shutdown processing may not be completed. With such condition, a dark current may stay high, allowing the 12V battery to be discharged and finally run out.

Causal factor: Inappropriate software of Remote Tuner

- (*) Remote Tuner:
Controls the audio signal from the entertainment system-related parts

REPAIR: Dealers are to reprogram the software of remote tuner using an USB memory stick.
Please refer to "Repair Procedure" on the MGSS for the details.
