40 Clicking noise from wheel bearing

40 23 52 2024318/13 March 23, 2023. Supersedes Technical Service Bulletin Group 40 number 22-38 dated April 14, 2022, for reasons listed below.

Technical Service Bulletin

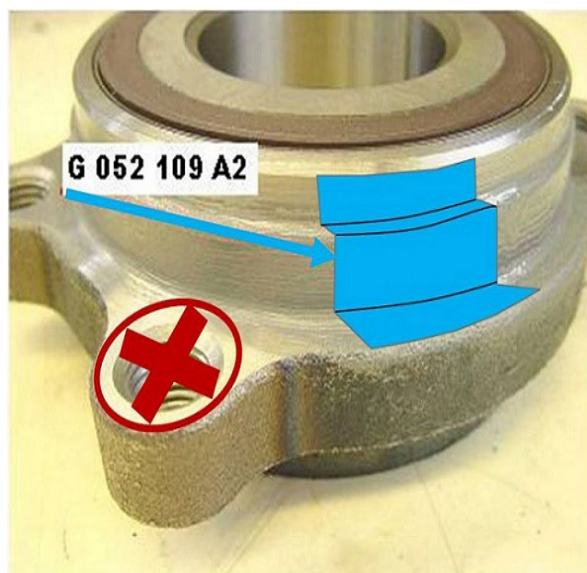
Microscopic movements between the wheel bearing and the wheel bearing housing may cause the noise (front left and/or the front right bearing can be affected).

Figure 1. Area to apply the paste.

1. On the affected side(s), remove any corrosion and dirt from the wheel bearing housing and the wheel bearing.
2. Using a brush, apply a thin coat of paste part number G 052 109 A2, using about .21 ounces or 6 grams (roughly 1/20) from the tube on the wheel bearing housing as shown (Figure 1). Make sure not to apply any paste on the threads.
