# Technical Service Bulletin

<b>Subject:</b>  <b>SCRATCH ON SEAT BACK BAR GARNISH FROM CONTACT WITH CONVERTIBLE TOP</b>	<b>Bulletin No.: 09-017/23</b>
	<b>Last Issued : 03/29/2023</b>

2016-2023 MX-5

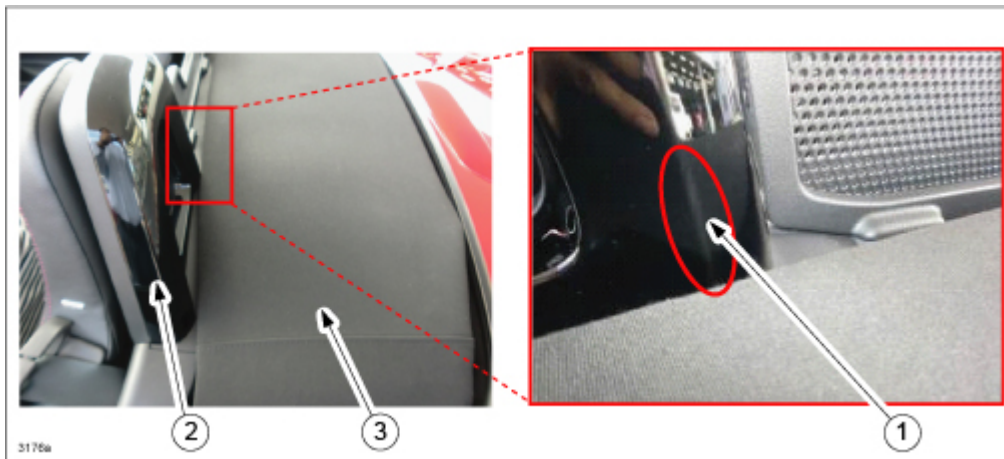
Some vehicles may exhibit scratches (1) on the rear of the seat back bar garnish (2) from contact with the convertible top (3).

Due to assembly variations, the clearance between the seat back bar garnish and the convertible top is too small on some vehicles.
