**2023-03-03**

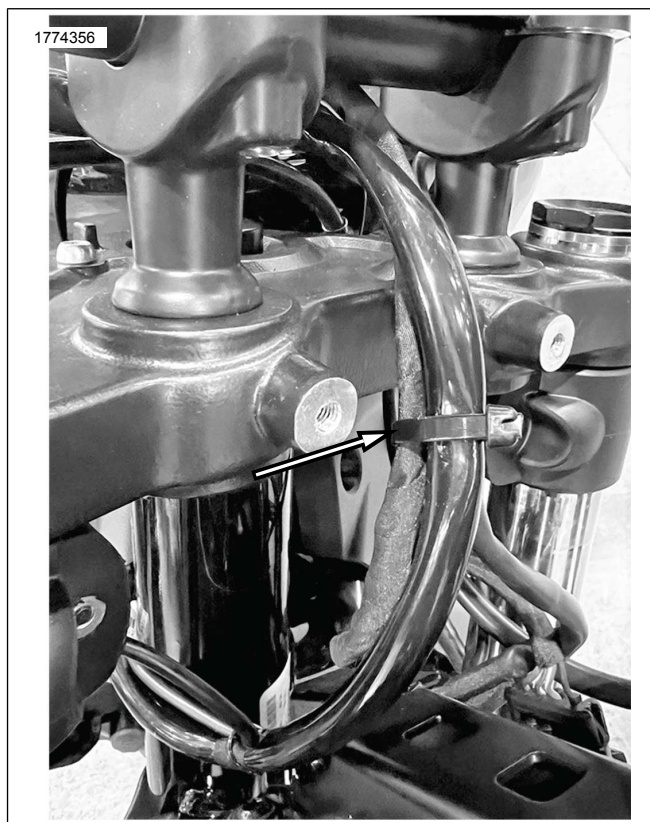
**Figure 4. Harness Routing With Cable Strap**

- See Figure 4. Some RH975 vehicles were built with a cable strap that is causing tension on the Hand Control Module (HCM) harnesses when the steering is in full-left lock or full-right lock. **If a cable strap is found, it should be removed.**

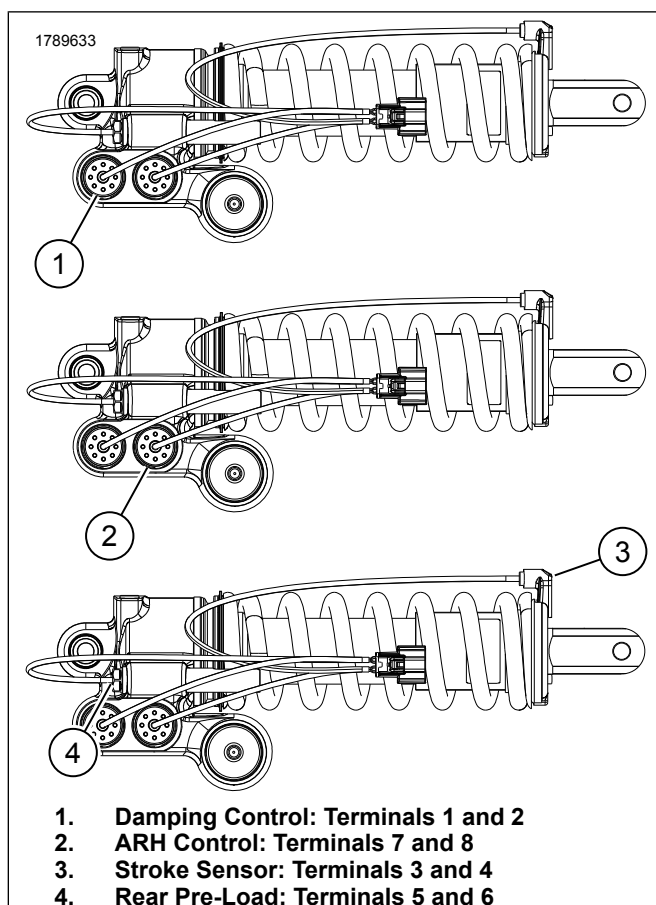
Figure 5. [344 A/B] and [345 A/B]

- Perform a general inspection of HCM jumper harness routing and correct cable strap locations. Confirming full-left lock to full-right lock that there is no excessive tension on the wire harness.
- Inspect for pinched wires near lower left engine guard mounting point.  
PAN AMERICA (RA1250, RA1250S)
- See Figure 5 and Figure 6. Inspect semi-active equipped suspension connectors [344A/B] and [345A/B] for properly seated terminals.
- Correct as needed and if a correction was performed, also perform a BCM Suspension Calibration procedure using Digital Technician II (DT II).

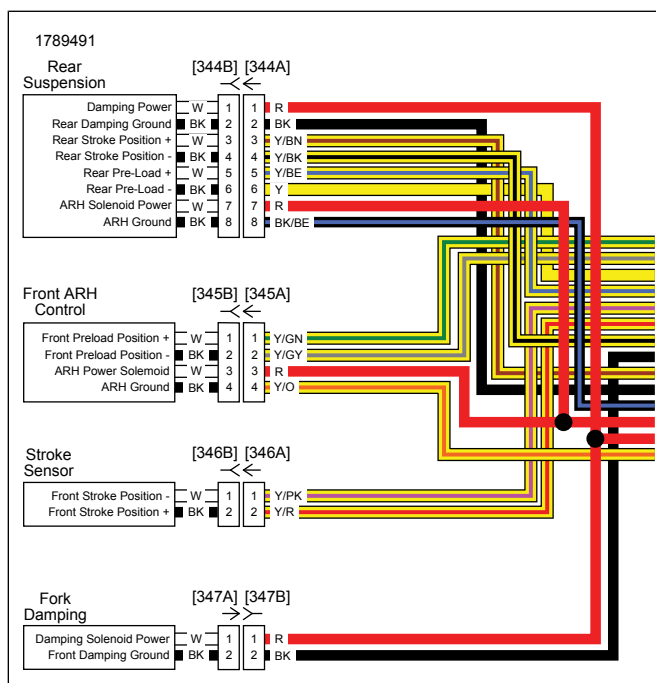
Figure 6. Black and White Wires

- **Note wire locations.** If the black and white wires are switched on a single sensor, this does not affect the function of the system. If the wires are switched between sensors, this must be corrected.
