GLOBAL SAFETY FIELD INVESTIGATIONS
DCS6522
URGENT - DISTRIBUTE IMMEDIATELY

Subject: N222375791-01 - Customer Satisfaction Program
Park Assist Retrofit

Models: 2022 – 2023 Cadillac XT4
2022 – 2023 Cadillac XT5
2022 – 2023 Cadillac XT6
2022 – 2023 Chevrolet Camaro
2022 Chevrolet Silverado 1500 LTD
2022 – 2023 Chevrolet Silverado 2500HD/3500HD
2022 GMC Sierra 1500 Limited
2022 – 2023 GMC Sierra 2500HD/3500HD

N222375791 Park Assist Retrofit

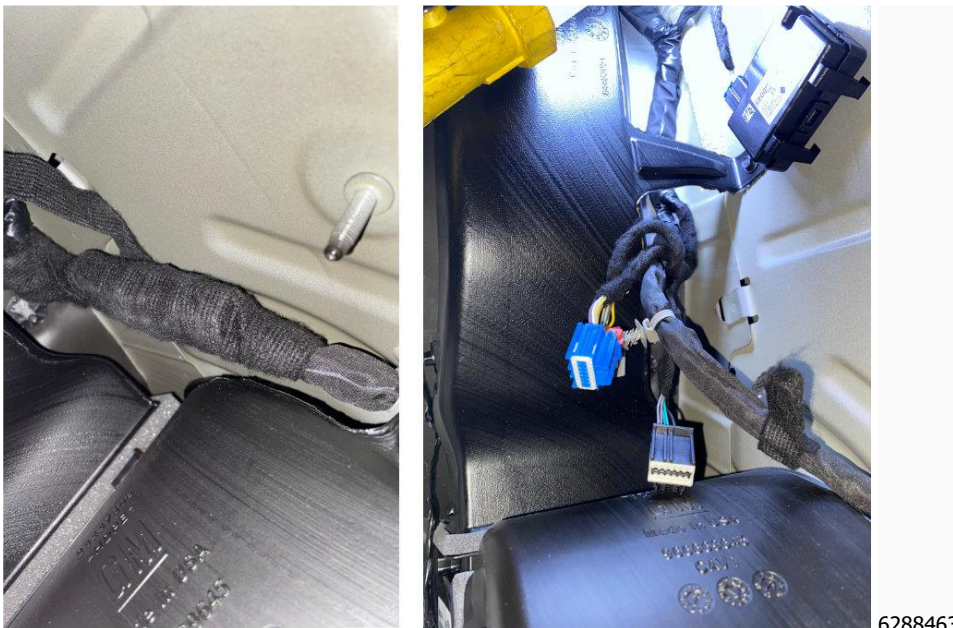
Camaro

Note: The wiring harness for the Parking Assist Control Module may be wrapped around an adjacent wiring harness as shown above. Remove the attaching tape by unwrapping. Do NOT cut the tape as it could damage the wiring harness.

1. Install the new Parking Assist Control Module. Refer to *Parking Assist Control Module Replacement* in SI.
Caution: When starting SPS2, select *Reprogram NOT Replace and Reprogram*.
2. Reprogram the Parking Assist Control Module. Refer to *K182 Parking Assist Control Module: Programming and Setup* in SI.
3. Perform setup and configuration on the Parking Assist Control Module. Refer to *K182 Parking Assist Control Module: Programming and Setup* in SI.
4. Perform setup and configuration on the Instrument Cluster. Refer to *P16 Instrument Cluster: Programming and Setup* in SI.

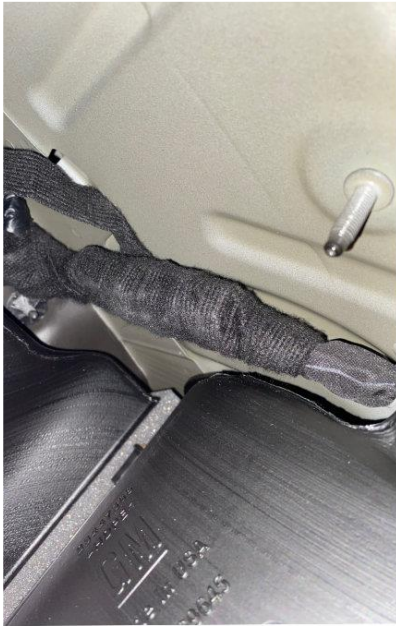
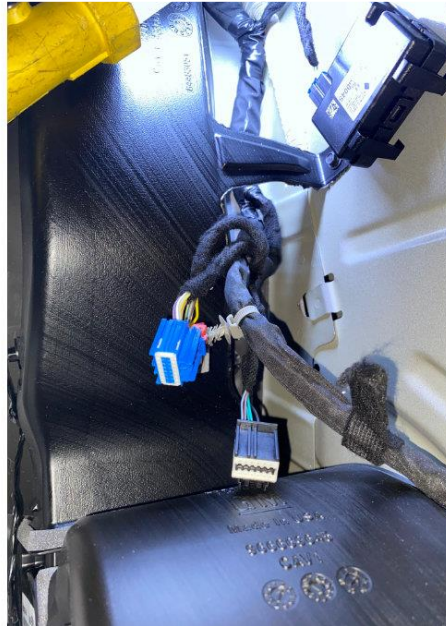
XT6

Note: The wiring harness for the Parking Assist Control Module may be wrapped around an adjacent wiring harness as shown above. Remove the attaching tape by unwrapping. Do NOT cut the tape as it could damage the wiring harness.

1. Install the new Parking Assist Control Module. Refer to *Parking Assist Control Module Replacement* in SI.

2. Reprogram the Parking Assist Control Module. Refer to *K182 Parking Assist Control Module: Programming and Setup* in SI.
3. Perform setup and configuration on the Parking Assist Control Module. Refer to *K182 Parking Assist Control Module: Programming and Setup* in SI.
4. Perform setup and configuration on the Instrument Cluster. Refer to *P16 Instrument Cluster: Programming and Setup* in SI.

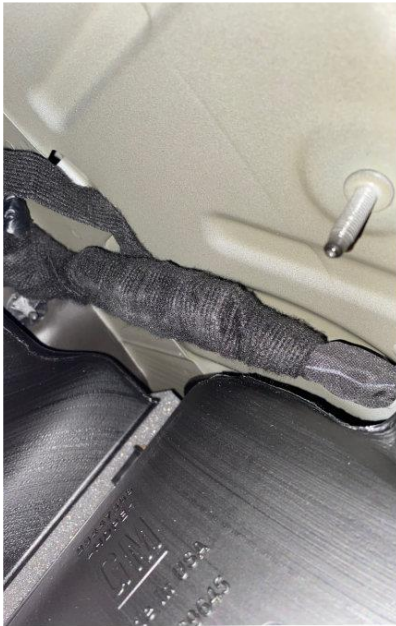
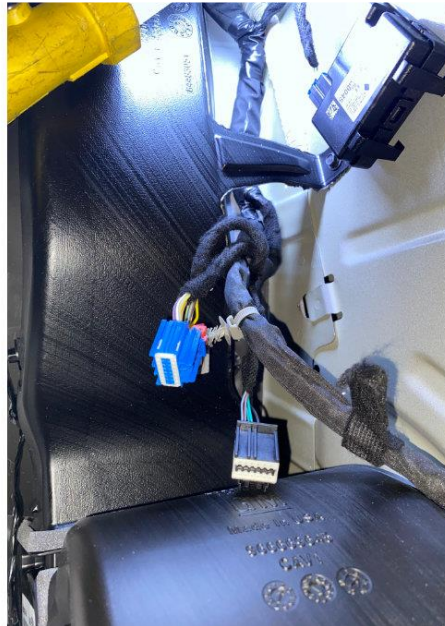
XT5

Note: The wiring harness for the Parking Assist Control Module may be wrapped around an adjacent wiring harness as shown above. Remove the attaching tape by unwrapping. Do NOT cut the tape as it could damage the wiring harness.

- Install the new Parking Assist Control Module. Refer to *Parking Assist Control Module Replacement* in SI.

- Reprogram the Parking Assist Control Module. Refer to *K182 Parking Assist Control Module: Programming and Setup* in SI.
- Perform setup and configuration on the Parking Assist Control Module. Refer to *K182 Parking Assist Control Module: Programming and Setup* in SI.
- Perform setup and configuration on the Instrument Cluster. Refer to *P16 Instrument Cluster: Programming and Setup*.

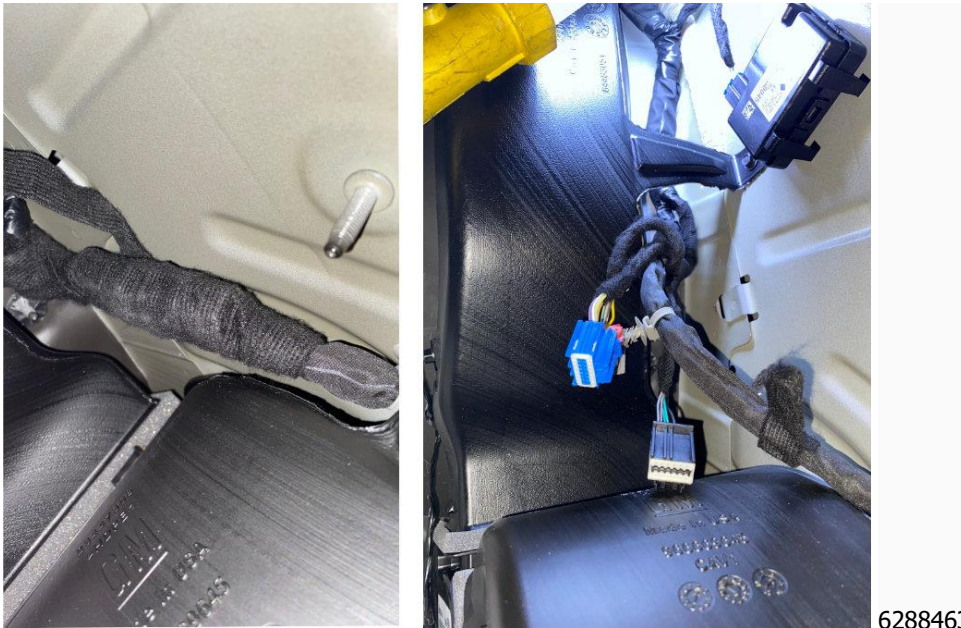
XT4 with UD7

Note: The wiring harness for the Parking Assist Control Module may be wrapped around an adjacent wiring harness as shown above. Remove the attaching tape by unwrapping. Do NOT cut the tape as it could damage the wiring harness.

1. Install the new Parking Assist Control Module. Refer to *Parking Assist Control Module Replacement* in SI.

2. Reprogram the Parking Assist Control Module. Refer to *K182 Parking Assist Control Module: Programming and Setup* in SI.
3. Perform setup and configuration on the Parking Assist Control Module. Refer to *K182 Parking Assist Control Module: Programming and Setup* in SI.
4. Perform setup and configuration on the Instrument Cluster. Refer to *P16 Instrument Cluster: Programming and Setup*.

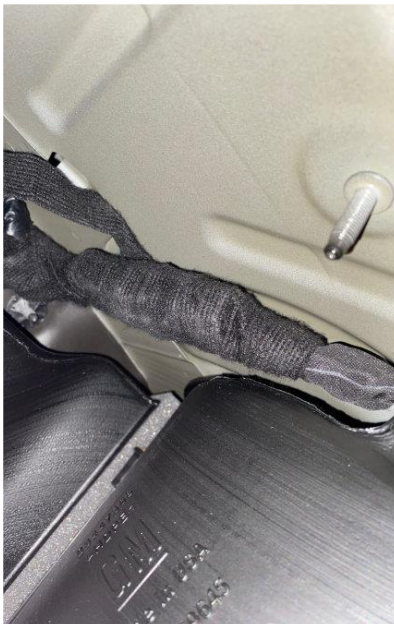
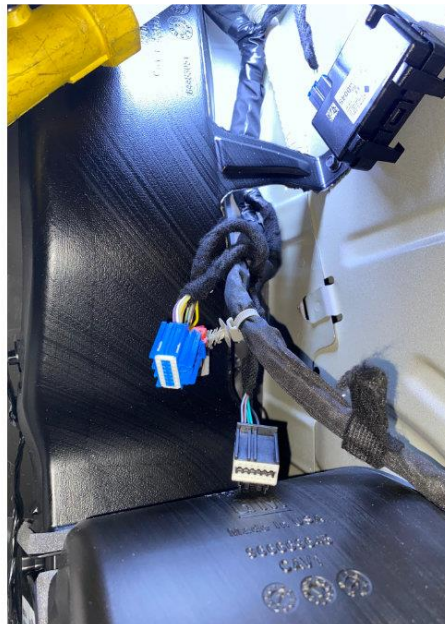
XT4 with UD5 without UGN, UVZ, or UKL

Note: The wiring harness for the Parking Assist Control Module may be wrapped around an adjacent wiring harness as shown above. Remove the attaching tape by unwrapping. Do NOT cut the tape as it could damage the wiring harness.

1. Install the new Parking Assist Control Module. Refer to *Parking Assist Control Module Replacement* in SI.

2. Reprogram the Parking Assist Control Module. Refer to *K182 Parking Assist Control Module: Programming and Setup* in SI.

3. Perform setup and configuration on the Parking Assist Control Module. Refer to *K182 Parking Assist Control Module: Programming and Setup* in SI.
4. Perform setup and configuration on the Instrument Cluster. Refer to *P16 Instrument Cluster: Programming and Setup*.

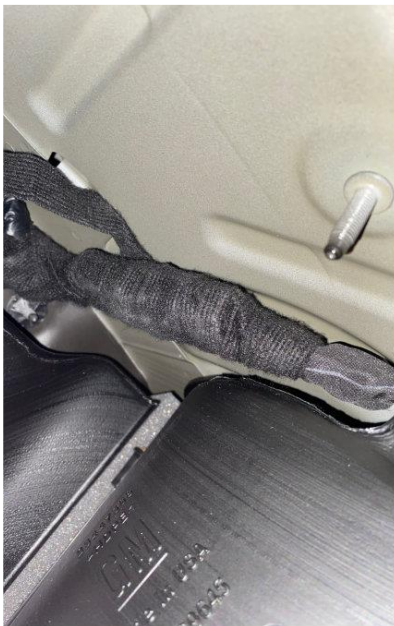
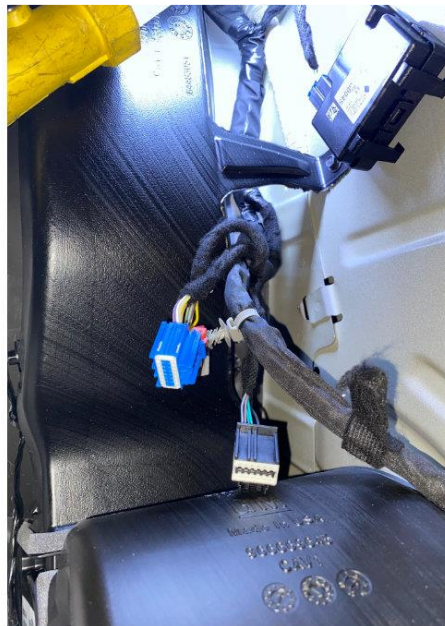
XT4 with UD5 with UGN, UVZ, or UKL

Note: The wiring harness for the Parking Assist Control Module may be wrapped around an adjacent wiring harness as shown above. Remove the attaching tape by unwrapping. Do NOT cut the tape as it could damage the wiring harness.

1. Install the new Parking Assist Control Module. Refer to *Parking Assist Control Module Replacement* in SI.

2. Reprogram the Parking Assist Control Module. Refer to *K182 Parking Assist Control Module: Programming and Setup* in SI.

3. Perform setup and configuration on the Parking Assist Control Module. Refer to *K182 Parking Assist Control Module: Programming and Setup* in SI.

4. Perform setup and configuration on the Instrument Cluster. Refer to *P16 Instrument Cluster: Programming and Setup*.

5. Reprogram the Active Safety Control Module. Refer to *K124 Active Safety Control Module: Programming and Setup*.

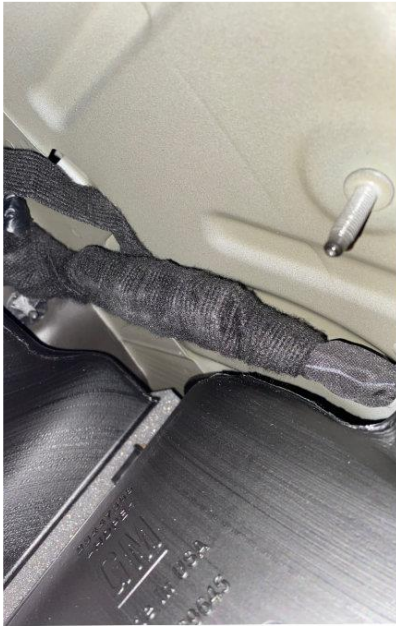
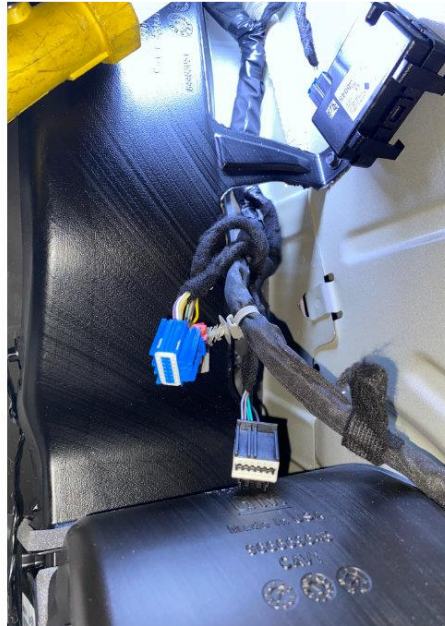
Silverado/Sierra (Includes both 2022 and 2023 LDs and HDs)

Note: The wiring harness for the Parking Assist Control Module may be wrapped around an adjacent wiring harness as shown above. Remove the attaching tape by unwrapping. Do NOT cut the tape as it could damage the wiring harness.

1. Install the new Parking Assist Control Module. Refer to *Parking Assist Control Module Replacement* in SI.

2. Reprogram the Parking Assist Control Module. Refer to *K182 Parking Assist Control Module: Programming and Setup* in SI.
3. Perform configuration on the Parking Assist Control Module. Refer to *K182 Parking Assist Control Module: Programming and Setup* in SI.
4. Reprogram the Body Control Module. Refer to *K9 Body Control Module: Programming and Setup* in SI.
5. Perform program and configuration on the Instrument Cluster. Refer to *P16 Instrument Cluster: Programming and Setup* in SI.
