92 Headlight washer jet does not retract

92 23 34 2065982/2 March 3, 2023. Supersedes Technical Service Bulletin Group 92 number 22-29 dated February 8, 2022, for reasons listed below.

Model(s)	Year	VIN Range	Vehicle-Specific Equipment
A6	2019 – 2024	All	Not Applicable
A6 allroad, and S6	2020 – 2024		
RS 6 Avant	2021 – 2024

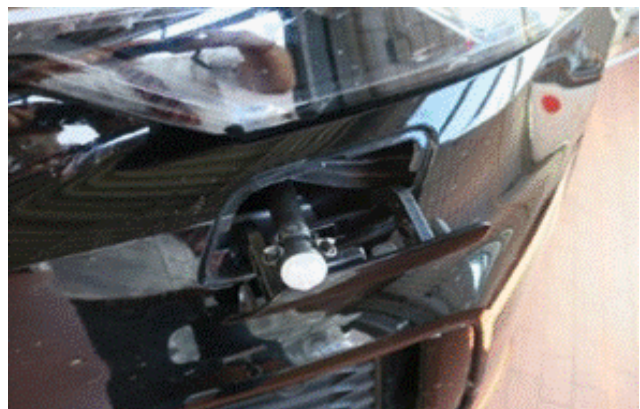
The headlamp washer nozzle/pressure cylinder does not retract automatically after a wash cycle (Figure 1).

Figure 1. The headlamp washer nozzle jammed in the extended position.

The headlamp washer nozzle/pressure cylinder binds against the headlamp washer system nozzle cover and does not retract automatically after a wash cycle.

- A precise tolerance between the headlamp washer system nozzle cover and the bumper cover aperture may prevent full closure in the presence of dirt and debris in the area.
- The headlamp washer system nozzle cover return spring exerts too great a force preventing the nozzle from retracting.
- There is physical interference between the headlamp washer system nozzle cover and the bumper cover due to inadequate positioning of the headlamp washer nozzle/pressure cylinder.

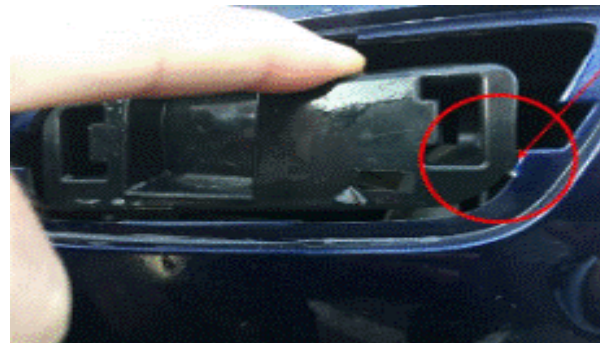
Figure 2. Interference between the headlamp washer system nozzle cover and the bumper cover.

1. Remove the headlamp washer outer cover and inspect for possible interference with the cover mechanism and the bumper cover as shown in Figure 2. Using a cutting instrument carefully trim the area of interference on the cover mechanism just enough to provide appropriate clearance to allow free movement.

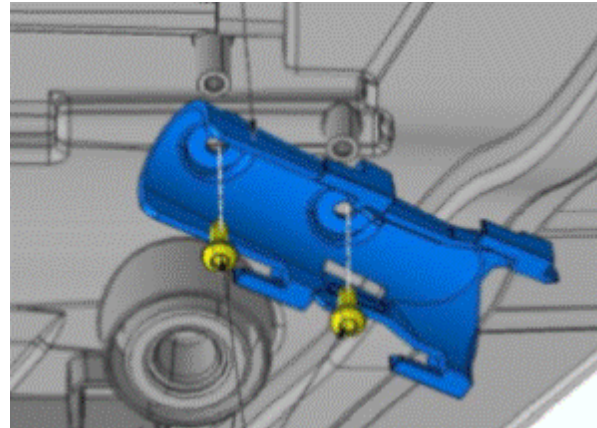
Figure 3. Headlamp washer cylinder mounting bracket screws.

2. Additionally, a small adjustment can be made to the position of the headlamp washer cylinder by loosening the two washer cylinder mounting bracket screws (Figure 3) and rotating it such that the nozzle end is rotated away from the center line of the vehicle toward the turn signal lamp on the respective side being serviced (Figure 4). Tighten the screws in the adjusted position.

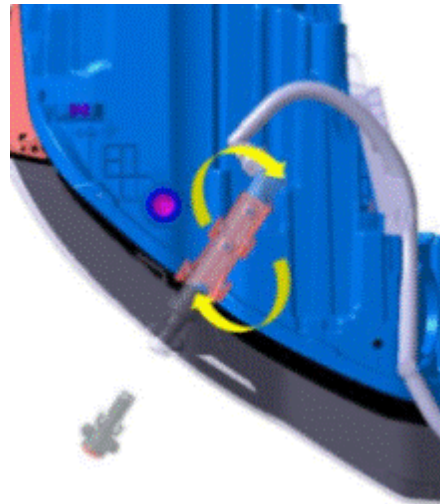
Figure 4. Desired angle of rotation of the washer cylinder.

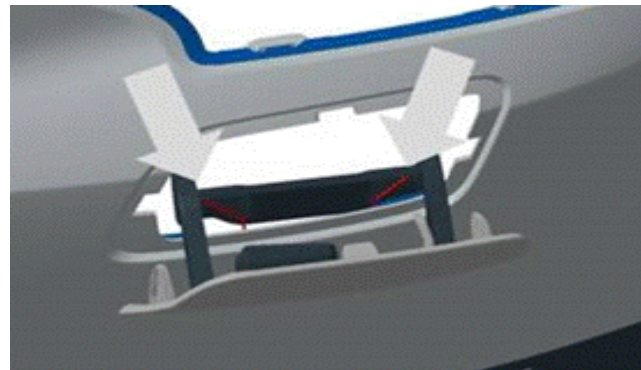
4. Make an attempt to relieve the pressure exerted on the headlamp washer system nozzle cover with your finger. If the nozzle retracts on its own check the cover spring clip version. Figure 5 shows the old version which has been found to exert excessive pressure and prevent smooth nozzle retraction.

Figure 5. Old version cover spring clip.

6. If the old spring clip version is installed and the nozzle retracts on its own after relieving the cover pressure, replacing the spring clip may solve the problem. Replace the spring clips for both the left and right sides in this case. Only the improved version spring clip is available.
7. If the nozzle does not retract after relieving the cover pressure and/or the spring version installed is of the improved type and all other inspections, adjustments, and repairs have been performed, continue root cause diagnosis as the solution specified in this TSB will not aid in solving the problem. Do not replace the headlamp washer cylinders as a replacement will not remedy this problem.

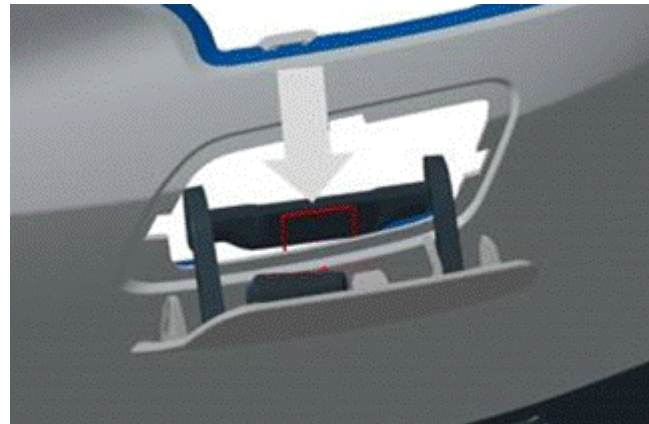
5. Figure 6 shows the improved spring clip with reduced tension.

Figure 6. Improved version cover spring clip.
