## Body/Chassis – Tailgate Anti-trap Sensor Replacements

18-22MY Range Rover (L405)

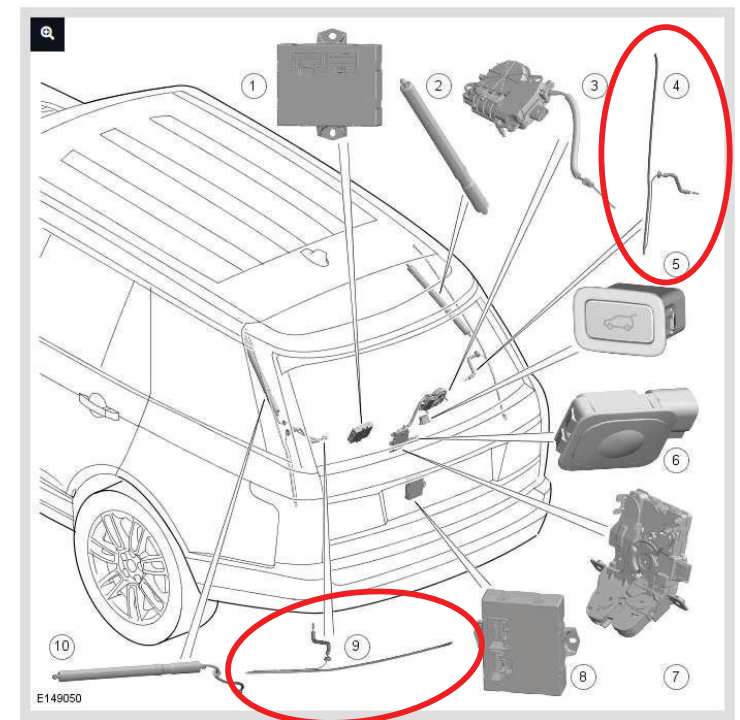
- Tailgate anti-trap sensors are being replaced for power tailgates not power folding due to a false signal.

- Anti-trap sensors being returned for inspection/testing are not finding a fault with the sensors.

- Poor connection between the anti-trap sensor and harness is suspected to be the potential cause.
- SSM75949 has been published aid in the diagnosis of an anti-trap sensor circuit issue and to request an EPQR be submitted with pictures of the sensor to harness connections.
