Service Bulletin

- Models: 2024 and Prior GM Passenger Cars and Trucks (including Medium Duty) Equipped with Gasoline, CNG or LPG Engine
- Attention: This bulletin also applies to any of the above models that may be Export from North America vehicles.

This bulletin has been revised to add the 2024 Model Year. Please discard Corporate Bulletin Number 00-06-01-026P.

Typical Intake Manifold Debris Views After Internal Engine Damage

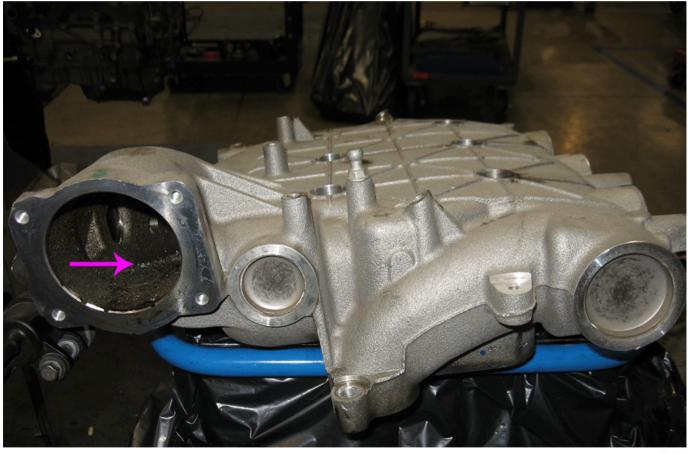
View of Debris in Aluminum Intake Manifold – Throttle Body Opening

- After removing the intake manifold from the engine, the technician **MUST** carefully inspect all of the cylinder head intake ports to see if the valve heads are still present and not bent. Usually when the valve heads are missing or sufficiently bent, internal engine component debris will be present to varying degrees in the intake port of the cylinder head. If this debris is present in **ANY** of the cylinder head intake ports, the intake manifold should be replaced.

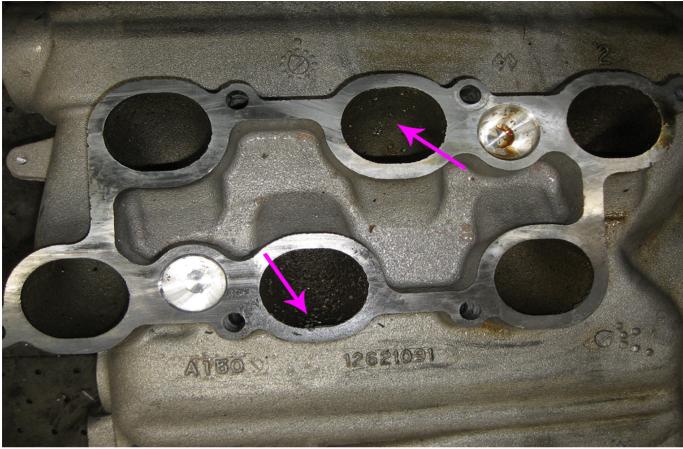
View of Debris in Aluminum Intake Manifold – Ports to Cylinder Heads

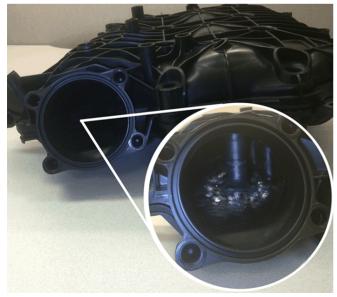
View of Debris in Plastic Intake Manifold – Throttle Body Opening

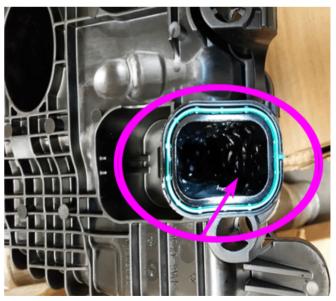
Broken valves, broken pistons and piston to cylinder head damage all create material debris that scatters throughout the induction system.

View of Broken Valve that Blew Debris Back into the Intake from the Combustion Chamber

⇒ If ANY of the above were to occur, the intake manifold MUST be replaced and the catalytic converters must be inspected or subsequent severe engine damage will occur. This replacement is required due to the complex inlet runner and plenum configuration of most of the intake manifolds, making thorough and complete component cleaning difficult and impossible to verify the complete removal of all debris.

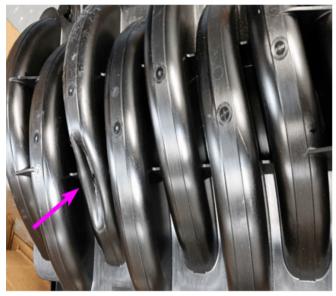
View of Intake from GEN 5 V8 that Experienced Lifter Collapse and/or Broken Valve Spring

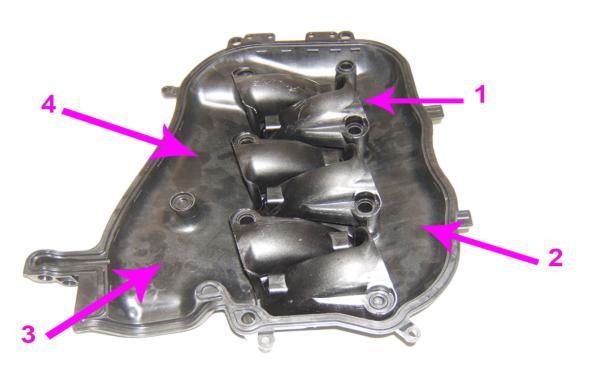
Internal View of Plastic Intake Manifold Lower Half – Plenum and Runner Complexity

Notice: The plastic intake manifold CANNOT be disassembled.

This internal view shows the plenum and runner complexity and is the reason why the intake manifold CANNOT be completely cleaned of debris.

- 1. Intake port to cylinder head opening.
- 2. Areas where debris can collect.
- 3. Areas where debris can collect.
- 4. Areas where debris can collect.
