**ANB4 - Retrofitting Locking Caps on the Front Left and Right Headlights (Stop Delivery / Recall Campaign)**

Revision: This bulletin replaces bulletin Boxster (986) Group 9 199/22 ANB4, dated January 6, 2023.

Model Line: **Boxster (986)**

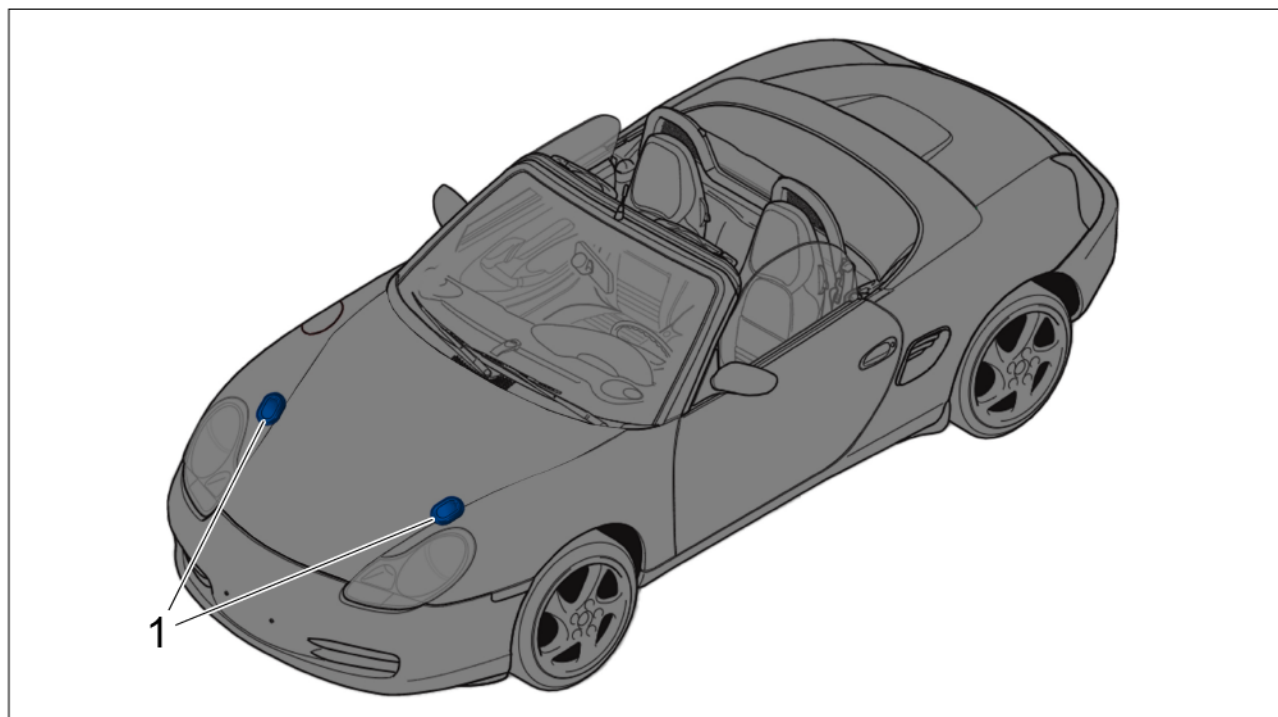
Cause: **There is a possibility that a locking cap that prevents the adjustment of the headlights in the horizontal direction was not installed on the affected vehicles during vehicle assembly. If this is the case, certain legal requirements will not be met in the USA and Canada markets.**

*Installation position of cap***1** – Locking cap (retrofit)**Required parts**

Action required: Check installation of the locking caps and retrofit a locking cap in the front luggage compartment on the left and right if necessary.

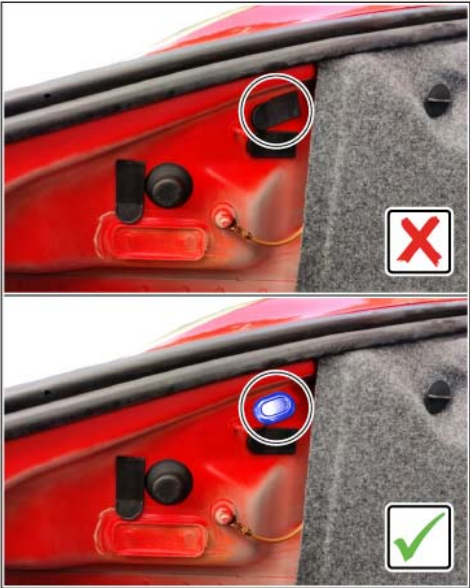
| Assessment | | Action |
|---|---|---|
| (✗) | There is <b>no</b> or only one <b>locking cap</b> installed in the front luggage compartment on the left and right. | Retrofit locking cap.<br>Continue with Step 4. |

- 3 Check that a locking cap is installed in the front luggage compartment on the left and right.  
⇒ *Checking locking cap*
