SERVICE PROGRAM BULLETIN

APPLICABILITY: 2020-2021MY Legacy and Outback
SUBJECT: Reprogramming of Denso CP1 Infotainment Units to Optimize System Performance
NUMBER: WRI-20R
DATE: 12/11/20
REVISED: 03/10/23

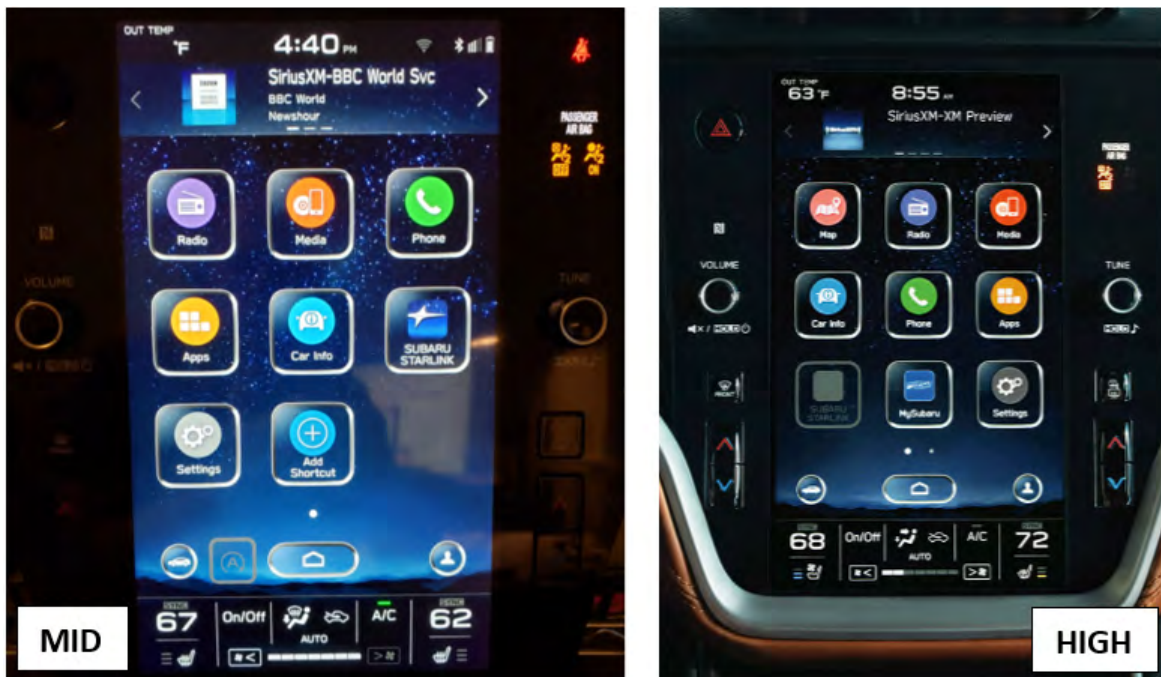
This Campaign affects certain “Mid” and “High” (w/ Navigation) -level CP1 Head Units with 11.6-inch display ONLY as pictured below. The “Base” model (2- 7.0-inch display screen unit) is NOT affected.

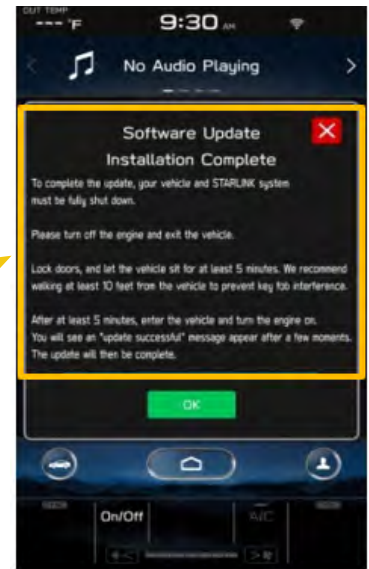
- Clarification of the post-FOTA procedure instructions required to complete the update. The screenshot below will appear and explain what must be done to complete the update installation.

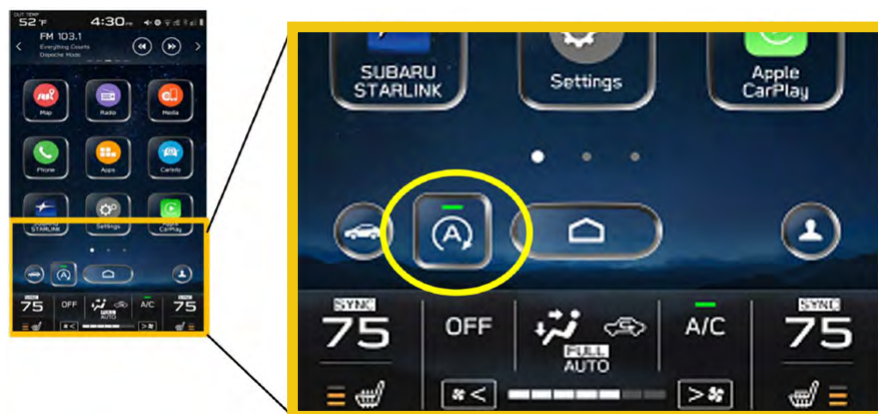
The Auto Stop-Start On/Off function button has been moved from the bottom to top layer of the system for easier use. A screenshot of how the button will appear is shown below.
