**PRODUCT CAMPAIGN BULLETIN**

**APPLICABILITY:** 2020MY Legacy and Outback  
**SUBJECT:** Rear Visibility FMVSS 111 Non-Compliance

**NUMBER:** WRH-20R  
**DATE:** 12/11/20  
**REVISED:** 03/10/23

**NHTSA ID:** 20V-766

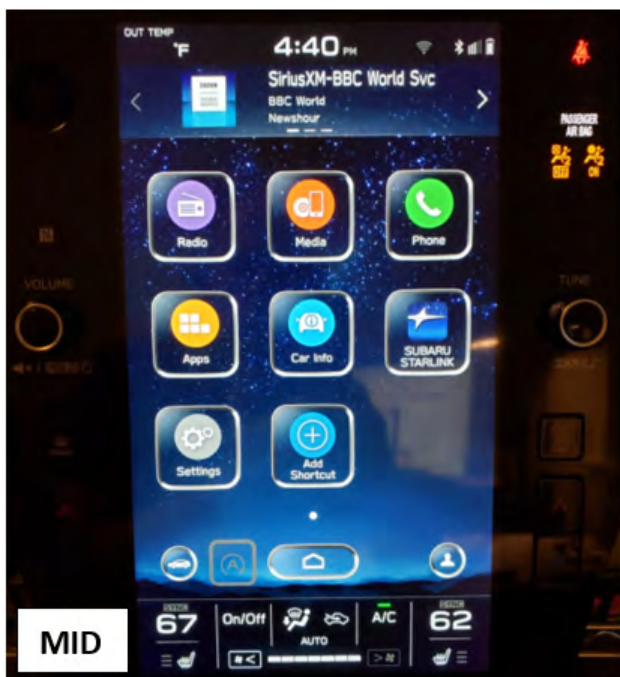
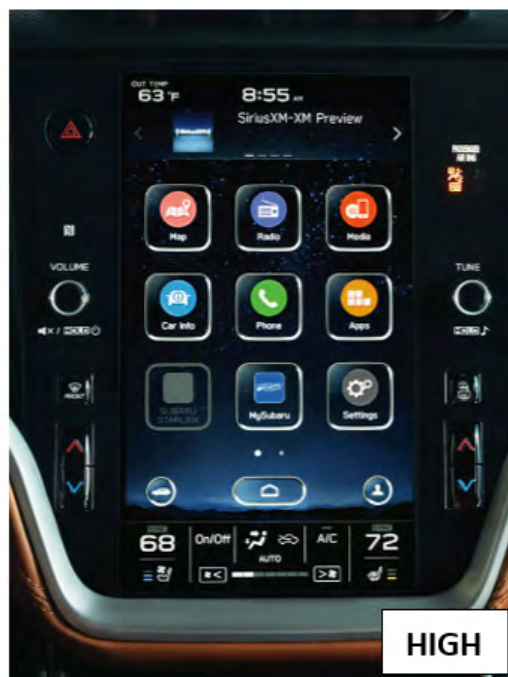
This Campaign affects certain “Mid” and “High” (w/ Navigation) -level CP1 Head Units with 11.6-inch display ONLY as pictured below. The “Base” model (2- 7.0-inch display screen unit) is NOT affected.

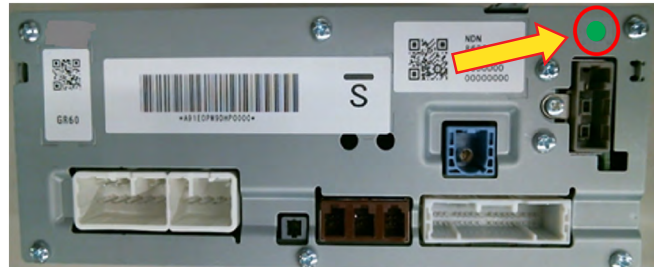
**STEP 2a:** When receiving the exchange CCM, inspect the back of the module for a GREEN dot as shown here. This **GREEN** dot signifies the module has already been updated with the latest Version 4.0 software. **NOTE:** All related CCMs shipped to retailers after 12/3/2020 have this dot. The **GREEN** dot will be applied to related exchange modules for six months. After that time, the dot will be discontinued but the modules will be OK for use. Proceed with CCM R&R following the procedure in the applicable Service Manual.

- Always record the serial number of the exchange CCM being installed on the Repair Order (RO).
- Confirm and record the software version number installed in the exchange CCM on the RO. See **STEP 3** for instructions.
- After CCM replacement, ALWAYS confirm proper back-up camera operation before releasing the vehicle.

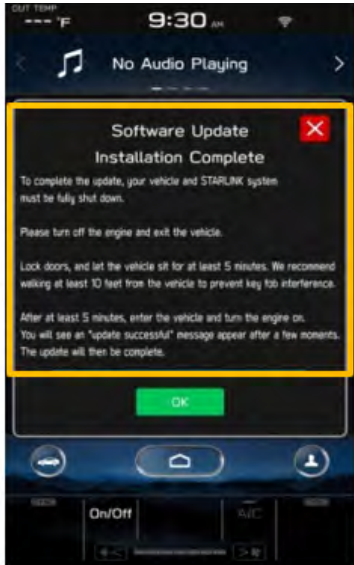
- Clarification of the post-FOTA procedure instructions required to complete the update. The screenshot below will appear and explain what must be done to complete the update installation.

**Software Update Installation Complete**  
To complete the update, your vehicle and STARLINK system must be fully shut down. Please turn off the engine and exit the vehicle. Lock doors, and let the vehicle sit for at least 5 minutes. It is recommended to walk at least 10 feet from the vehicle to prevent key fob interference. After waiting at least 5 minutes, enter the vehicle and turn the engine on. An "Update Successful" message will appear after a few moments. The update will then be complete.

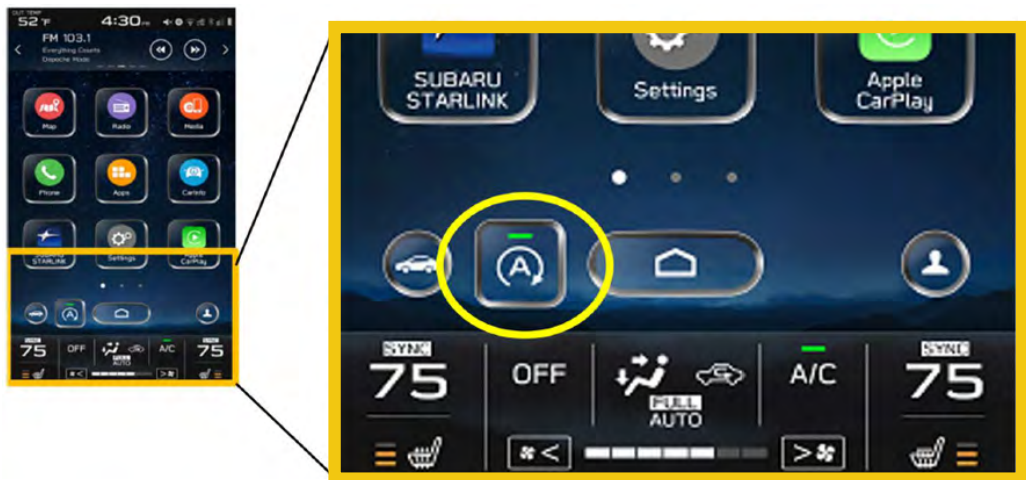
The Auto Stop-Start On/Off function button has been moved from the bottom to top layer of the system for easier use. A screenshot of how the button will appear is shown below.
