**SERVICE BULLETIN**

**APPLICABILITY:** 2020-22MY Legacy and Outback Models      **NUMBER:** 15-261-20R  
**SUBJECT:** Reprogramming File Availability for Optimization of Gen 4 Denso CP1 Infotainment Systems      **DATE:** 03/10/20  
**REVISED:** 03/13/23

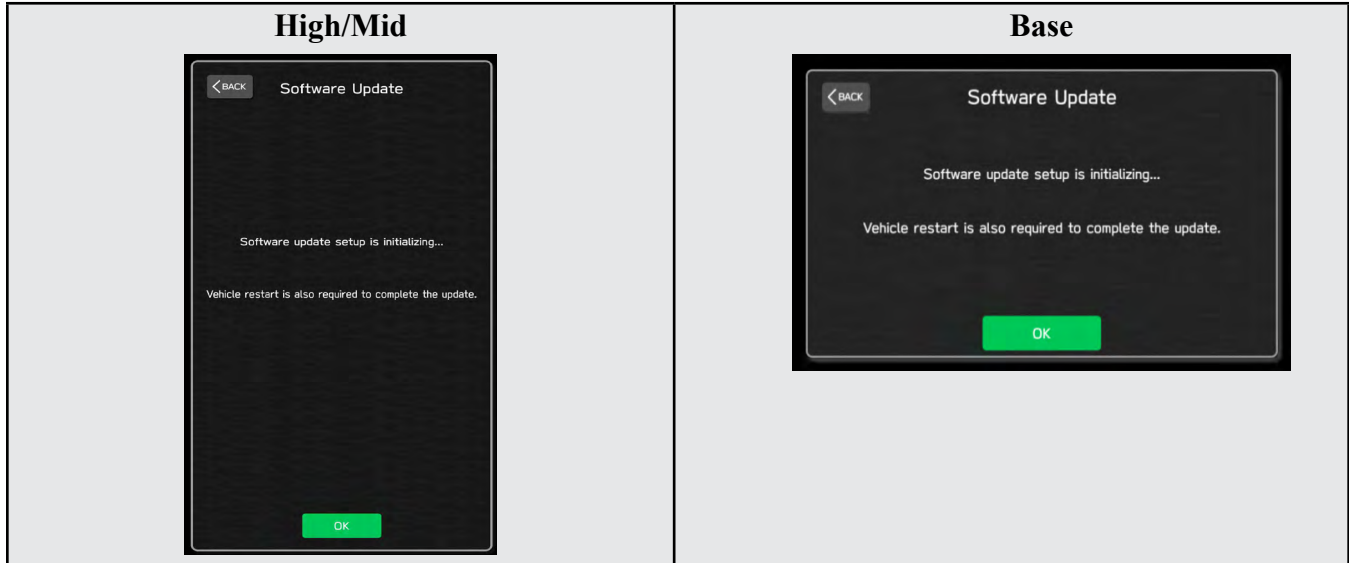
- If the screen shown below appears, **WAIT** for approximately 30 minutes or as long as necessary (waiting for longer than 60 minutes might indicate system malfunction). In that case please perform recovery according to the instructions in “Appendix B ” to allow the Software update setup initialization process to complete.

1. Turn the ignition OFF, open the driver’s door, close the driver’s door and **WAIT** for 3 or more minutes before proceeding further.
2. Open the driver’s door again and either turn the ignition ON (if a charger is connected) or start the engine.
3. Go to Dealership Mode menu again (PRESS and HOLD the RIGHT-side temperature control buttons (both up and down) and press the Tune / Scroll knob 6 times then release all to display the Dealership Mode) and select Software Update as in **STEP 4c** beginning on pg. 11.

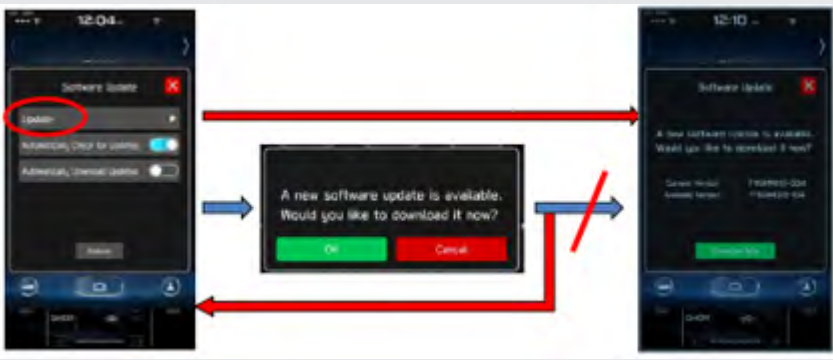
24	When using FOTA service to update the software by selecting “Setting” > “Software Update,” a message of “A new software update is available. Would you like to download it now?” is displayed but the downloading does not start after pressing “OK.” When this symptom occurs, it comes back to the “Software Update” screen. The downloading can be started by pressing the “Update” on the “Software Update” screen. (Temporary solution.)

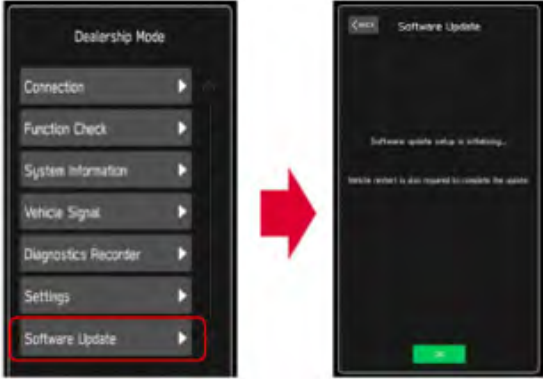
13	<p>When “Software Update” is selected in the Dealership Mode, the following initialization process does not end more than 20 minutes. *</p>

<p><b>Note*</b> In case this USB update failure occurs, retry updating according to the instructions in “Appendix A”</p>
14	<p>When the FOTA pop-up (new software availability notification) is displayed while the CarPlay is being used, the display comes back to CarPlay screen even if the customer tries to get into the FOTA screen.</p>

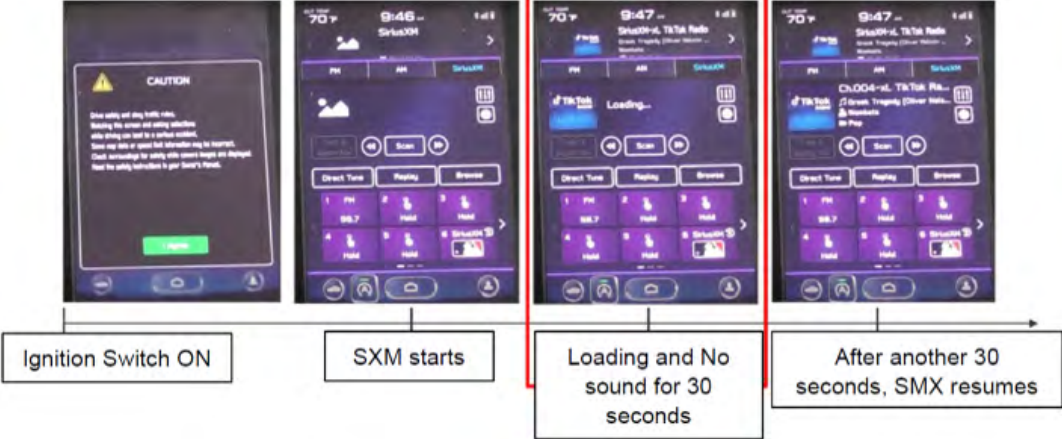
27	<p>About 30 seconds after starting the SXM the operation is paused with loading screen and resume after another 30 seconds. This symptom occurs when the SXM screen had been selected as audio source at the previous ignition off timing.</p>
