SERVICE PROGRAM BULLETIN

APPLICABILITY: 2022MY Forester
2022MY WRX
2022-23MY BRZ

NUMBER: WRB-23R

SUBJECT: Telematics Data Communications Module
Reprogramming

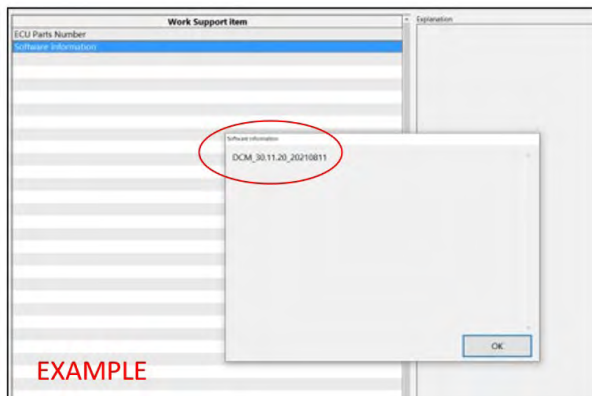
STEP 1: Connect the applicable Subaru Select Monitor (SSM) to the vehicle. Read the Software Information of the DCM. Record this information for confirmation after reprogramming is performed.

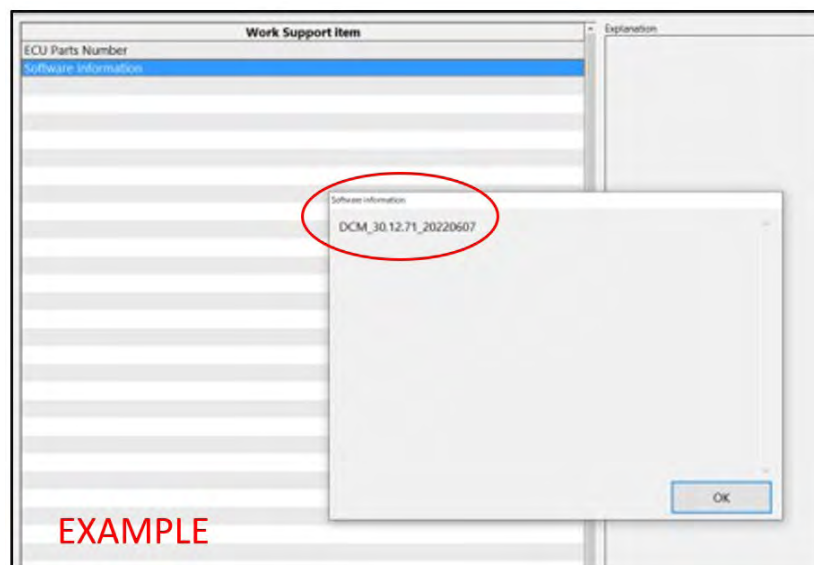
STEP 9: Using the applicable SSM, read the Software Information of the DCM.
