**SERVICE BULLETIN**

**APPLICABILITY:** 2020-2022MY Outback & Legacy  
 2022-2023MY BRZ  
 2022-2023MY WRX

**NUMBER:** 15-270-20R  
**DATE:** 8/19/2020  
**REVISED:** 03/15/23

**SUBJECT:** FOTA (Firmware Over-The-Air) Reprogramming for DENSO Gen 4 Audio / Navigation Infotainment Systems

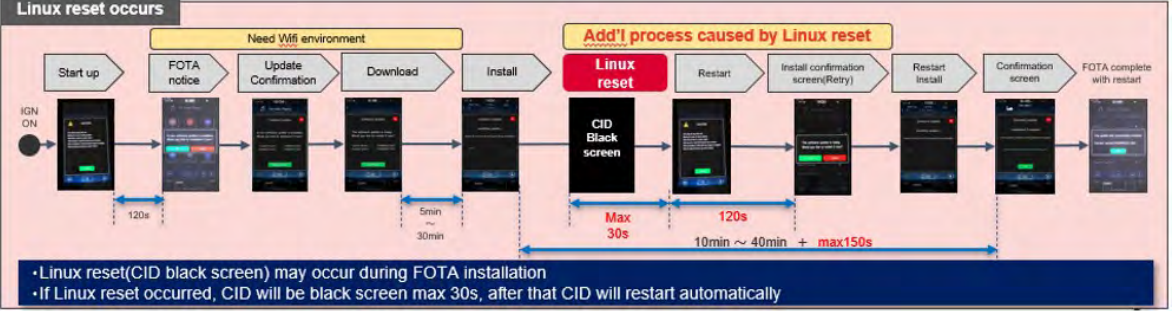
No.	Conditions/Symptoms to be improved
1	<p>System restarts itself during FOTA (Firmware Over The Air) update. FOTA operation is conducted in two processes: downloading (from the server to the Cockpit Control Unit via Wi-Fi) and installation (inside the Cockpit Control Unit). During the FOTA operation, after the new software has been downloaded to the Cockpit Control Unit (CCU) customer is to push “Install Now” on the Center Information Display (CID) to start installation of the software.</p>

<p>However, in rare case, the CCU restarts itself* during installation.</p>

<p><b>Note*)</b> Even if this symptom occurs, after approximately 2 minutes, the system resumes, and the CID comes back to the below screen. Customer can then push the “Install Now” to proceed with the installation.</p>

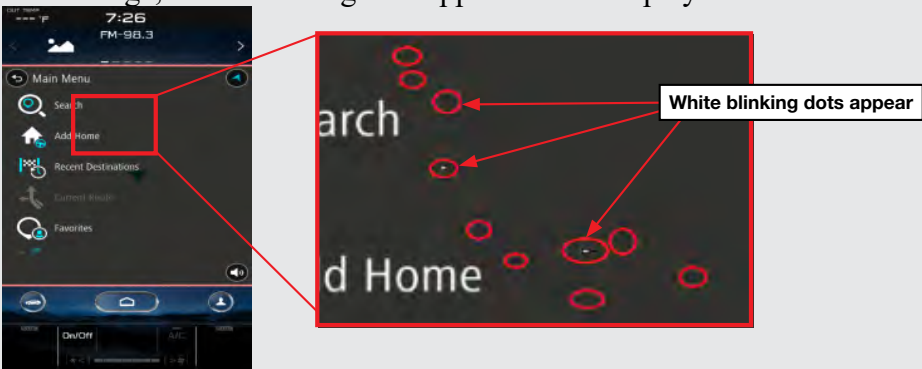
No.	Symptom to be improved	FOTA
1	Several minutes after Engine start, Center Information Display (CID) reboots itself	Yes
2	<p>After extended usage, white blinking dots appear on the display.</p>

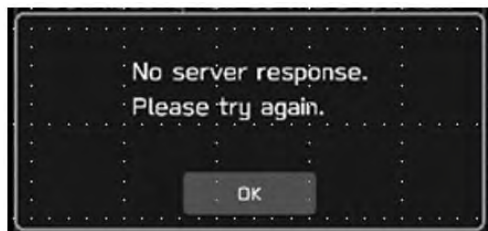
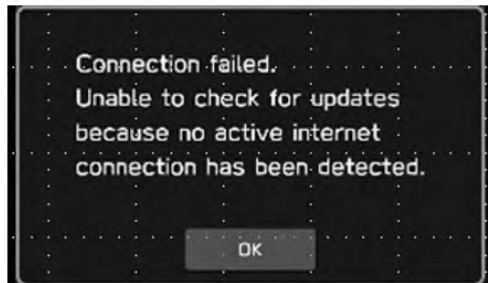
#### 2. If you receive one of the following two messages during the update process:

- a. Check the internet connection to ensure it is active and shows full signal strength.
  - i. Select General tab under “Setting” screen and change the “Wi-Fi” to Off once then turn it back to On again.

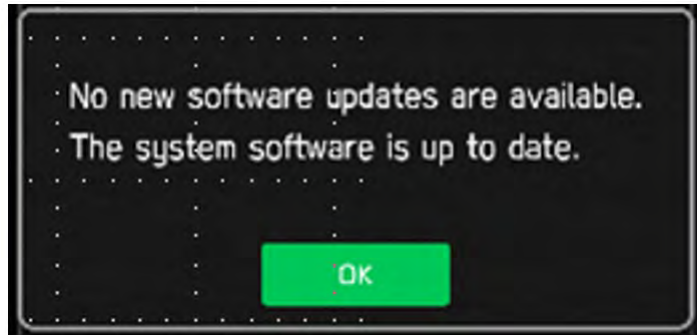
3. If the system says I'm up to date when checking for updates:

- a. If current software version is the latest, you don't need an update and no action is necessary.  
b. If the software version is not the latest, you are likely not eligible for FOTA update at this time. Please proceed with USB update following TSB 15-261-20.

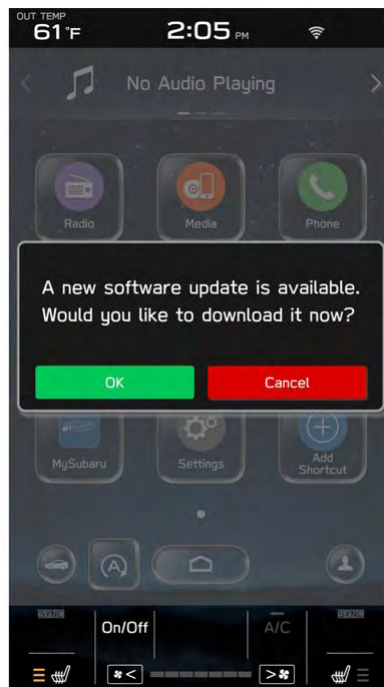
4. If the "OK" button does not respond when I begin the update process:

- a. If CarPlay application is running at the time the pop-up screen comes up, the screen is being disabled for OK operation. Please press the home button on the display, go to Settings, Software Updates, Update, and begin again.

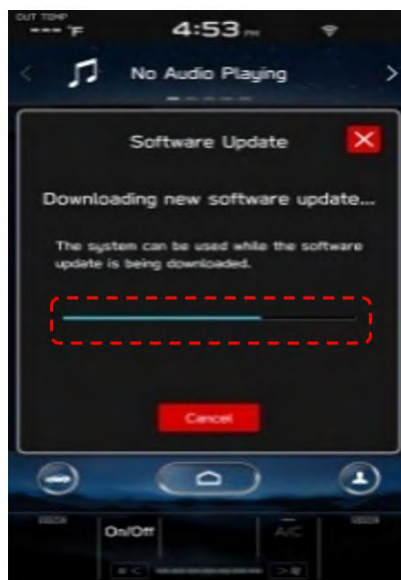
- 5. If the “progress bar” does not progress after selecting “Download” or, if you receive a “Connect to Wi-Fi” popup while downloading:

- a. Check your internet connection to ensure its active and shows full bars of connectivity.

- b. Try moving the vehicle closer to the Wi-Fi source. If that is not possible, try a different Wi-Fi connection such as a phone hotspot.

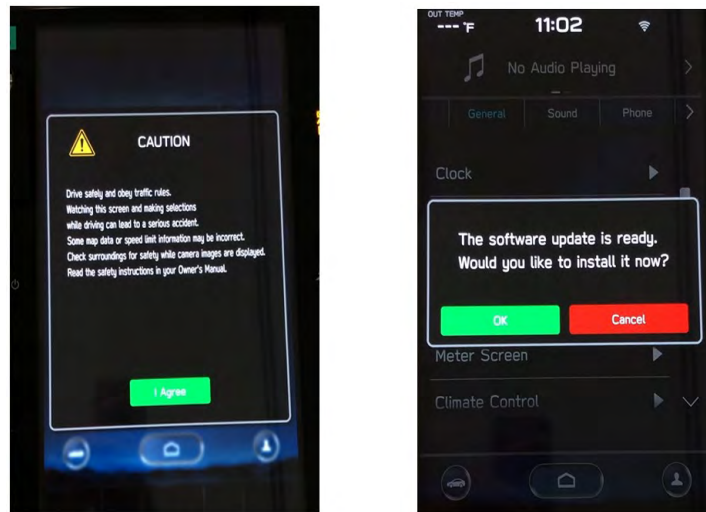
**6. If you encounter a blank screen and the update restarts during the installation process:**

- a. If the display screen goes blank during the installation process, leave the vehicle on and allow the system to restart. After up to two minutes, you will receive the message: “The software update is ready. Would you like to install it now?”. Press OK to continue.

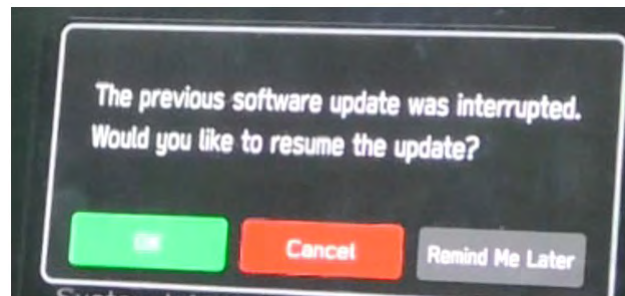
**7. If you receive the following message during the update:**

- a. The above message will display if the vehicle is turned off during the software update process. Select “OK” to resume the process.
