TECHNICAL SERVICE BULLETIN

Classification: FA12-001J	Reference: NTB12-055J	Date: March 29, 2023
------------------------------	--------------------------	-------------------------

CLICKING NOISE FROM FRONT OR REAR AXLE DURING TAKE-OFF/ACCELERATION

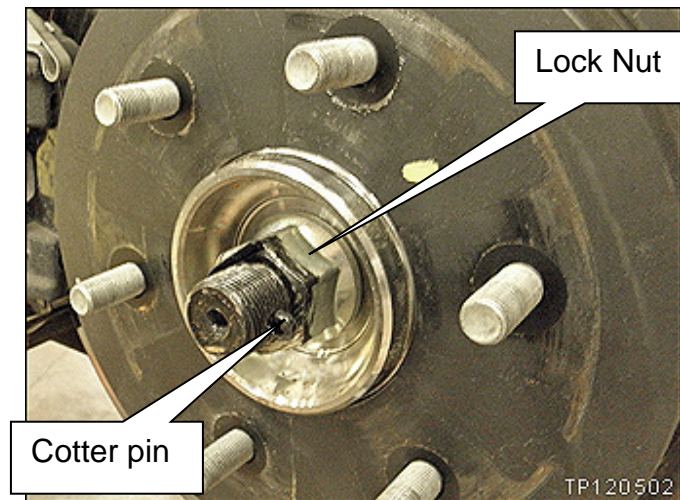
Figure 1

A “clicking” noise coming from either left or right front/rear CV-type axles during take-off/acceleration.

1. Remove the front or rear (depending on model) wheel bearing Cotter Pin and Lock Nut from the axle.

Some of the **APPLIED VEHICLES** require the axle nut to be removed with a Cape Chisel, to prevent axle thread damage. Refer to NTB21-013 for specific details.

HINT: Do not remove the axle from the hub or transmission for this bulletin.
