# **SERVICE BULLETIN**

APPLICABILITY: 2019-22MY Ascent NUMBER: 07-219-23R

SUBJECT: Genuine Alternative Battery Replacement

Bulletin Number: 07-219-23R; Revised: 03/27/23

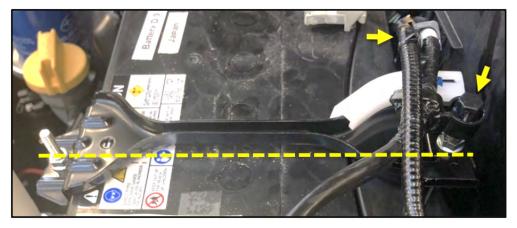
**NOTE:** Confirm the battery holder is center mounted with the battery cables secured and routed correctly.
